# Cayuga Coal Ash Disposal Facility

Mitigation & Remediation Options

John Dennis and Brian Eden

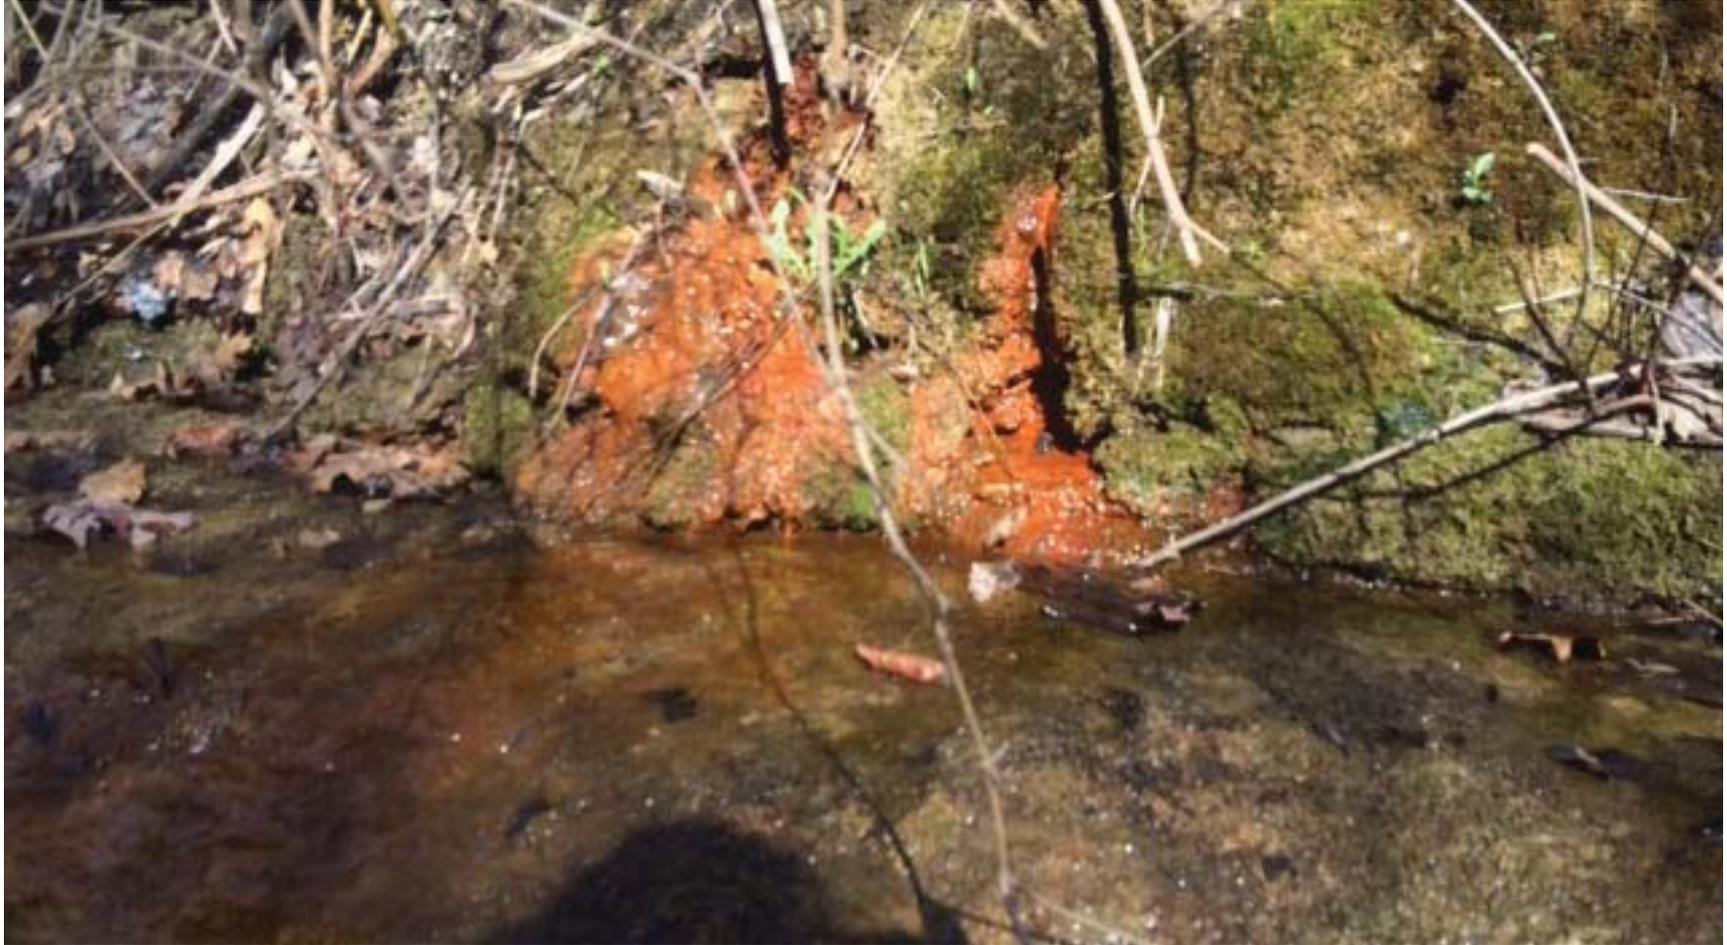
# Suspected Coal Ash Leachate Seep

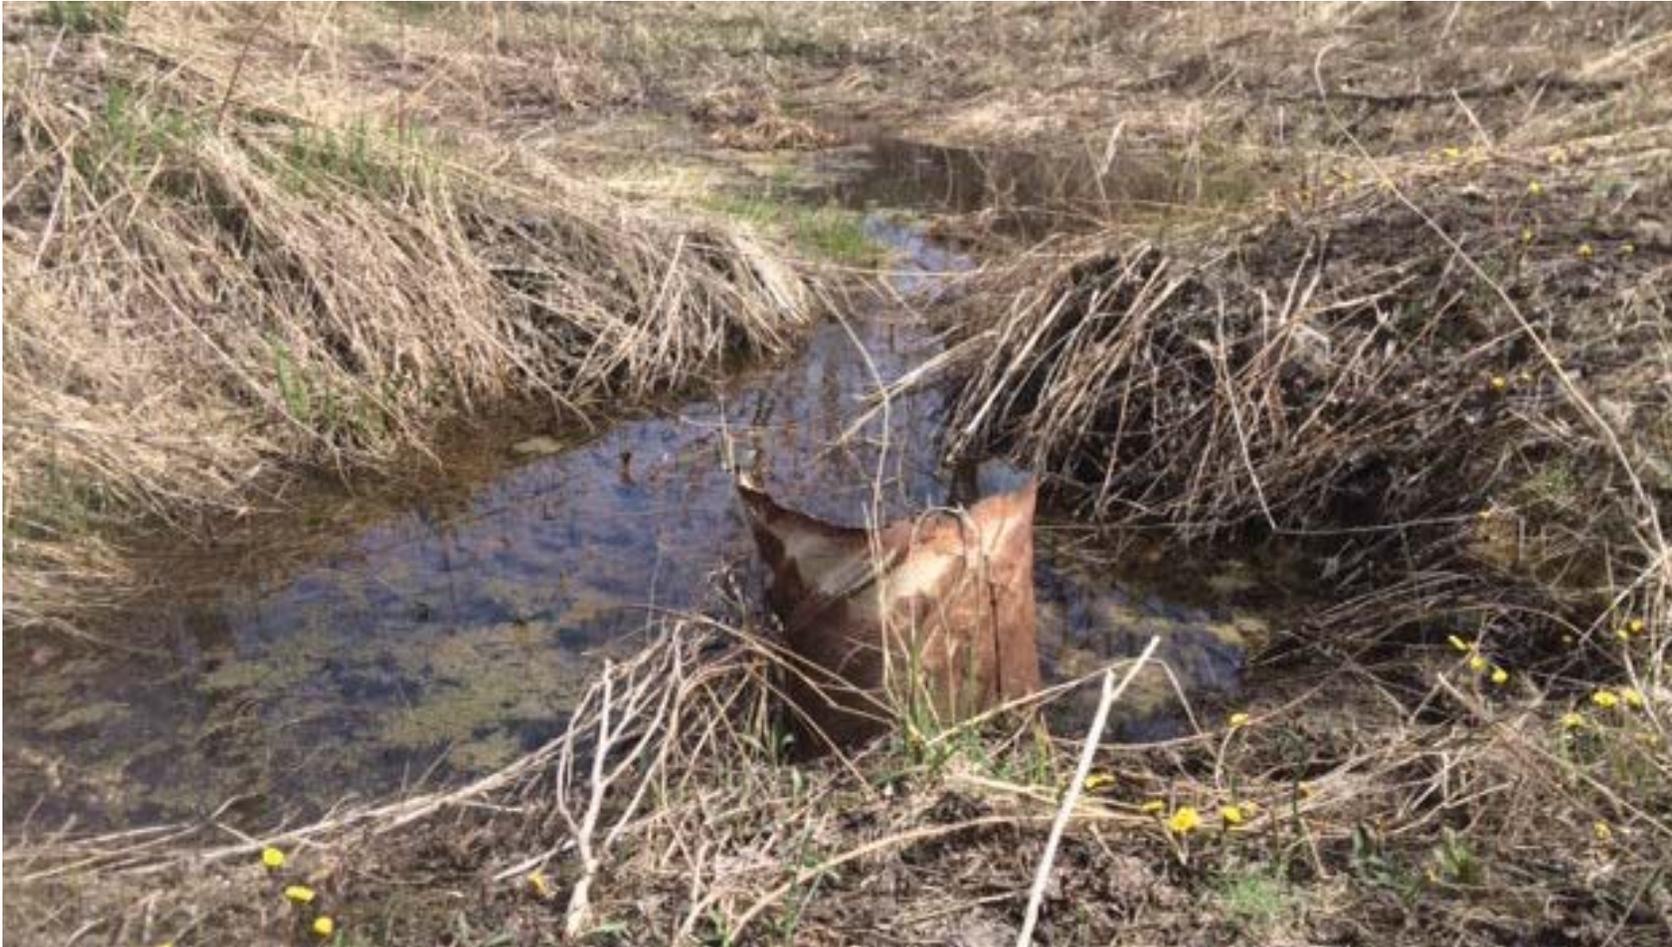
# Illegal Coal Pile Effluent Basin

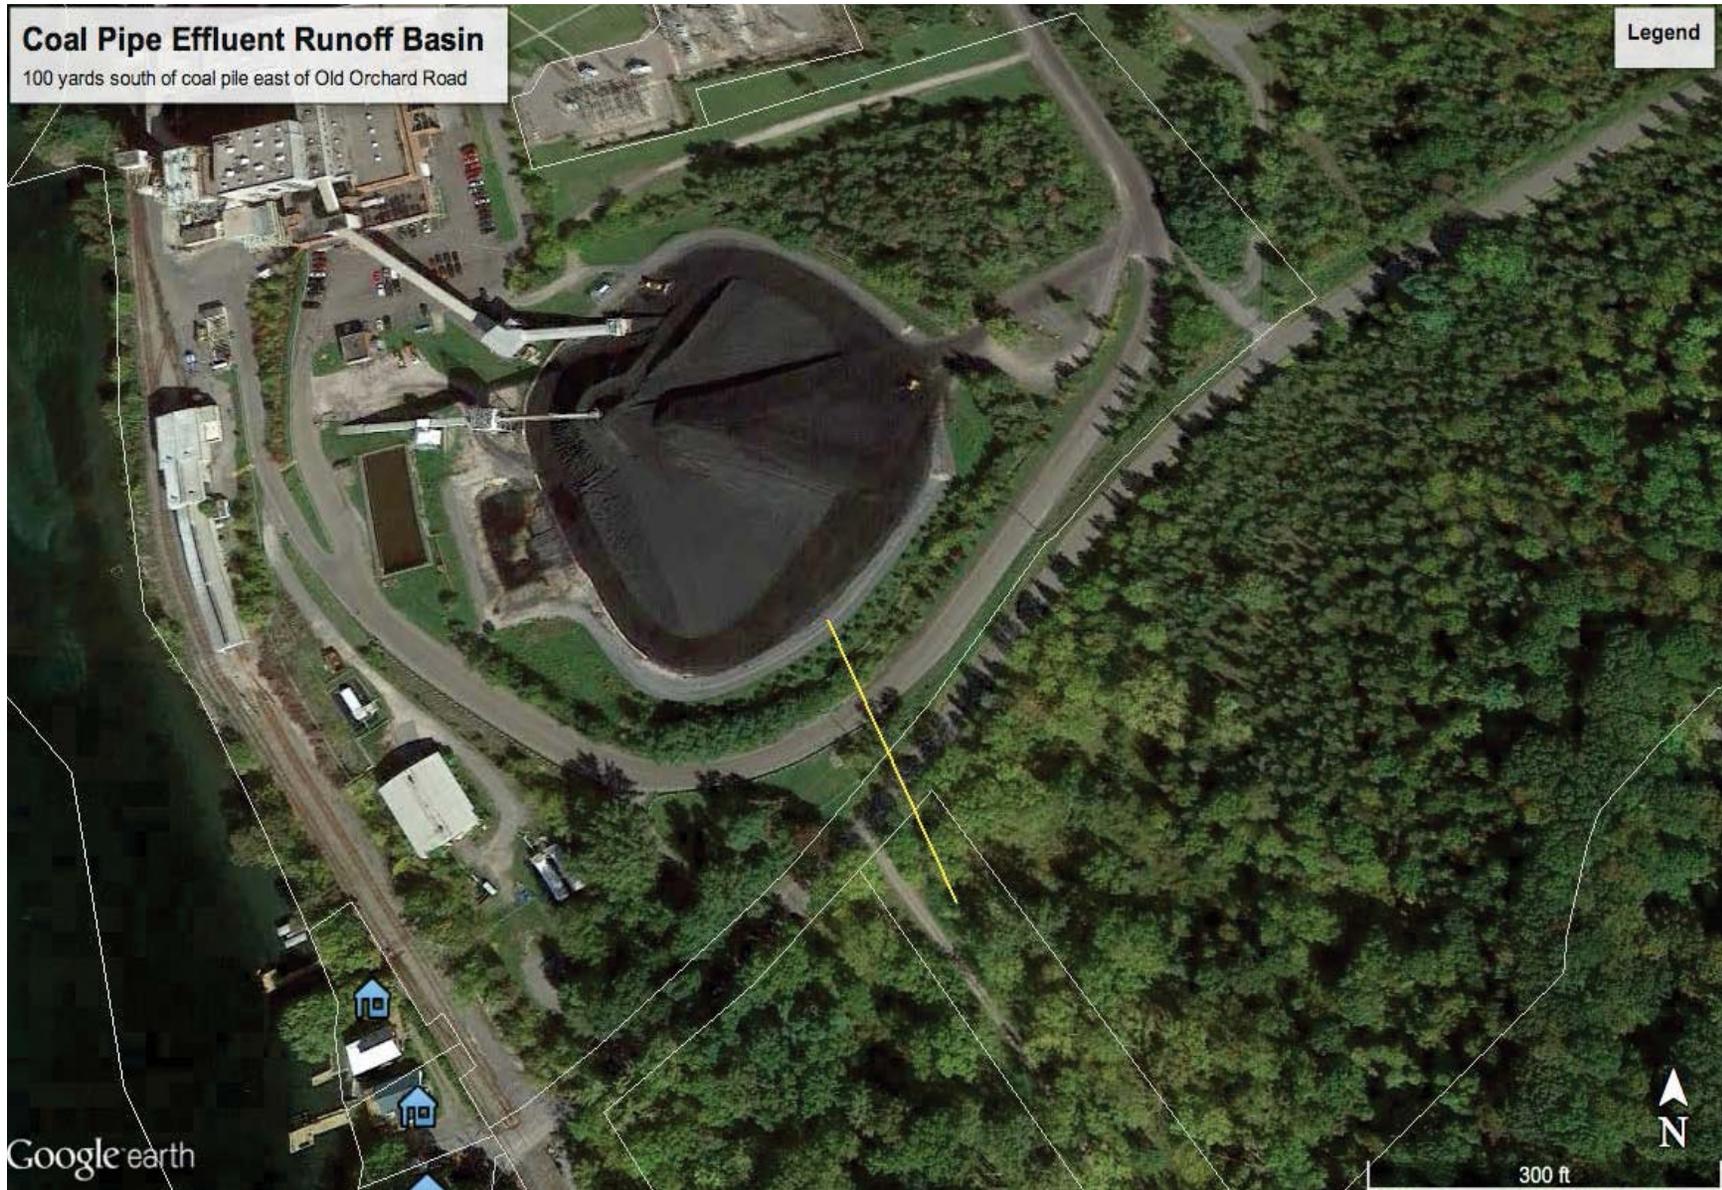
100 yards south of coal pile east of Old Orchard Road

# Coal Pipe Effluent Runoff Basin

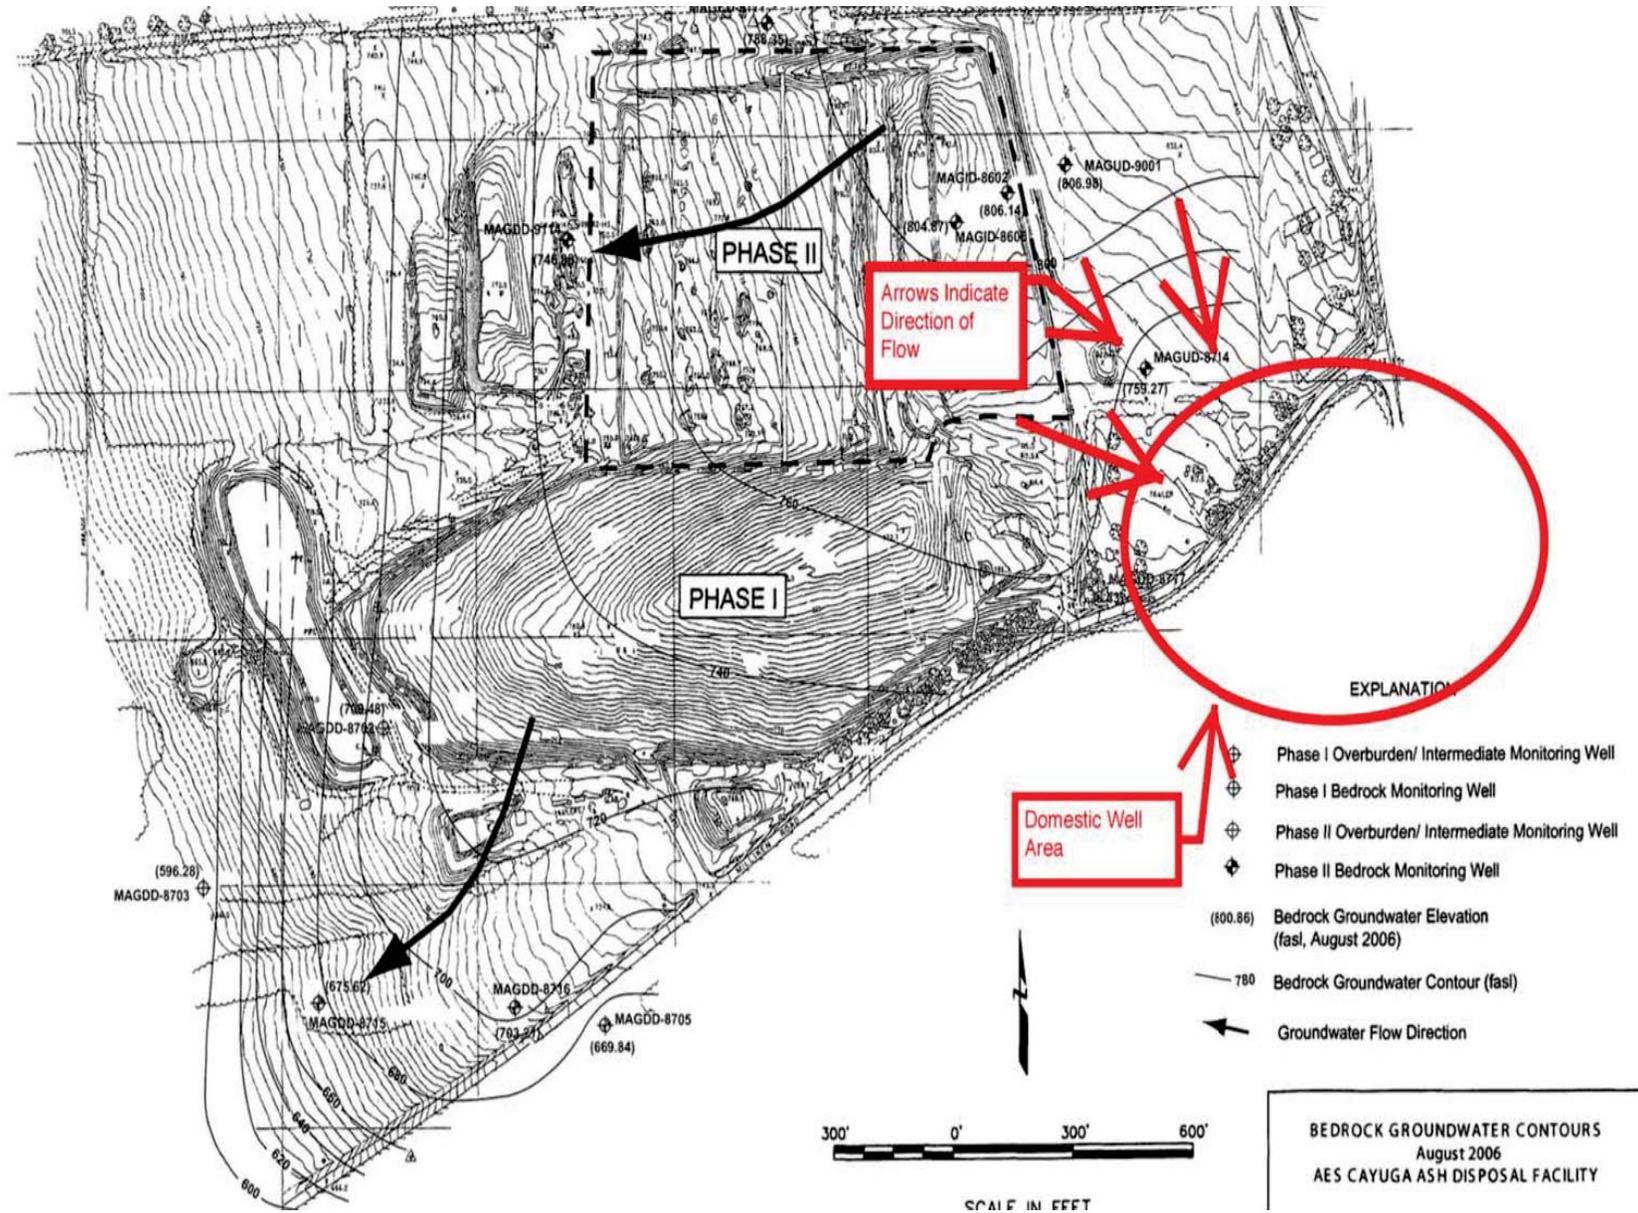
# Exceedances in Monitoring Wells

Well Name	Arsenic (mg/L)	Ammonia (mg/L)	Barium (mg/L)	Boron (mg/L)	TDS (mg/L)	Sodium (mg/L)	Sulfate (mg/L)	Chloride (mg/L)	Iron (mg/L)	Manganese (mg/L)	pH
<b>Standard</b>	<b>0.01 (MCL)</b>	<b>2.0</b>	<b>1.0</b>	<b>1.0</b>	<b>500</b>	<b>20</b>	<b>250</b>	<b>250</b>	<b>0.3</b>	<b>0.3</b>	<b>6.5- 8.5</b>
8105	<b>0.0134</b>	-	-	<b>8.33</b>	<b>1,380</b>	<b>60.3</b>	<b>560</b>	-	-	-	-
8703 SH	0.009	-	-	0.36	<b>500</b>	19.2	107	-	-	-	-
8703 DI	0.008	1.6	-	0.633	<b>950</b>	<b>275</b>	102	216	-	-	-
8703 DD	<b>0.0139</b>	1.4	<b>1.2</b>	0.785	<b>2,060</b>	-	-	<b>1,830</b>	<b>0.522</b>	-	-
8715 DI	-	-	-	-	<b>1,320</b>	<b>238</b>	-	<b>550</b>	-	-	-
8715 DD	0.0077	<b>4.3</b>	0.856	-	<b>1,580</b>	<b>234</b>	-	<b>664</b>	<b>1.45</b>	<b>0.336</b>	-
8716 DI	0.0078	-	-	-	415	15.9	-	-	<b>1.3</b>	-	-
8716 DD	0.005	<b>1.6</b>	-	-	-	-	-	-	-	-	-
8705 SH	0.0067	<b>0.7</b>	-	-	<b>610</b>	<b>59.4</b>	-	106	-	-	-
8705 DI	0.0083	-	-	-	<b>875</b>	<b>48.4</b>	148	<b>265</b>	<b>2.35</b>	-	-

8705 DD	<b>0.0118</b>	<b>4.4</b>	-	0.677	<b>900</b>	<b>351</b>	201	168	<b>0.831</b>	-	-
0501 SH	<b>0.0171</b>	-	-	-	400	-	-	-	-	-	-
0501 DD	-	-	-	-	-	-	-	-	-	-	11.8
X01 DW	<b>0.016</b>	-	-	-	<b>755</b>	<b>58.1</b>	94.6	195	<b>0.56</b>	-	-
