# Watershed Needs Assessment

## Buttermilk Creek Tompkins County, New York

March 2013

MMI #4395-03

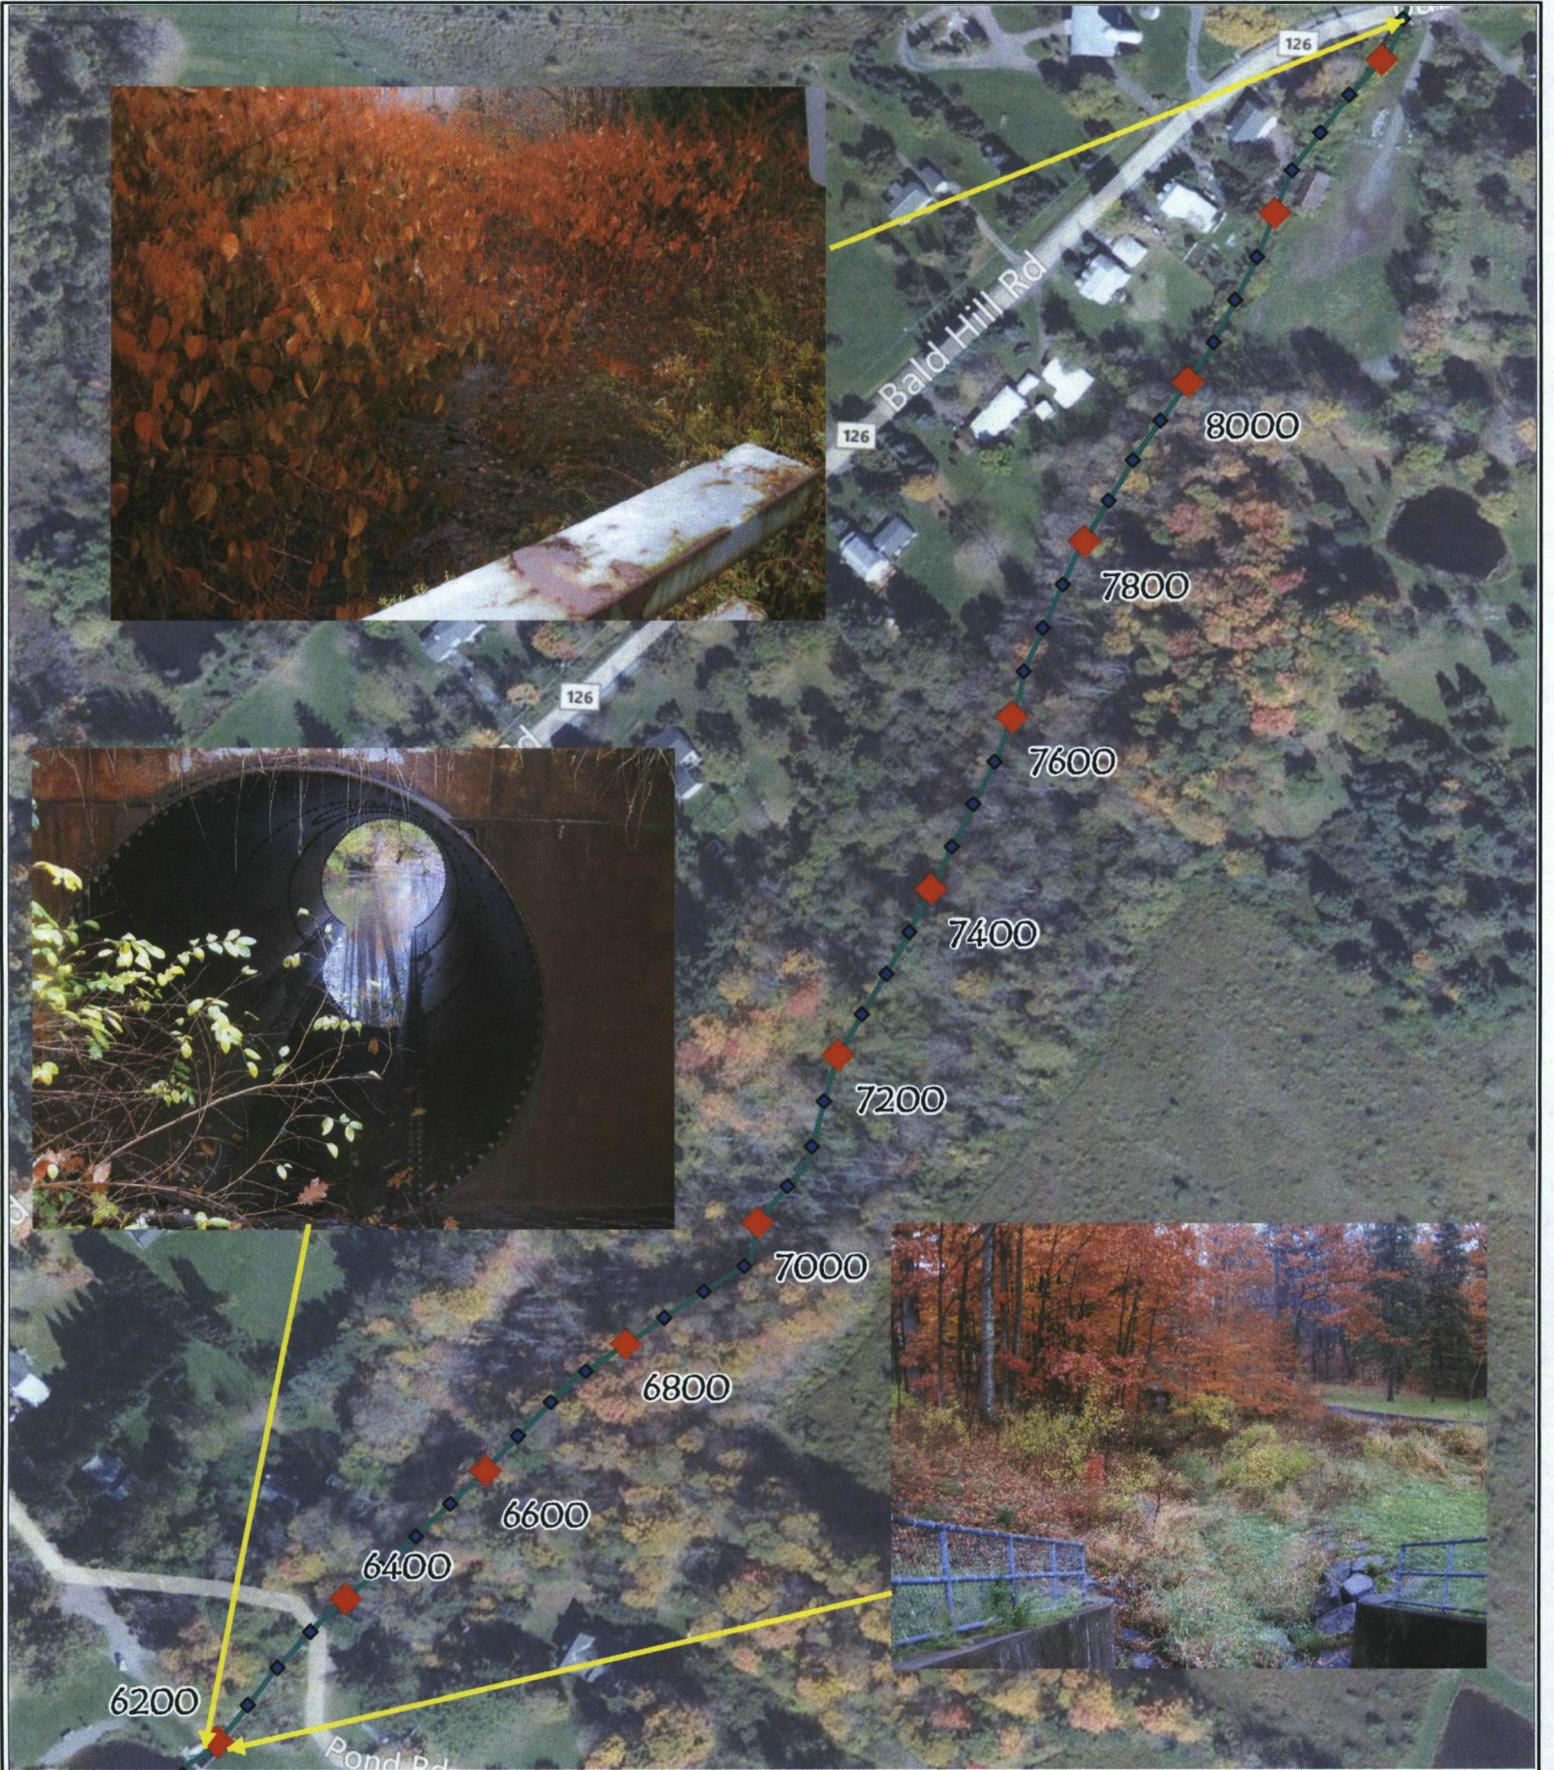
Figure 2-1: Segments #1 and #2

Figure 2-1 depicts Segment #2, which includes 2,100 feet of Buttermilk Creek extending from Pond Road (Station 63+50) to Bald Hill Road Bridge (Station 84+50). This segment is a single straight channel with largely uniform cobble dominated bed material. The average slope of the channel in this segment is 1.8%. The stream has a wooded corridor with a vegetated buffer until Station 79+50, where the buffer begins to deplete on both banks and the stream begins to become incised. The buffer is bordered by an open field to the east. To the west is Bald Hill Road with residential buildings on both sides of the road. The system's energy increases in this section. The typical width to depth ratio of the channel is 5:1 on the upstream section and 3:1 on the downstream section of this segment. Near Bald Hill Road there is a dense concentration of Japanese Knotweed. No active erosion was observed and no reports of nuisance flooding.

There are plans by the County to replace the aging Bald Hill Road Bridge in 2013. The span of the existing structure is 10.5 feet, with a vertical clearance of seven feet. The approach of this crossing is not ideal, as the bridge and creek do not cross perpendicular to one another but rather at an angle that alter the path of the channel. A larger span and/or different angle of approach would create a more efficient hydraulic alignment.

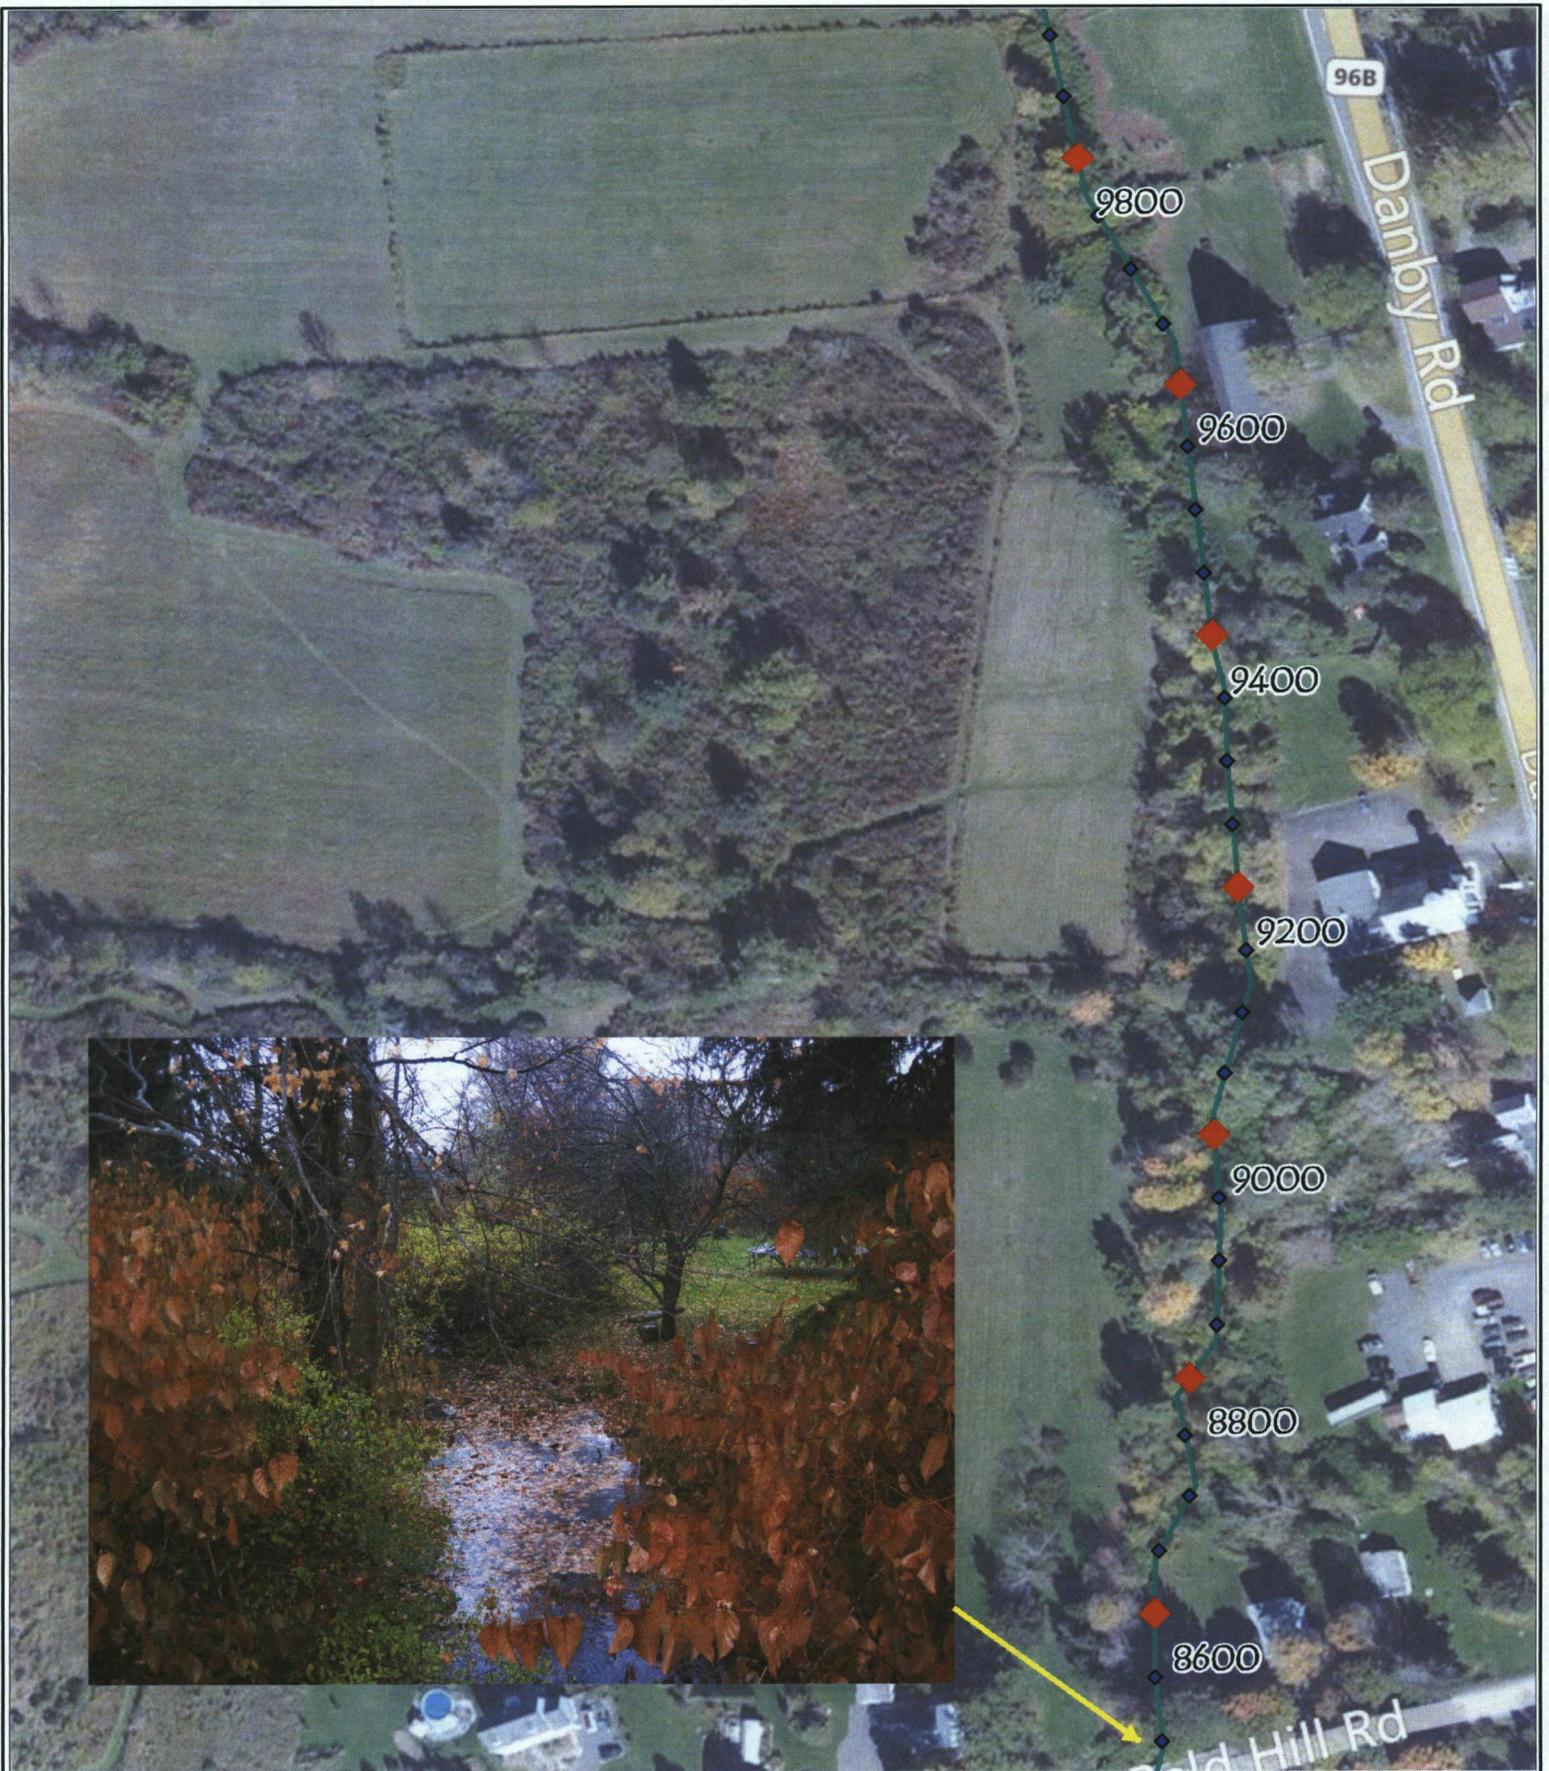
**Figure 2-2: Segment #3**

Figure 2-2 depicts Segment 3, which encompasses approximately 1,450 feet along Buttermilk Creek, extending from Bald Hill Road Bridge (Station 84+50) to a double culvert near Hornbrook Road (Station 99+00). This segment is a single relatively linear channel with small lateral meanders throughout the reach. The channel substrate consists of largely uniform cobble dominated bed material. The average slope of the channel in this segment is 2.1%. Dense Japanese knotweed was observed near 1800 Danby Road. The typical width to depth ratio of the channel is 2:1.

The newly constructed crossing west of Hornbrook Road is comprised of twin 50-inch corrugated plastic pipe culverts that appear to be undersized to handle significant storm events. No hydraulic computations were available to indicate that the crossing had been designed to any particular storm event. The upstream and downstream approaches are overgrown with invasives and other vegetation. No evidence of erosion was observed in this reach and no reports of flooding.

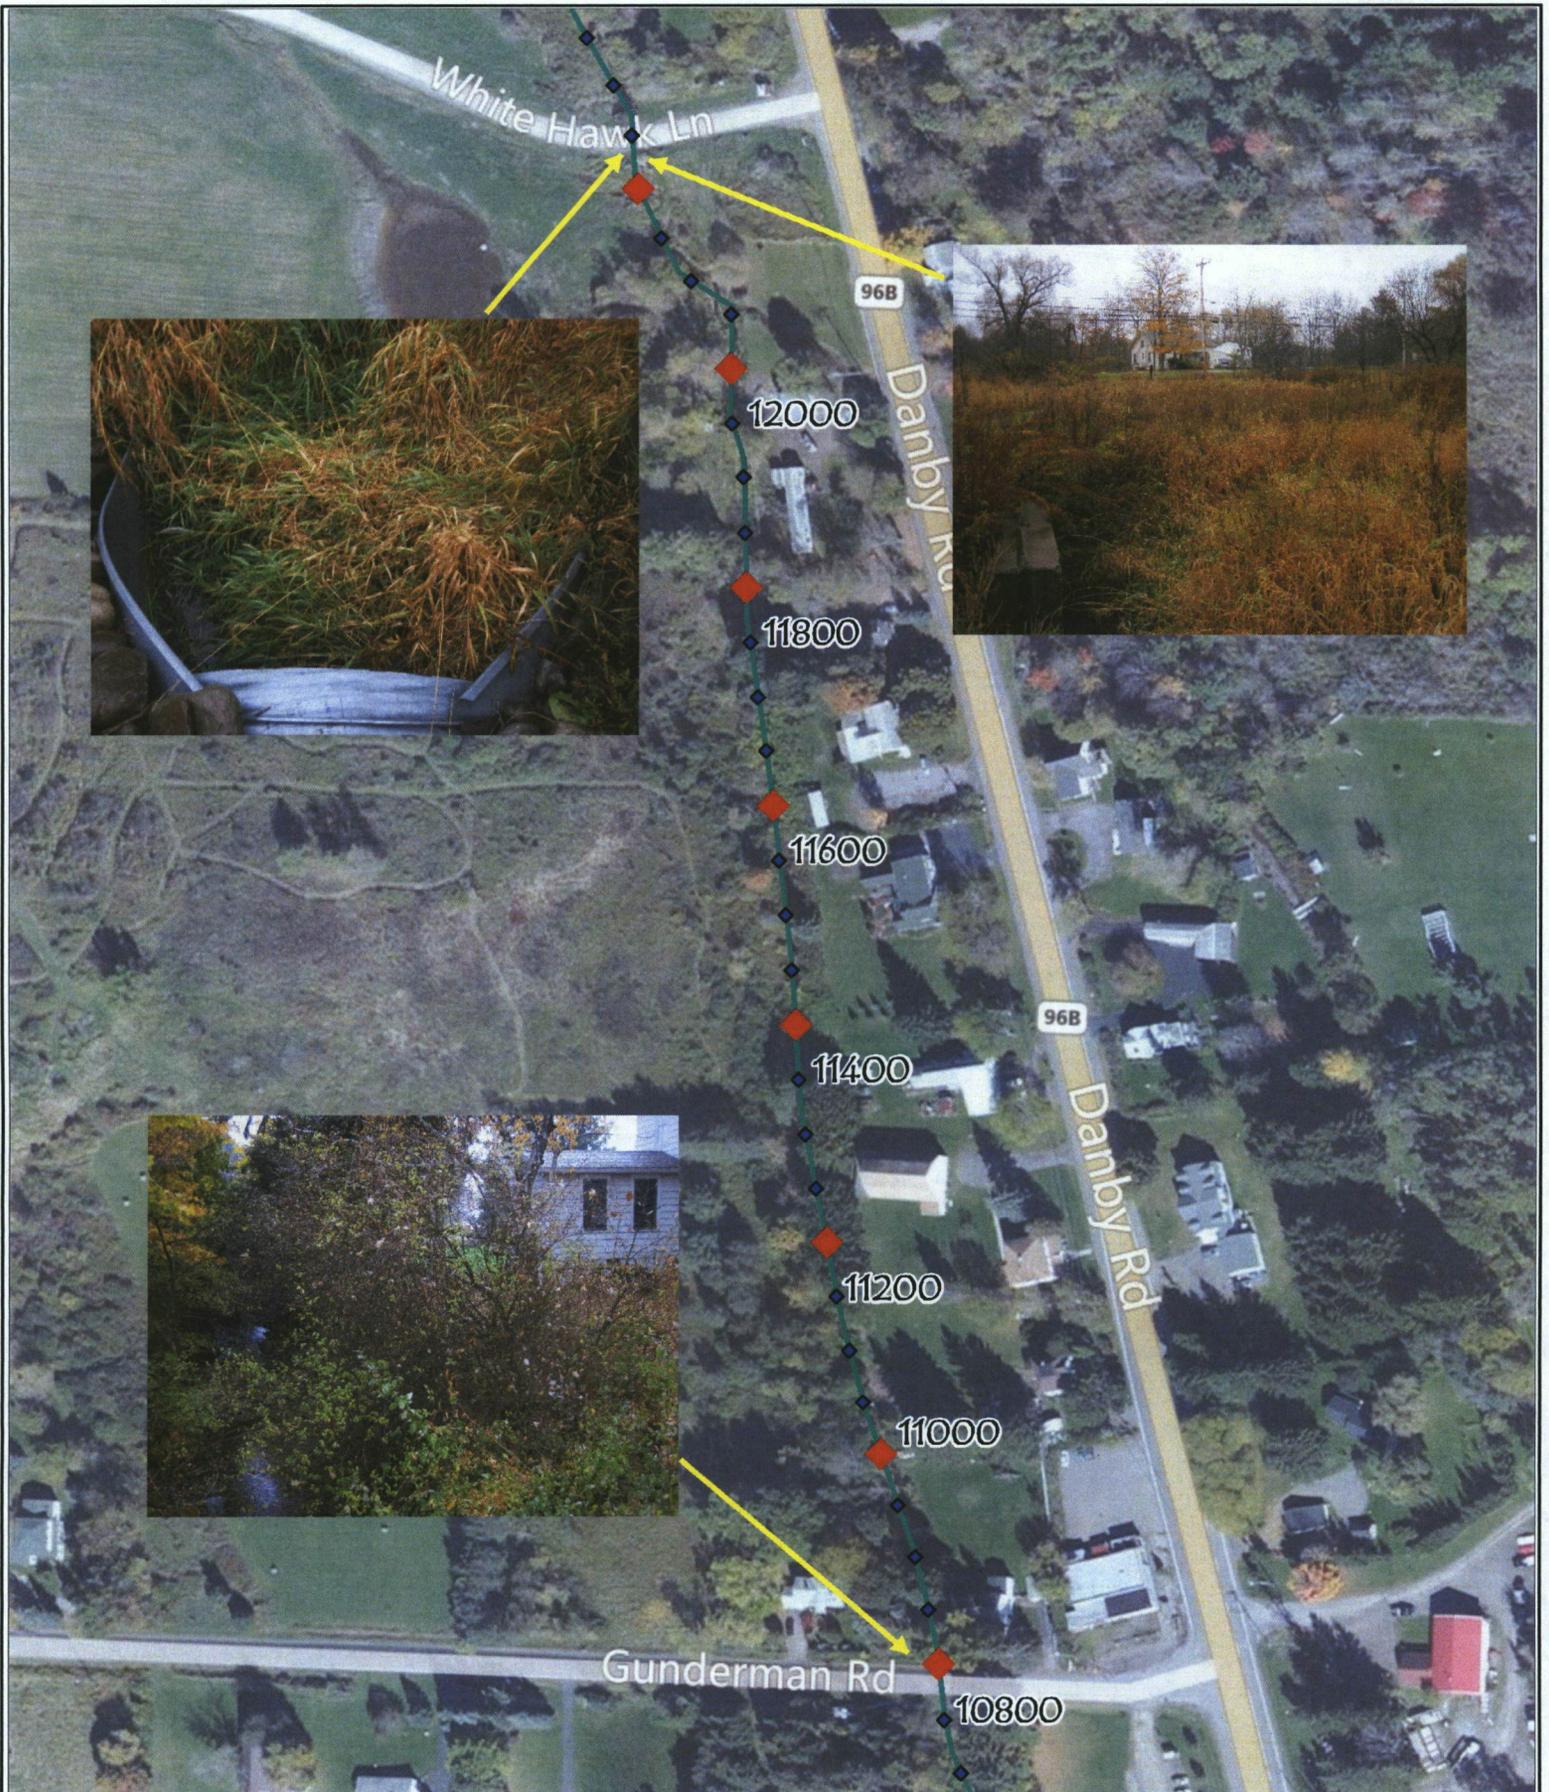
Figure 2-4: Segment #5

White Hawk Lane was constructed to support a development known as White Hawk EcoVillage, a community-centered development of 120 acres of land that will support approximately 30 to 40 residential dwellings. To date, five houses have been constructed.

An analysis of the existing culverts is recommended to assess the existing capacity at this crossing and to evaluate the requirements and cost of upgrading the culverts with capacity to support larger storm events. Such culvert crossings are generally designed to convey at least the 10- to 25-year storm event, and up to the 100-year storm event when the crossing is located at a point of critical ingress and egress. The appropriate design storm should be guided by the surrounding grades as well as the extent of predicted flooding. For example, if the area surrounding the culverts is predicted to become inundated during the 25-year storm, there would be no benefit of sizing the culverts to accommodate a 50-year storm. In such instance, the larger culverts would simply be under water and not capable of conveying any greater flow.

4. White Hawk Lane passes through a low lying wetland and has no adequate way of passing high flows through the existing culverts. An analysis of the existing culverts is recommended (consistent with item 3 above) to assess the existing capacity at this crossing and to evaluate the requirements and cost of a crossing with capacity to support larger storm events.

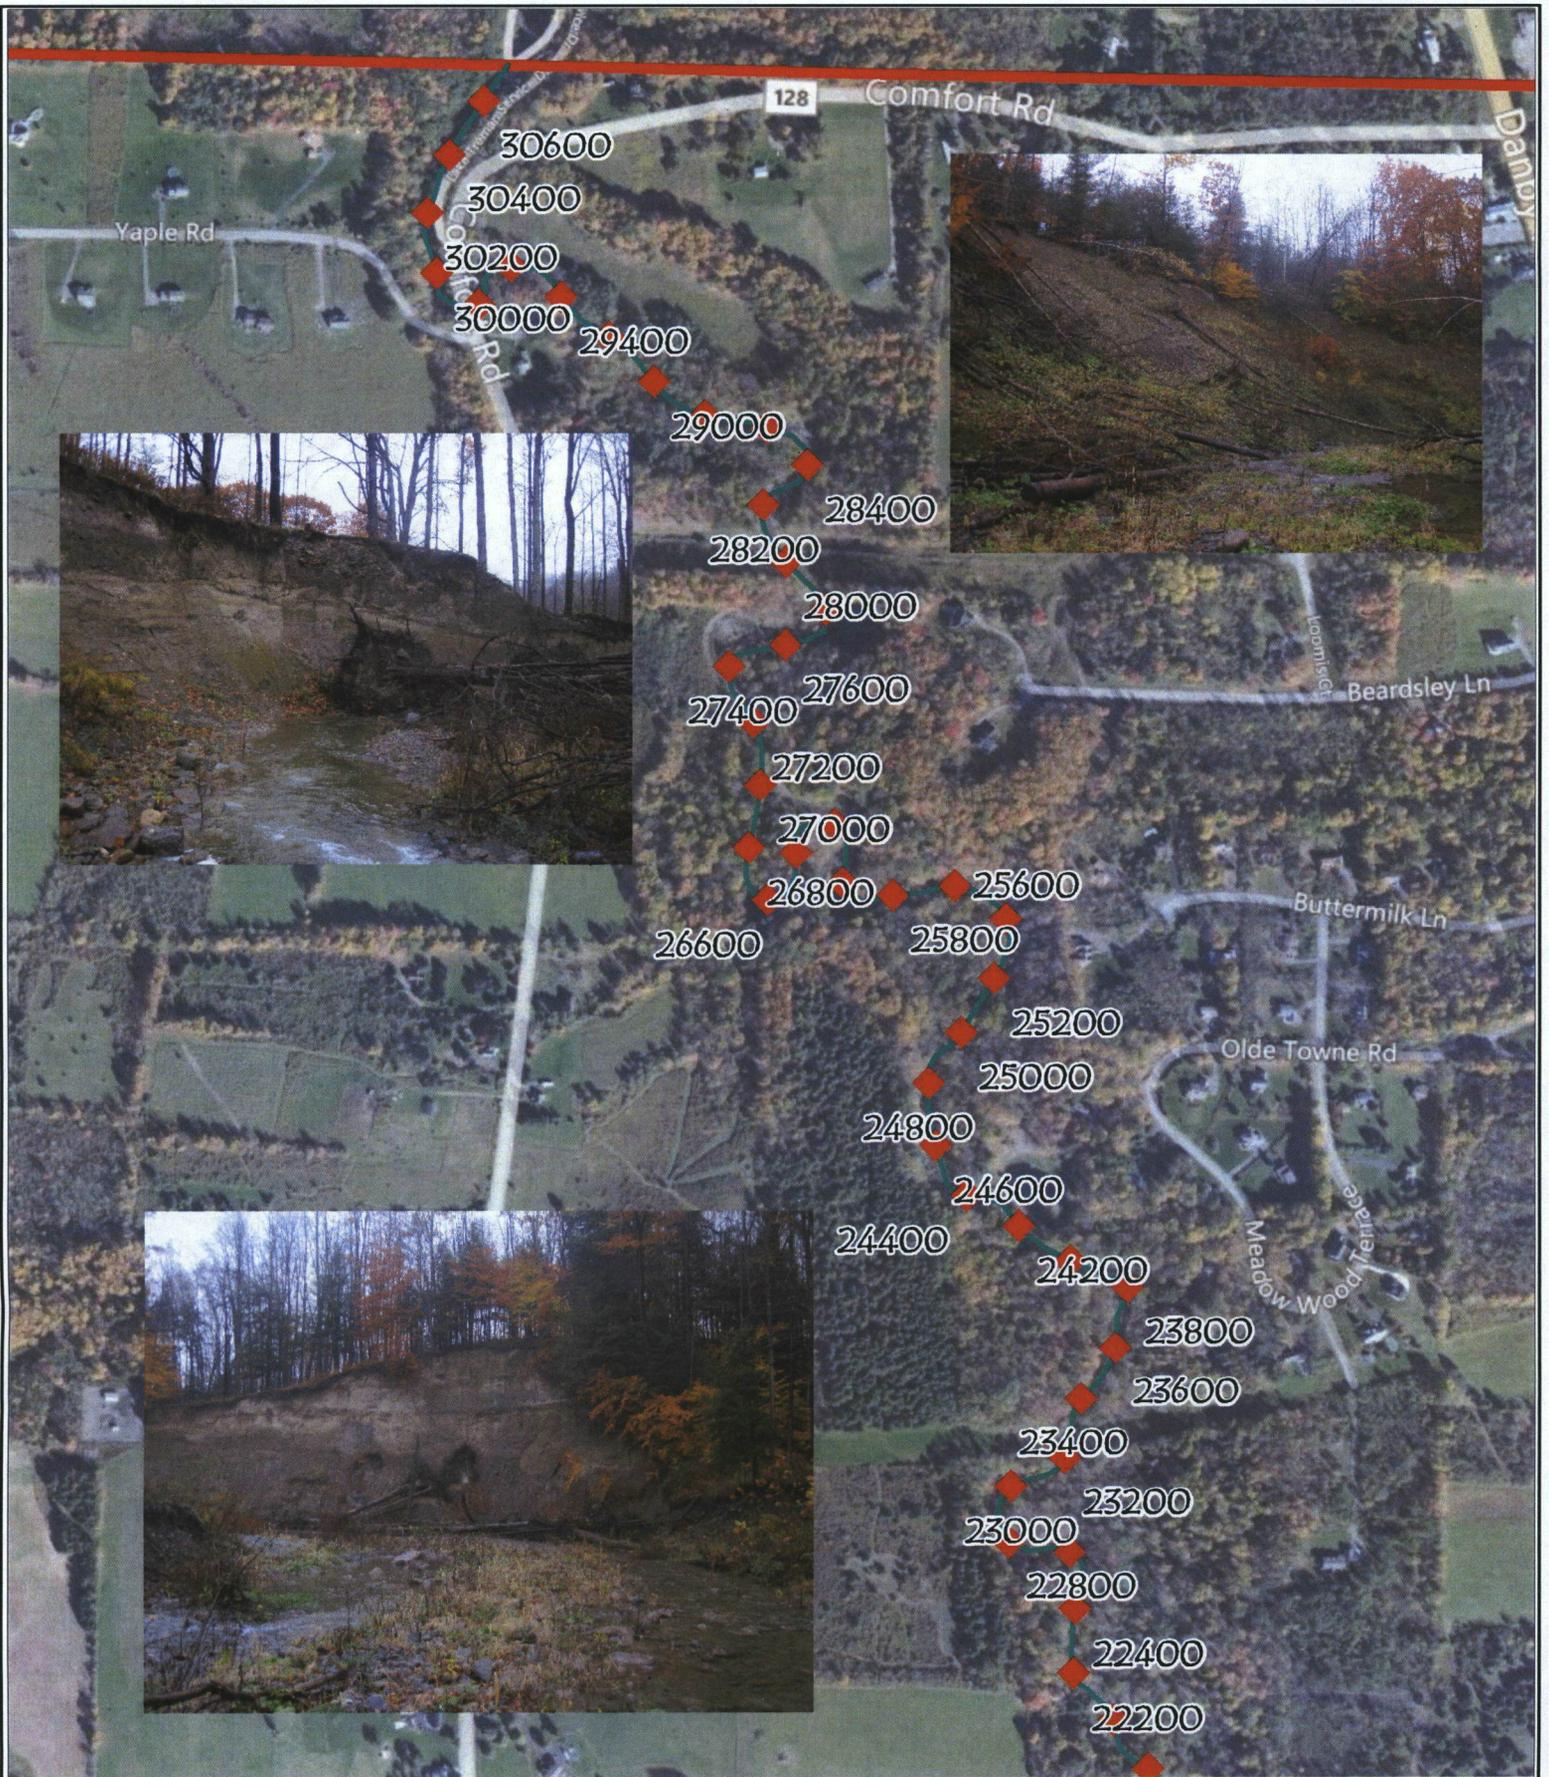
Figure 2-7: Segment #8

Figure 2-7 depicts Segment 8, which includes 8,140 feet of Buttermilk Creek extending 600 feet upstream of the utility/gas line crossing (Station 226+00) to the municipal border between Danby and Ithaca (Station 307+40). The slope of the channel in this segment steepens in the range of 1.5% to 2.8% as the channel enters into the gorged section of Buttermilk Creek (beginning at approximate Station 280+00. This segment begins to meander significantly, doubling back on itself and causing major bank erosion along the way. Bank failures range from a height of 10 feet to 60 feet and have become a significant source of sediment and turbidity under high flow conditions. Specifically, bank failures were observed at the locations indicated in Table 2-2.

Large woody debris has entered the system within this reach associated with bank failure and trees being deposited into the channel. These obstructions have caused debris dams that prevent the natural path of flow and induce localized scour. The channel has adequate floodplain connectivity in certain locations but also has choke points in this segment.

1. Judiciously apply engineered bank treatments in priority areas to protect existing structures, private property, and infrastructure, and where sediment contributions to Buttermilk Creek are the greatest. Table 2-2 presents a summary of bank failure locations. Within this list, priority should be given to sites with the greatest potential for sediment release as well as those that are located in close proximity to or have the potential to compromise existing development, including structures and infrastructure (utilities, roadways, etc.). Alternate water quality renovation approaches should be explored for the purpose of protecting downstream recreational uses and ecological habitat. The long-term economy of stabilizing individual sites (often on the order of

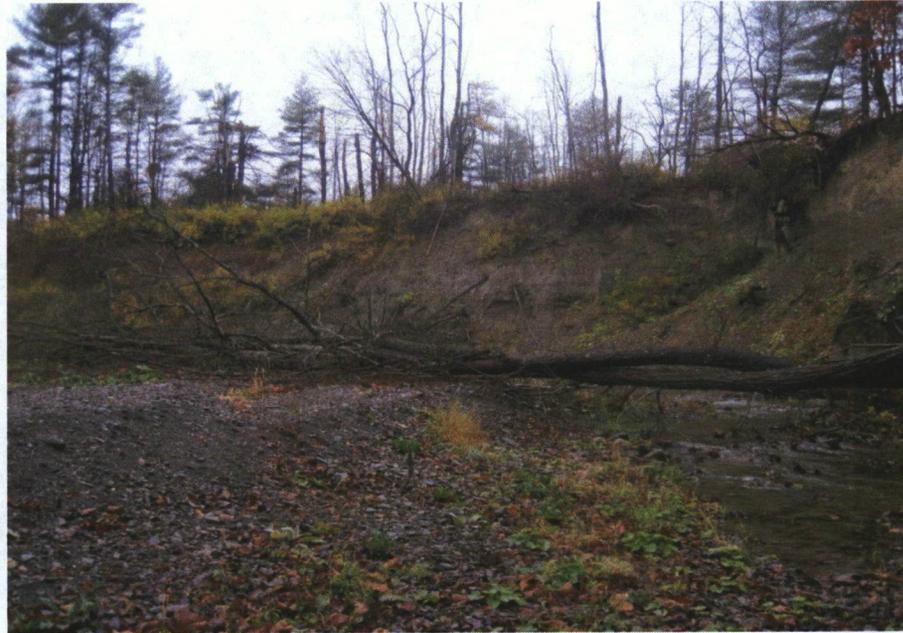
Bank Failure Site #1  
See Table 2-2

Major slope erosion/failure along left bank, large woody debris in channel, site upstream of gas line crossing.

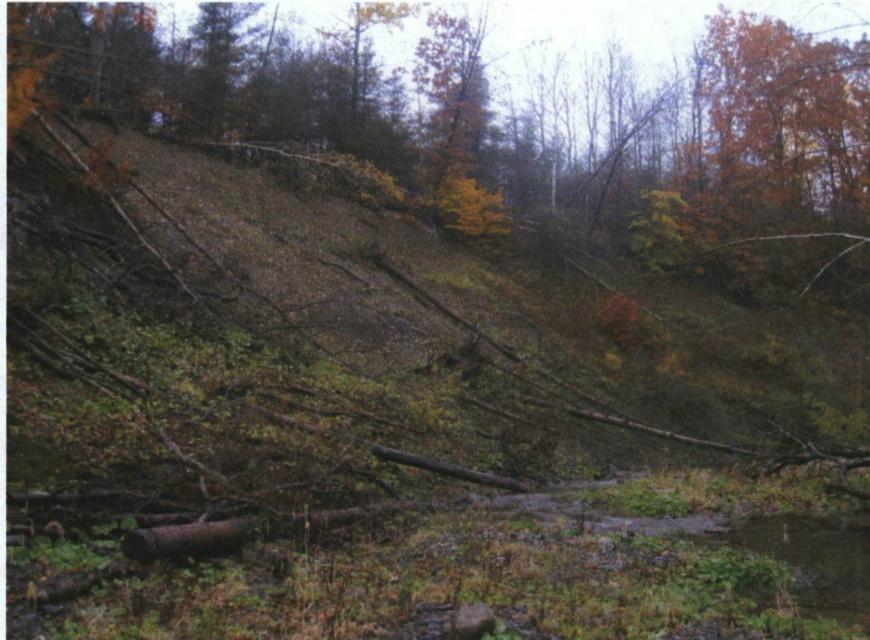
Bank Failure Site #2  
See Table 2-2

Major slope erosion/failure along left bank, large woody debris along slope and toe of site.

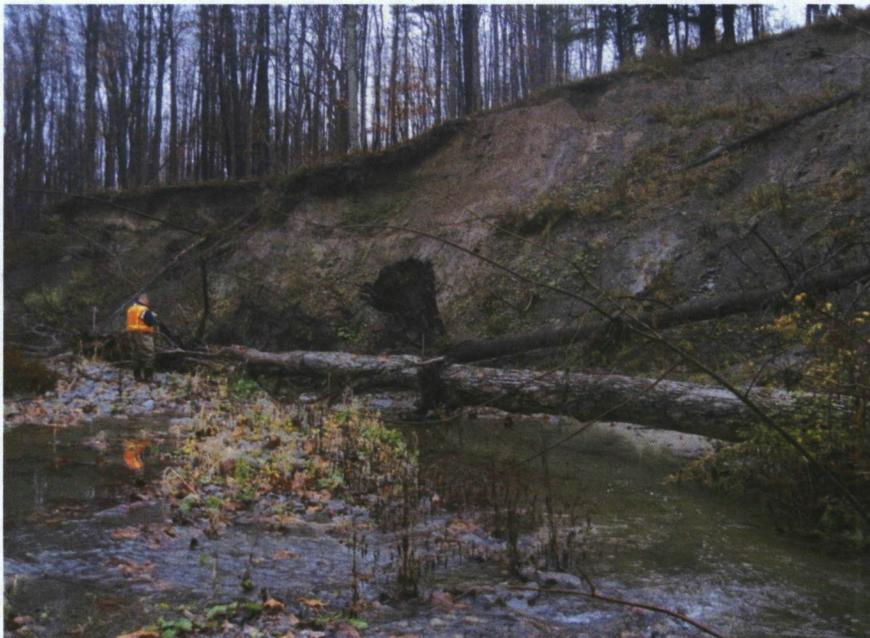
Bank Failure Site #2  
See Table 2-2

Major slope erosion/failure along left bank, large woody debris along slope and toe of site.

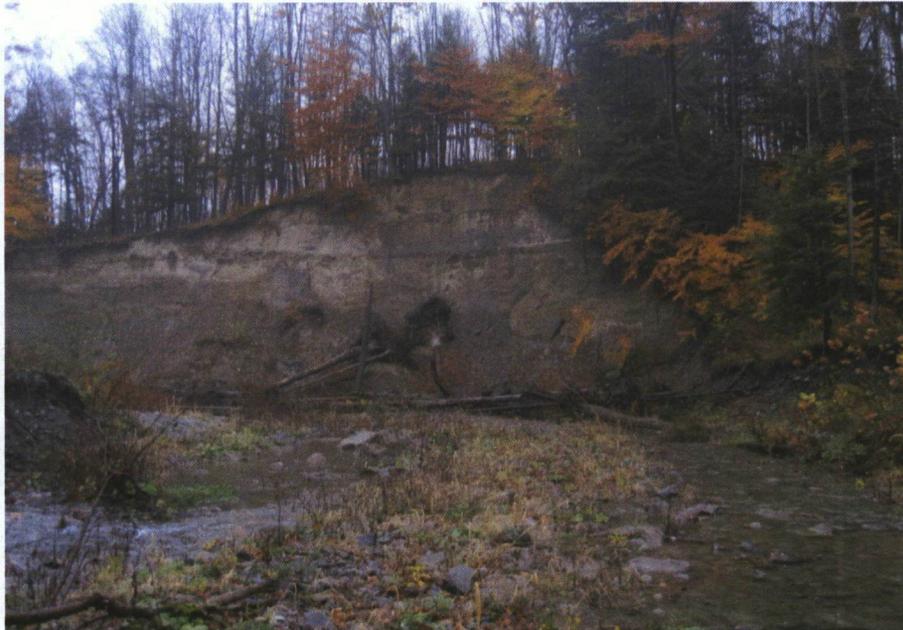
Bank Failure Site #3  
See Table 2-2

Major slope erosion/failure along right bank, large woody debris along toe of site.

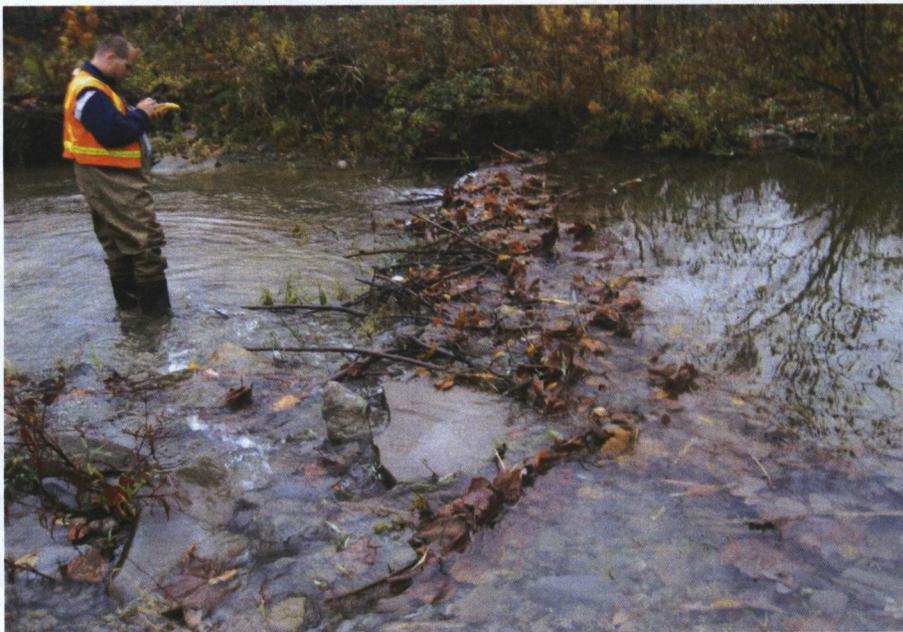
**STATION: 272+50**

Minor headcut/step in Buttermilk Creek downstream of previous slope failure sites.

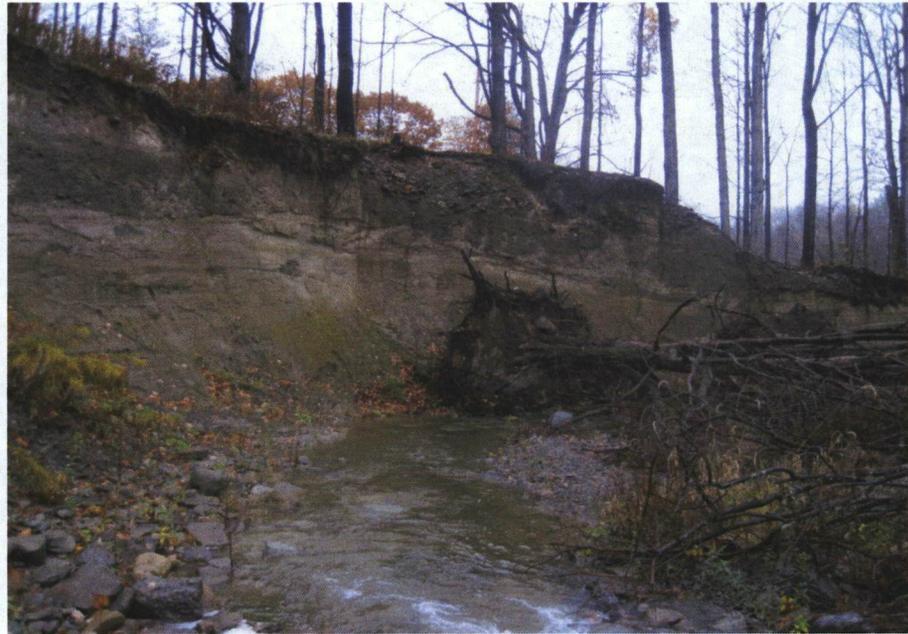
Bank Failure Site #7  
See Table 2-2

Major slope erosion/failure along left bank, large woody debris in channel.

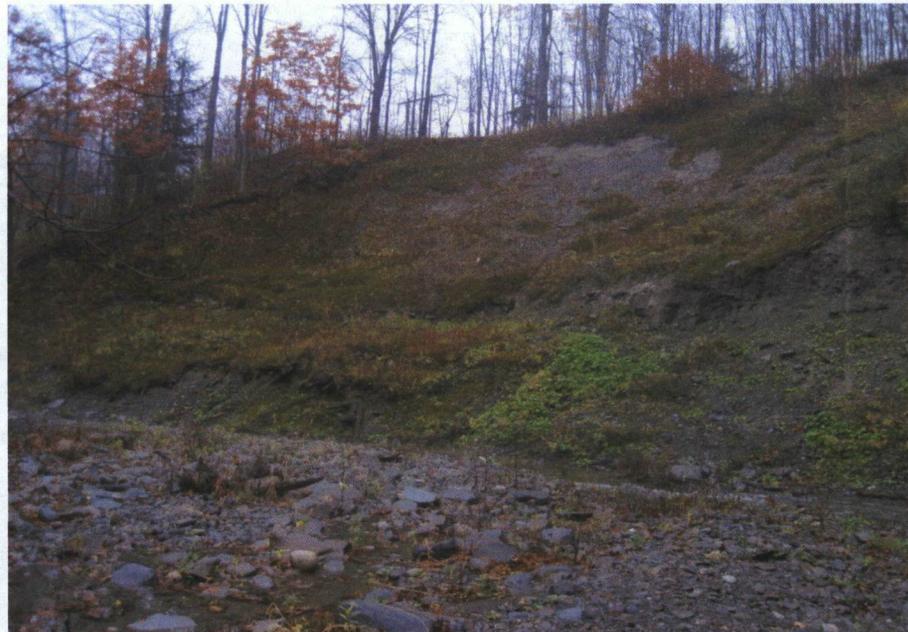
Bank Failure Site #8  
See Table 2-2

In other instances, erosion sites and bank failures may self-stabilize in time. One site on Buttermilk Creek that can be used as a template for self-healing bank stabilization occurs near Station 277+00. The bank has hit an angle of repose (i.e. has become stable) and has begun to vegetate itself. A lower floodplain bench at the toe of the bank has naturally formed. Additional armoring of the toe of this bank would further stabilize the site against high flow events. The use of a combination of low stone and log revetments can serve as a more natural reinforcement to the bank.

Stabilized/vegetated bank failure along right bank.
