Watershed Needs Assessment

Buttermilk Creek Tompkins County, New York

March 2013

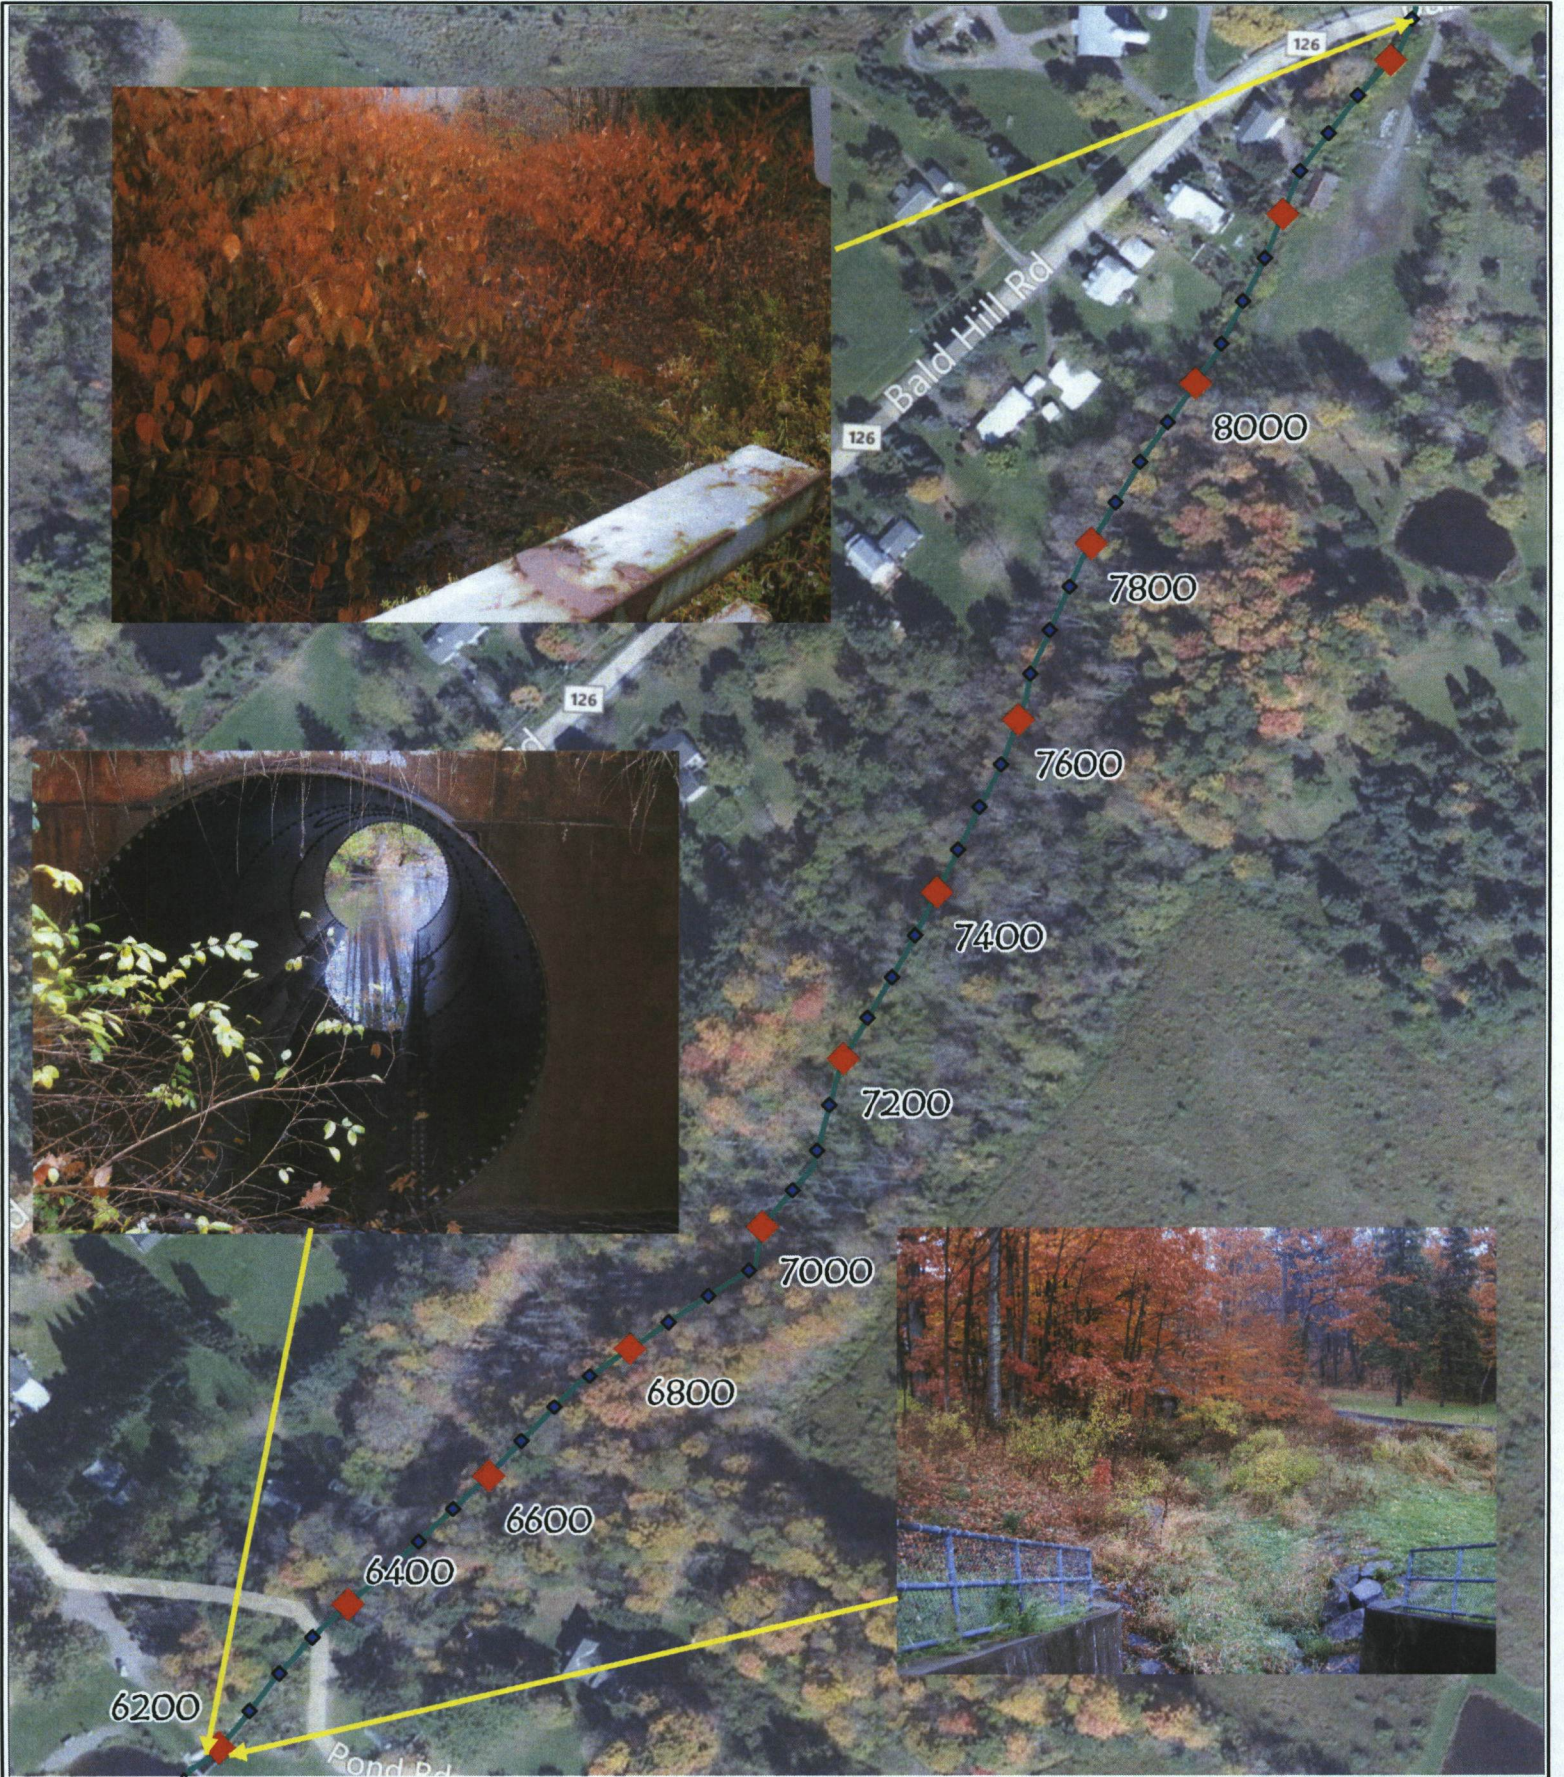
Figure 2-1: Segments #1 and #2

Figure 2-1 depicts Segment #2, which includes 2,100 feet of Buttermilk Creek extending from Pond Road (Station 63+50) to Bald Hill Road Bridge (Station 84+50). This segment is a single straight channel with largely uniform cobble dominated bed material. The average slope of the channel in this segment is 1.8%. The stream has a wooded corridor with a vegetated buffer until Station 79+50, where the buffer begins to deplete on both banks and the stream begins to become incised. The buffer is bordered by an open field to the east. To the west is Bald Hill Road with residential buildings on both sides of the road. The system's energy increases in this section. The typical width to depth ratio of the channel is 5:1 on the upstream section and 3:1 on the downstream section of this segment. Near Bald Hill Road there is a dense concentration of Japanese Knotweed. No active erosion was observed and no reports of nuisance flooding.

There are plans by the County to replace the aging Bald Hill Road Bridge in 2013. The span of the existing structure is 10.5 feet, with a vertical clearance of seven feet. The approach of this crossing is not ideal, as the bridge and creek do not cross perpendicular to one another but rather at an angle that alter the path of the channel. A larger span and/or different angle of approach would create a more efficient hydraulic alignment.

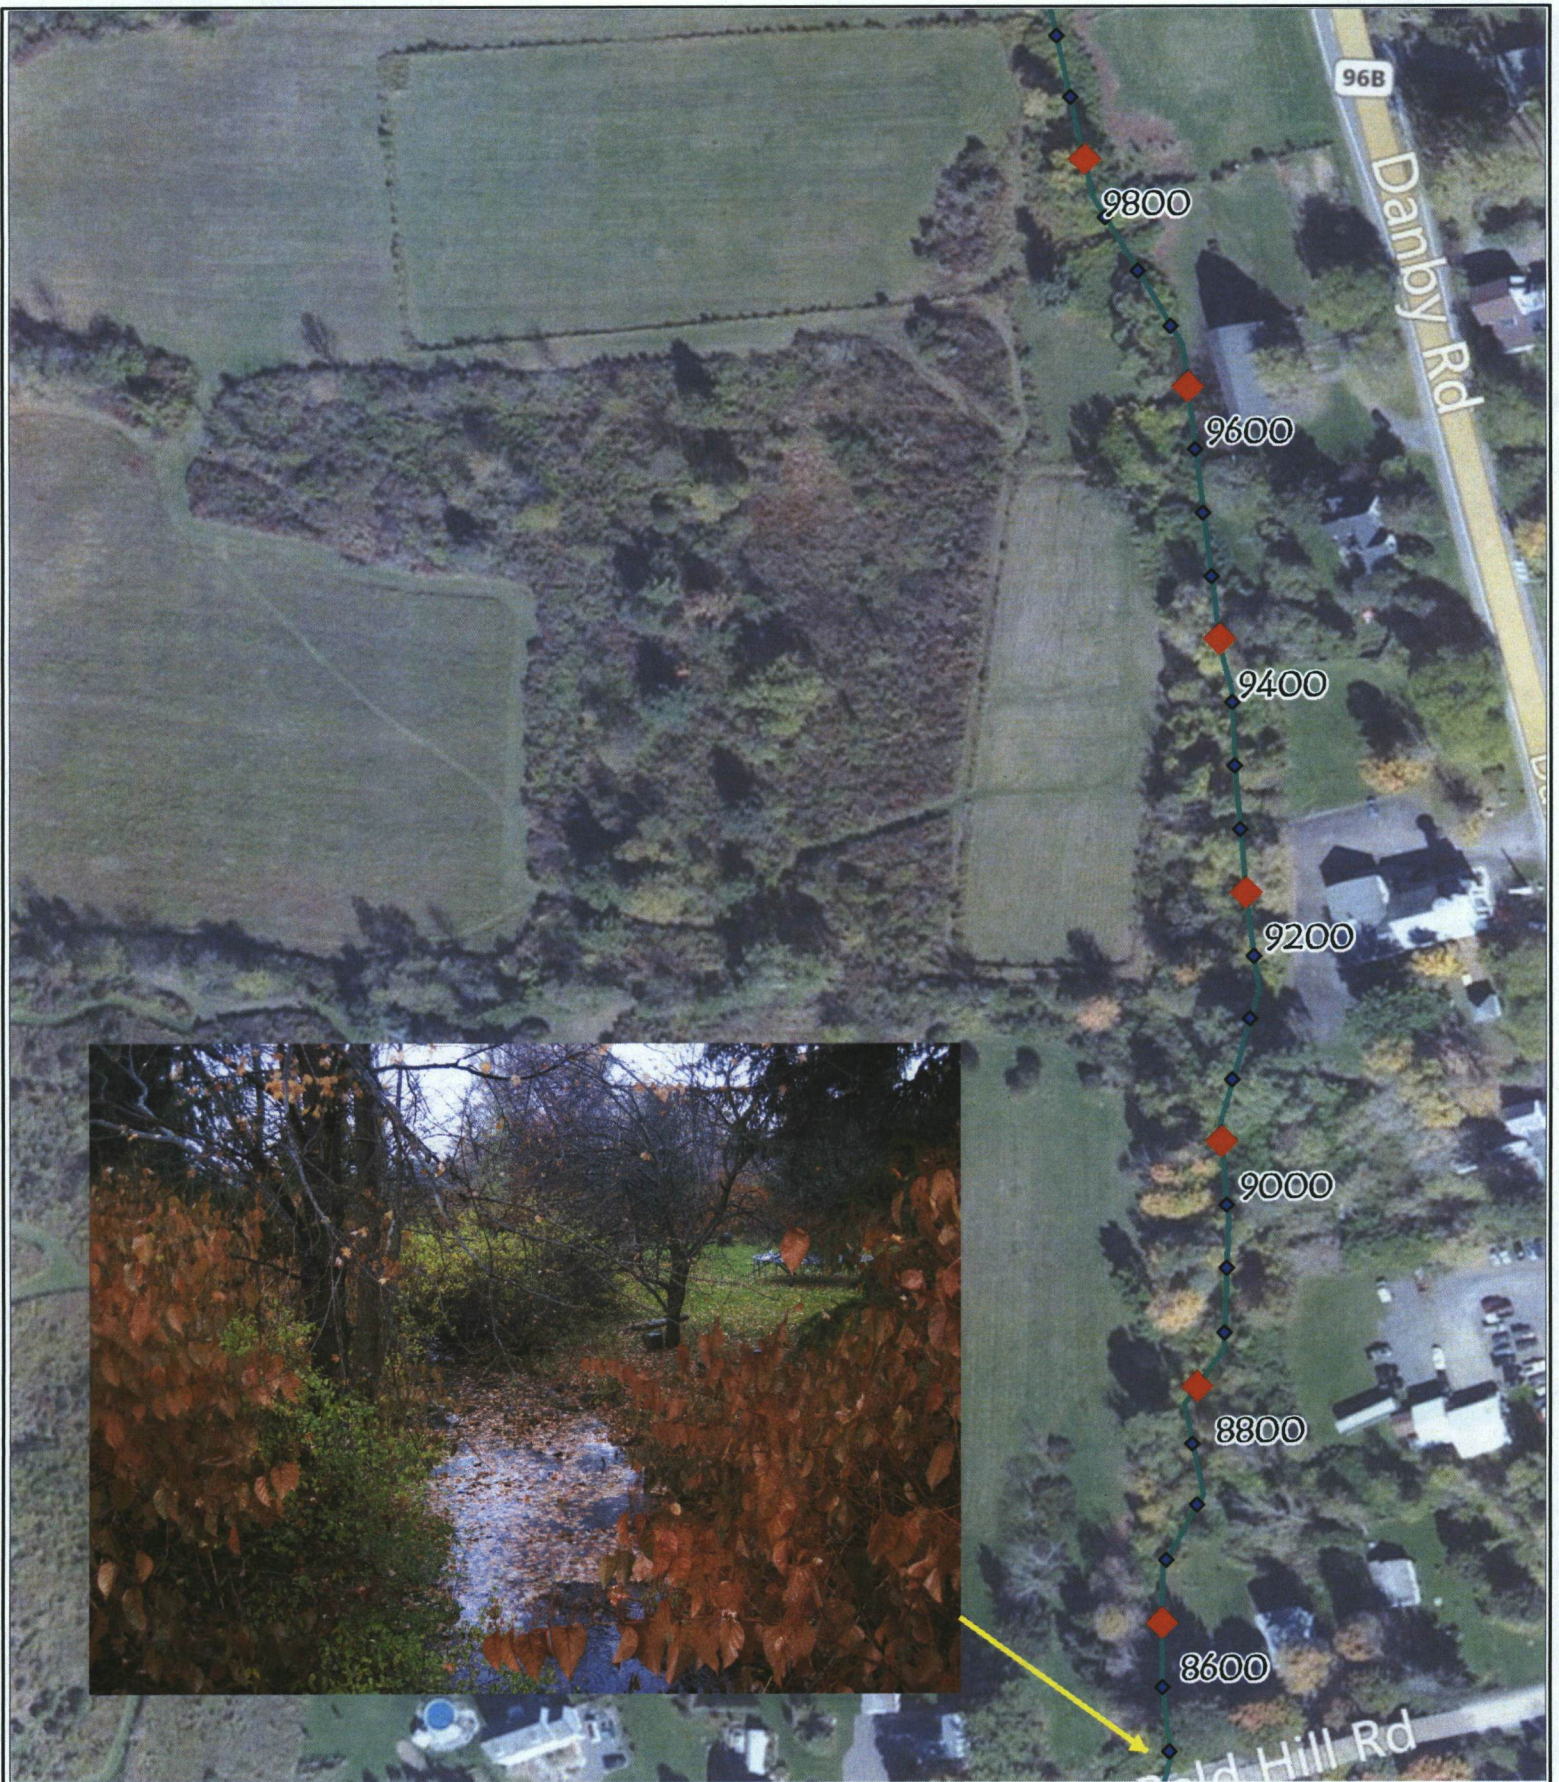
Figure 2-2: Segment #3

Figure 2-2 depicts Segment 3, which encompasses approximately 1,450 feet along Buttermilk Creek, extending from Bald Hill Road Bridge (Station 84+50) to a double culvert near Hornbrook Road (Station 99+00). This segment is a single relatively linear channel with small lateral meanders throughout the reach. The channel substrate consists of largely uniform cobble dominated bed material. The average slope of the channel in this segment is 2.1%. Dense Japanese knotweed was observed near 1800 Danby Road. The typical width to depth ratio of the channel is 2:1.

The newly constructed crossing west of Hornbrook Road is comprised of twin 50-inch corrugated plastic pipe culverts that appear to be undersized to handle significant storm events. No hydraulic computations were available to indicate that the crossing had been designed to any particular storm event. The upstream and downstream approaches are overgrown with invasives and other vegetation. No evidence of erosion was observed in this reach and no reports of flooding.

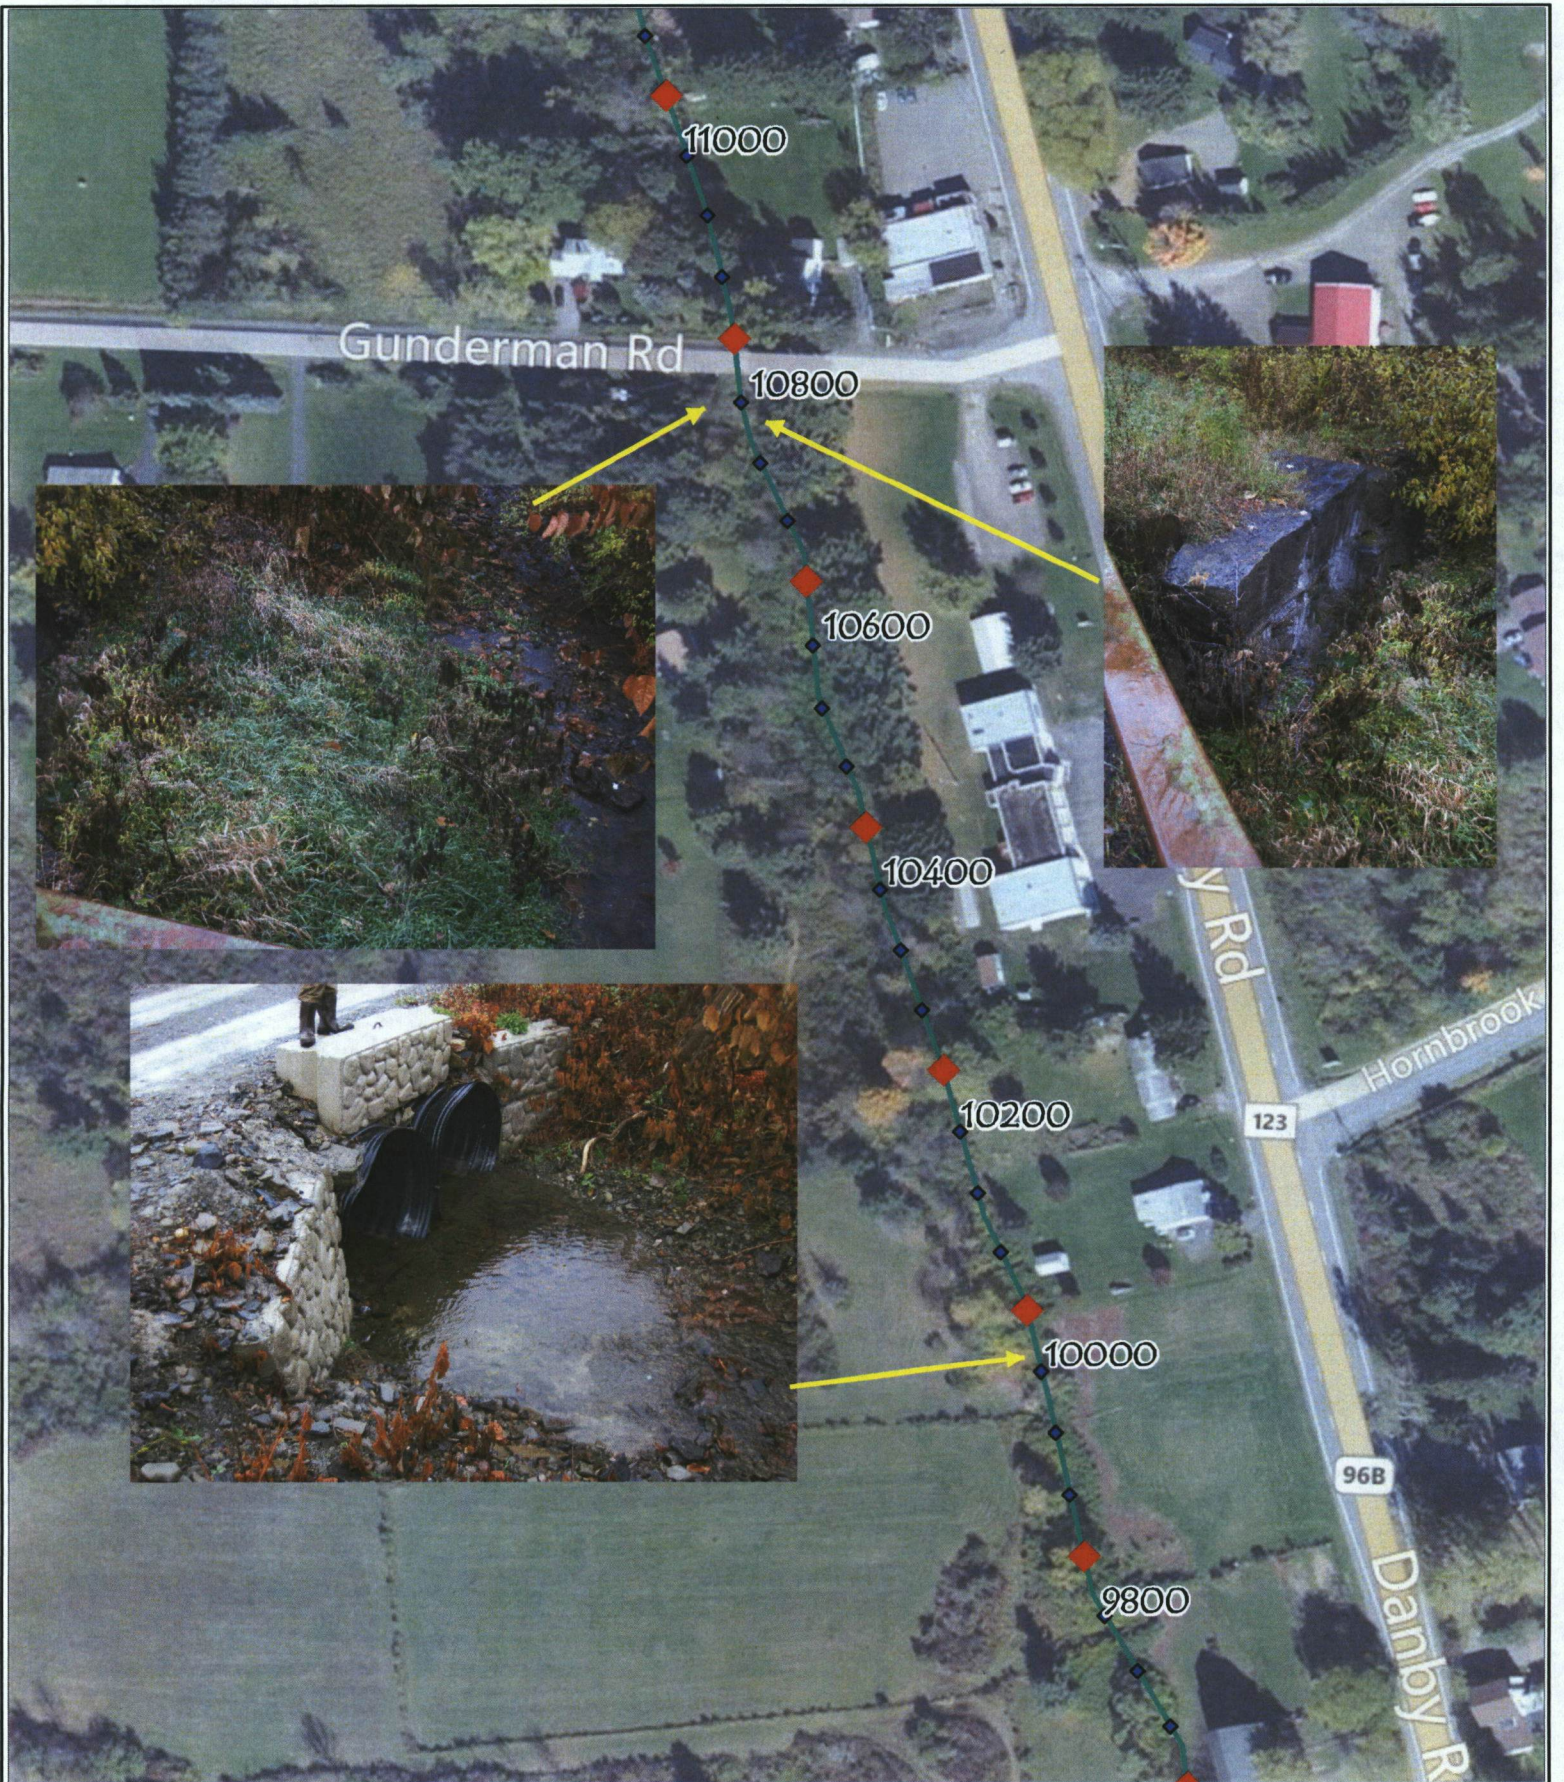
Figure 2-3: Segment #4

Figure 2-3 depicts Segment 4, which includes 900 feet of Buttermilk Creek, extending from the double culvert near Hornbrook Road (Station 99+00) to Gunderman Road Bridge (Station 108+00). The average slope of the channel in this segment is 1.1%. This segment is a relatively straight channel with some areas that consist of multiple flow paths and minor meanderings. Cobble and some boulders make up the bed material. A decrease in slope provides better floodplain access and increases the width to depth ratio of the stream. In 2010, two residential property owners worked with Tompkins County Stream Corridor and Flood Hazard Mitigation Program to plant and formally protect a 100-foot riparian buffer to the creek. While the buffer continues to be healthy, it is bordered by Japanese Knotweed. The width of the stream increases throughout the segment, with a resulting width to depth ratio of 4:1.

The Gunderman Road bridge has a span of 13 feet and a vertical clearance of nine feet. The bridge is believed to be in good condition and there are no plans for its replacement. The upstream and downstream approaches are very overgrown with invasives and other vegetation. No erosion was observed in this reach and there are no known areas of flooding.

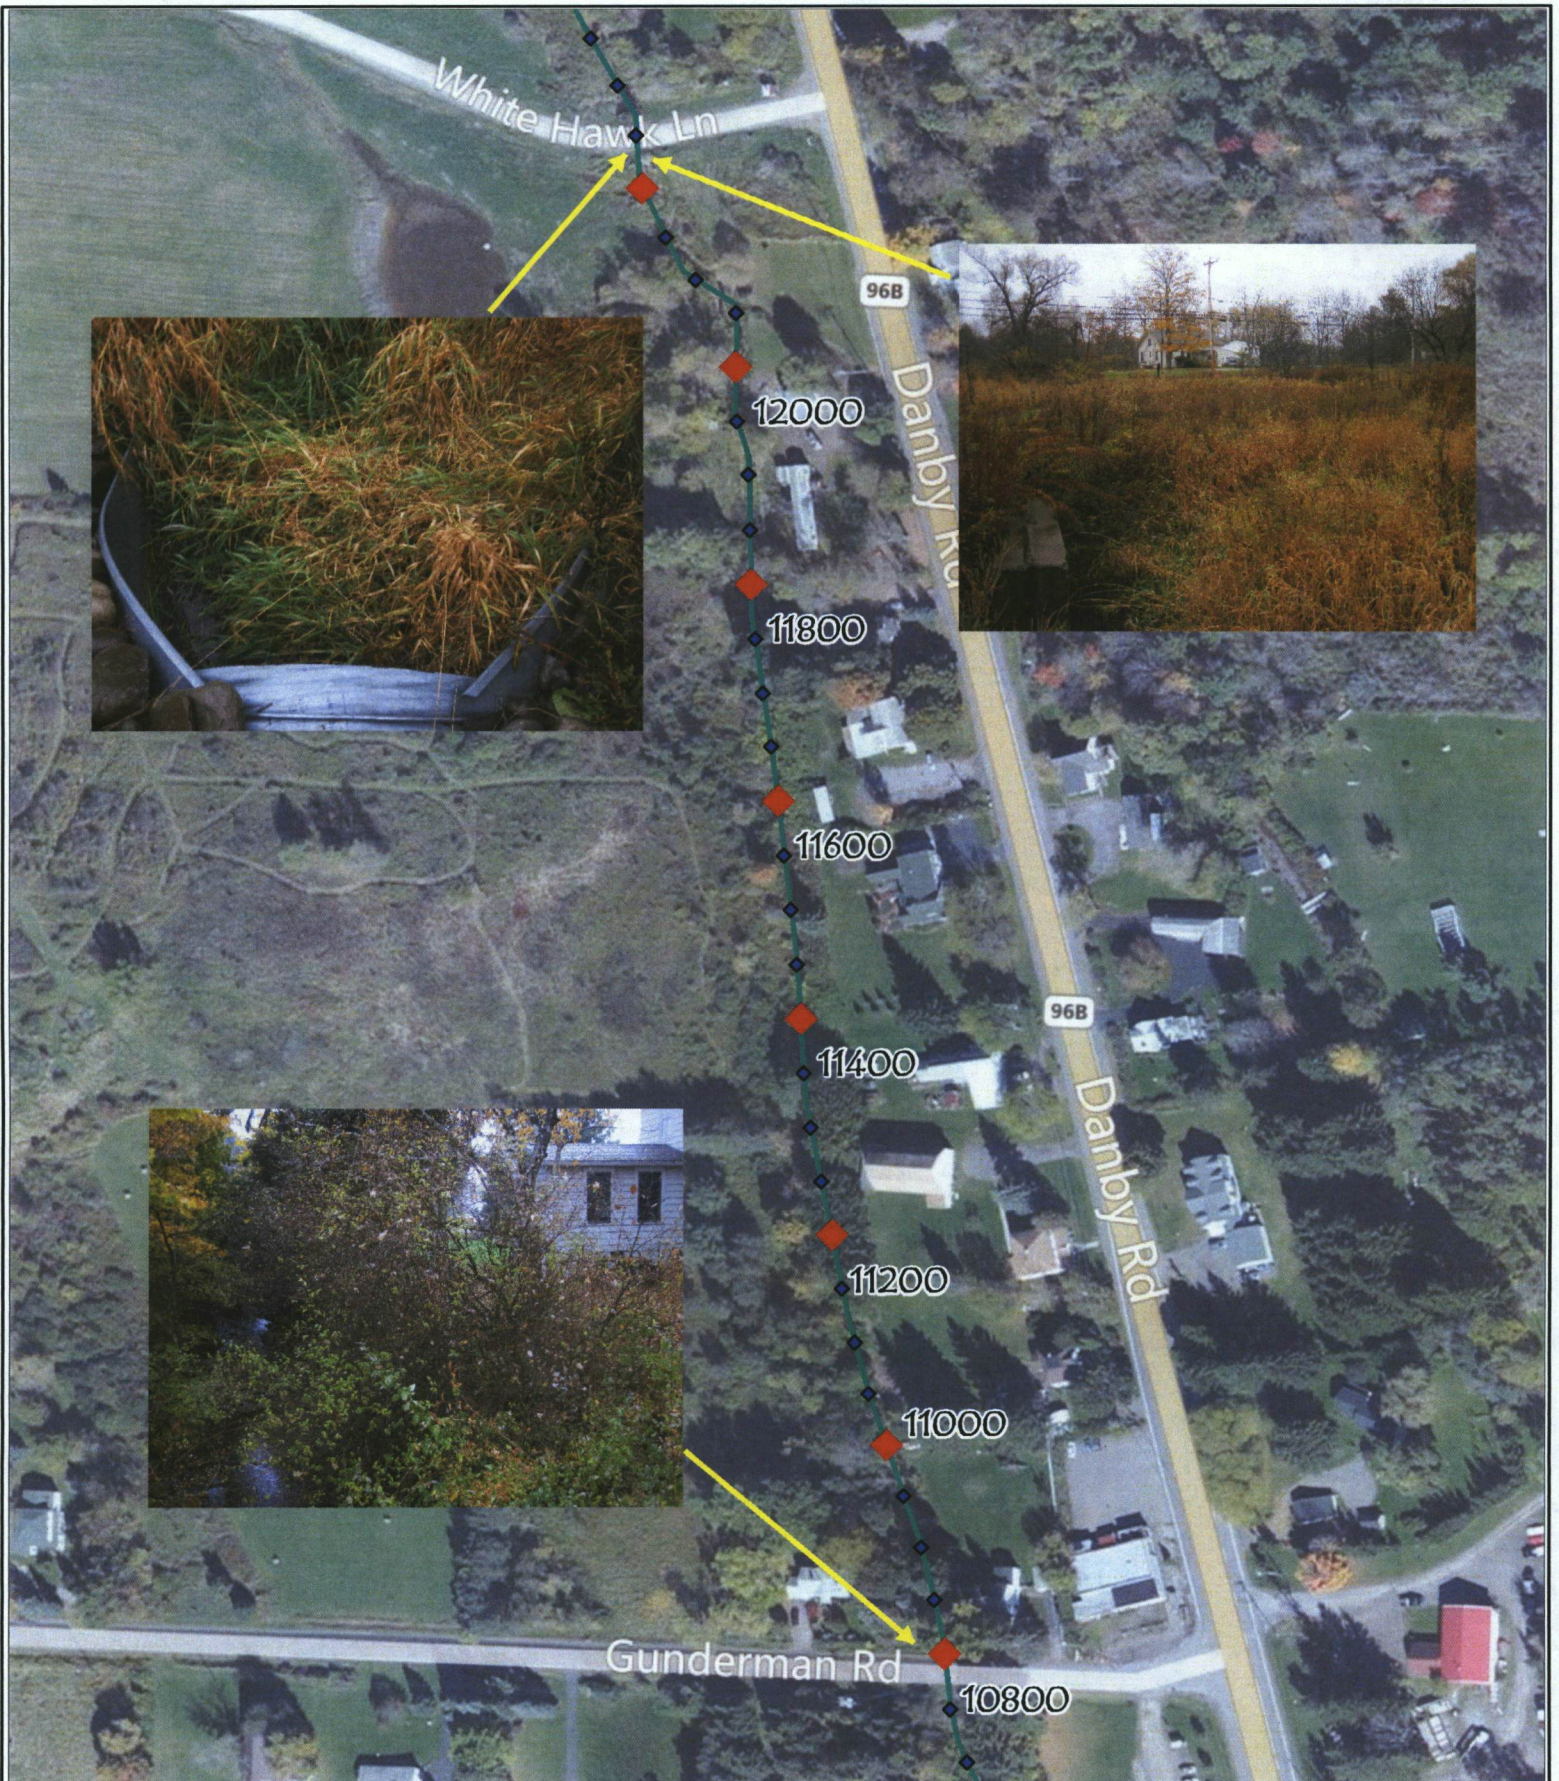
Figure 2-4: Segment #5

White Hawk Lane was constructed to support a development known as White Hawk EcoVillage, a community-centered development of 120 acres of land that will support approximately 30 to 40 residential dwellings. To date, five houses have been constructed.

An analysis of the existing culverts is recommended to assess the existing capacity at this crossing and to evaluate the requirements and cost of upgrading the culverts with capacity to support larger storm events. Such culvert crossings are generally designed to convey at least the 10- to 25-year storm event, and up to the 100-year storm event when the crossing is located at a point of critical ingress and egress. The appropriate design storm should be guided by the surrounding grades as well as the extent of predicted flooding. For example, if the area surrounding the culverts is predicted to become inundated during the 25-year storm, there would be no benefit of sizing the culverts to accommodate a 50-year storm. In such instance, the larger culverts would simply be under water and not capable of conveying any greater flow.

4. White Hawk Lane passes through a low lying wetland and has no adequate way of passing high flows through the existing culverts. An analysis of the existing culverts is recommended (consistent with item 3 above) to assess the existing capacity at this crossing and to evaluate the requirements and cost of a crossing with capacity to support larger storm events.

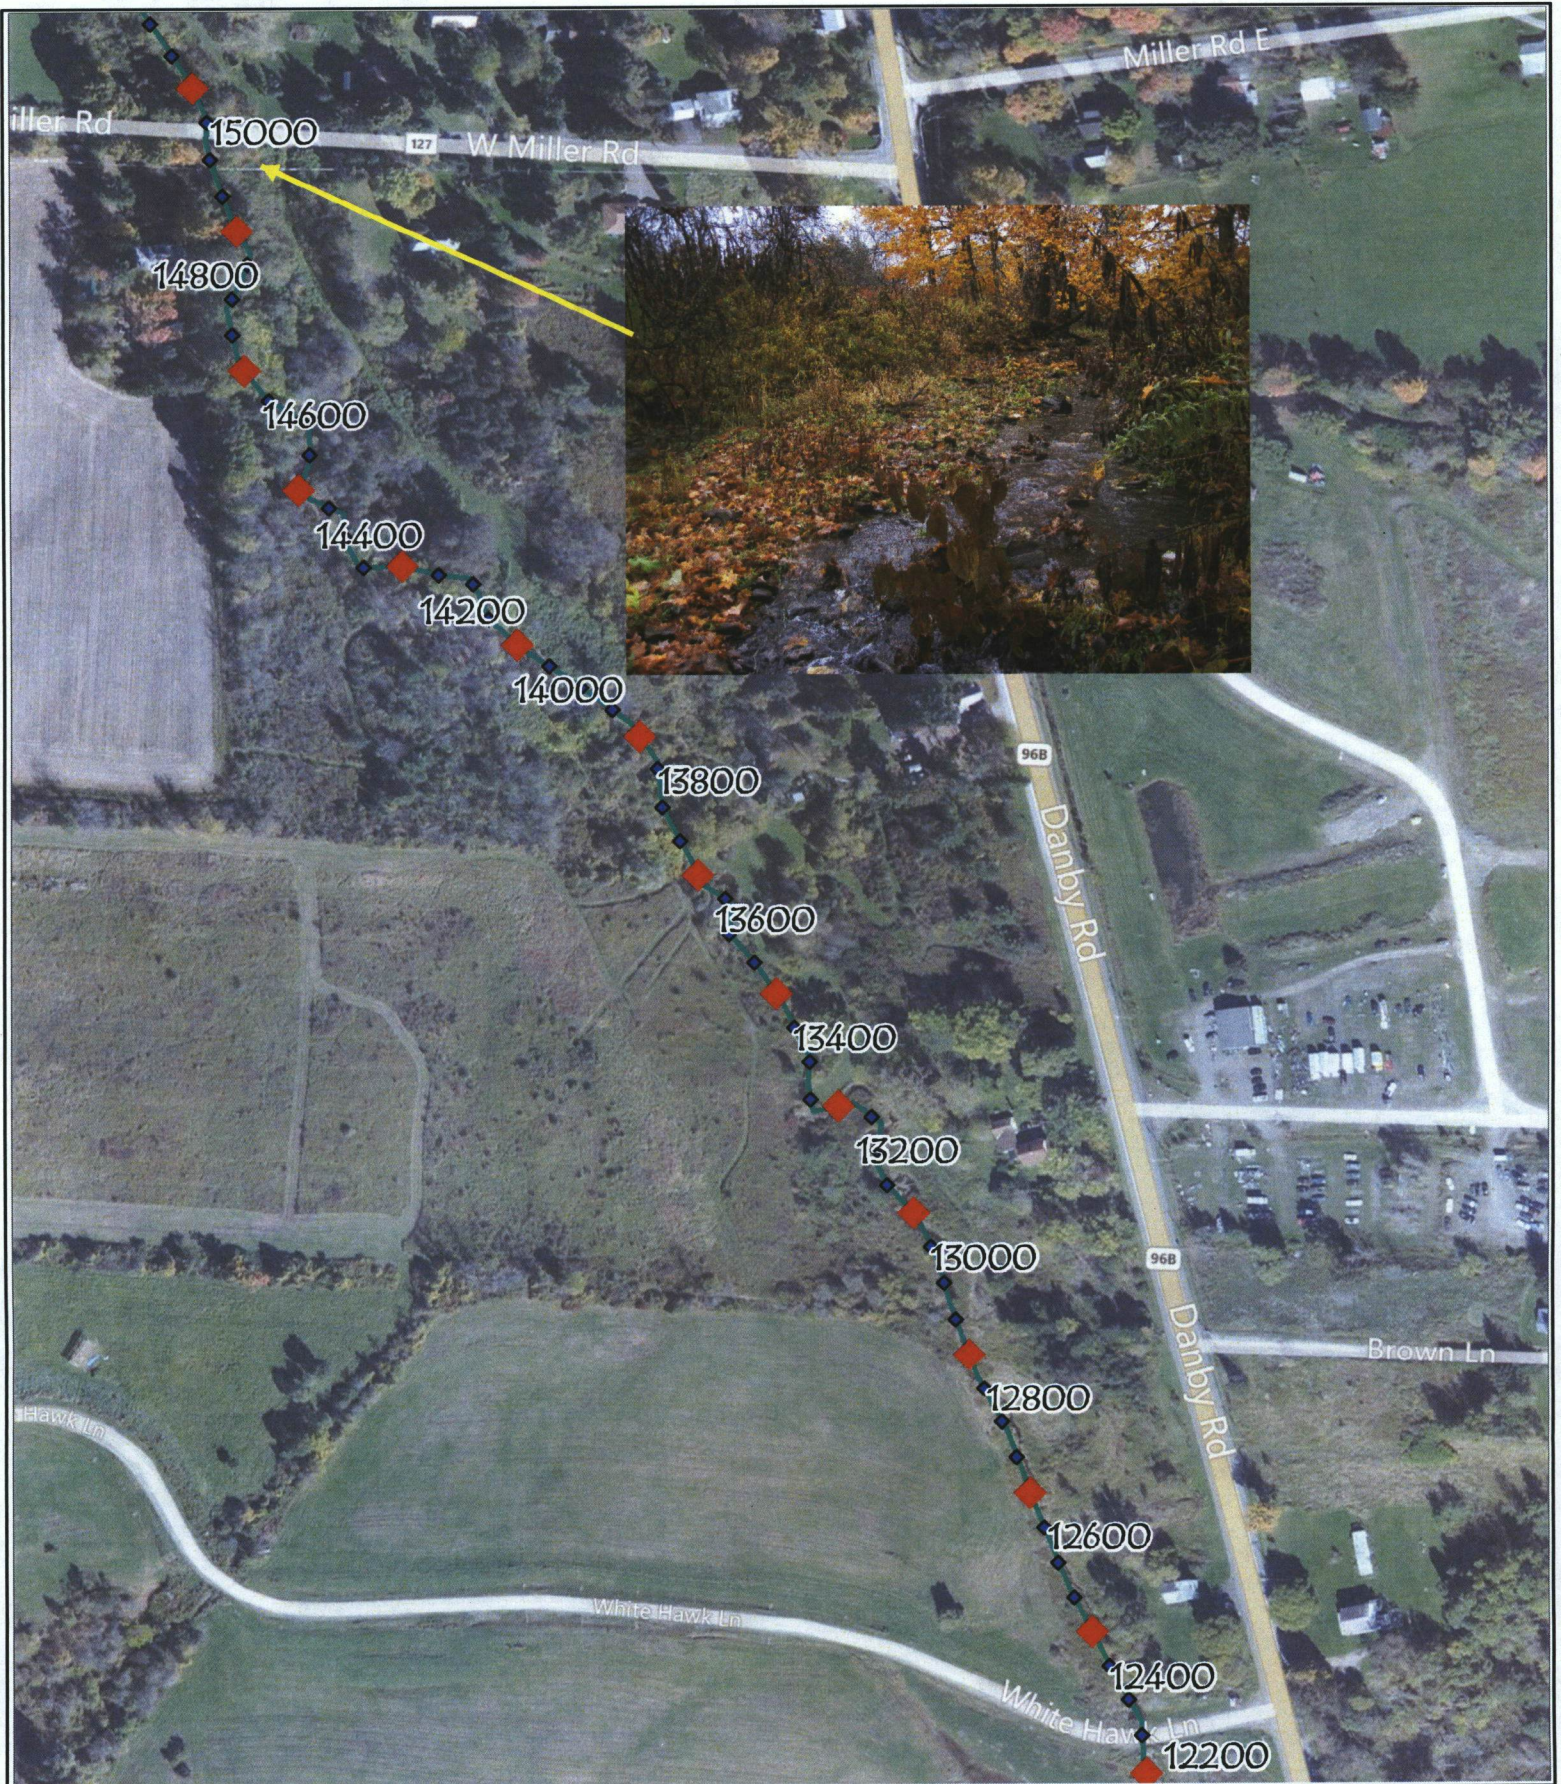
Figure 2-5: Segment #6

Floodplain access exists through most of this segment. Some terraces limit access in areas just upstream of West Miller Road. Adjacent land use is comprised primarily of open fields and agricultural uses to the west and some residential development along Danby Road (Route 96B) to the east. Downstream of White Hawk Lane, the creek begins to trend northwest, away from Danby Road, with increasing tree cover along the eastern bank. The width to depth ratio is approximately 3:1 in this segment. No evidence of erosion was observed in this reach and no reports of flooding.

West Miller Road Bridge is planned to be replaced by the County in 2013. The existing bridge spans 19 feet, with a vertical clearance of eight feet. Large trees line the banks and appear to be stable. One house is in close proximity to the creek at the West Miller Road crossing, but believed to be on a stable terrace with limited risk to flooding.

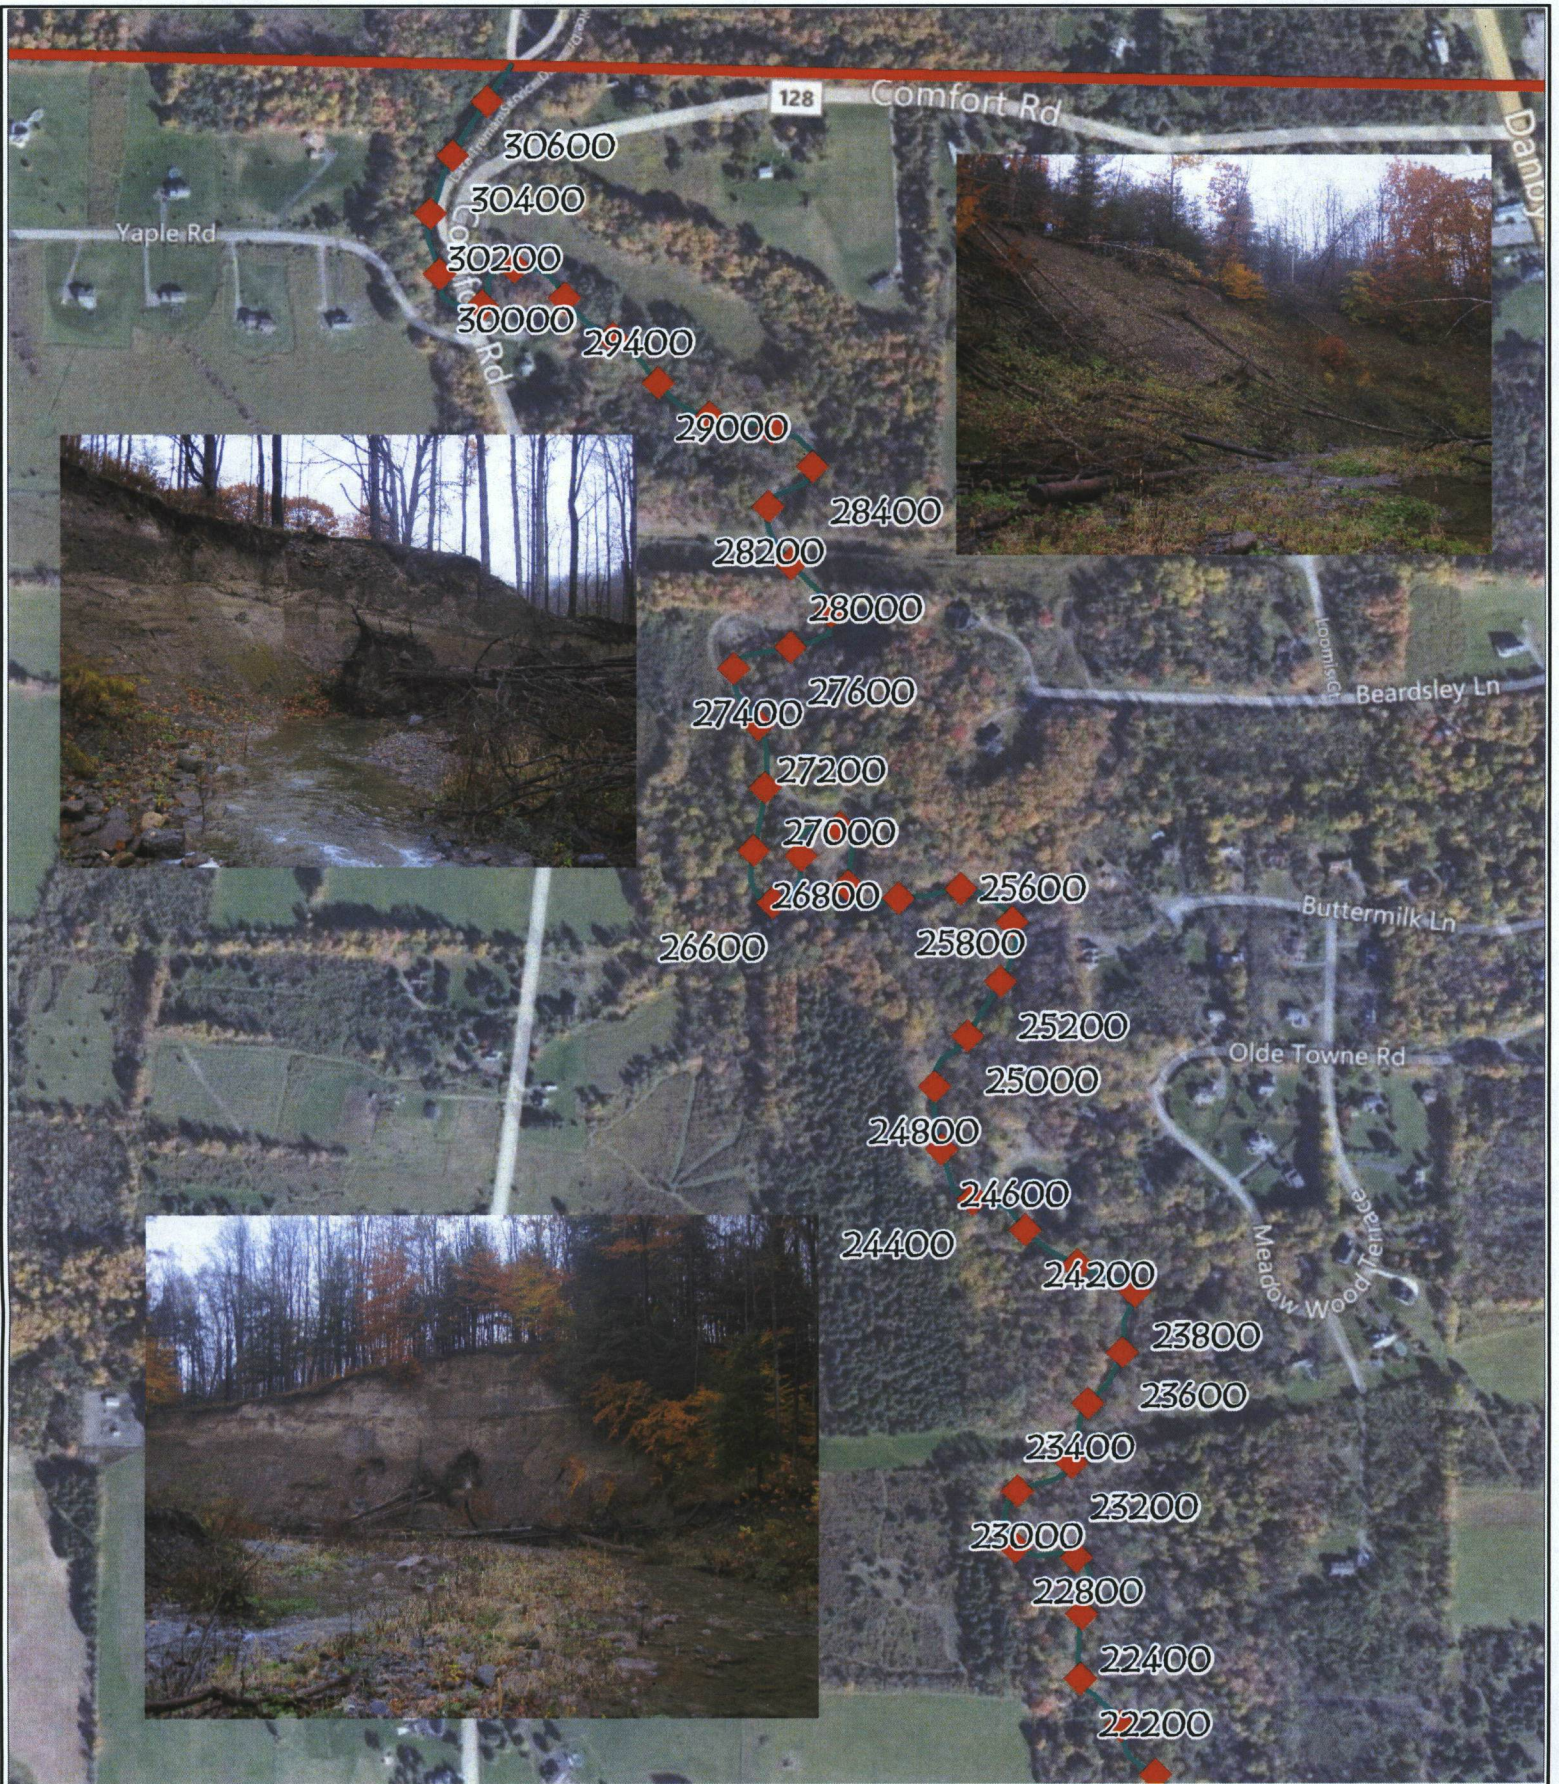
Figure 2-7: Segment #8

Figure 2-7 depicts Segment 8, which includes 8,140 feet of Buttermilk Creek extending 600 feet upstream of the utility/gas line crossing (Station 226+00) to the municipal border between Danby and Ithaca (Station 307+40). The slope of the channel in this segment steepens in the range of 1.5% to 2.8% as the channel enters into the gorged section of Buttermilk Creek (beginning at approximate Station 280+00. This segment begins to meander significantly, doubling back on itself and causing major bank erosion along the way. Bank failures range from a height of 10 feet to 60 feet and have become a significant source of sediment and turbidity under high flow conditions. Specifically, bank failures were observed at the locations indicated in Table 2-2.

Bank Failure Site #	Station #	Failure Height	Failure Location (Looking Downstream)
1	230+00	30 feet	Left Bank
2	245+00 to 249+00	45 feet	Left Bank
3	254+00	54 feet	Right Bank
4	260+00	20 feet	Left Bank
5	262+00	20 feet	Right Bank
6	266+00	20 feet	Left Bank
7	274+50	25 feet	Left Bank
8	277+00	40 feet	Right Bank

Large woody debris has entered the system within this reach associated with bank failure and trees being deposited into the channel. These obstructions have caused debris dams that prevent the natural path of flow and induce localized scour. The channel has adequate floodplain connectivity in certain locations but also has choke points in this segment.

1. Judiciously apply engineered bank treatments in priority areas to protect existing structures, private property, and infrastructure, and where sediment contributions to Buttermilk Creek are the greatest. Table 2-2 presents a summary of bank failure locations. Within this list, priority should be given to sites with the greatest potential for sediment release as well as those that are located in close proximity to or have the potential to compromise existing development, including structures and infrastructure (utilities, roadways, etc.). Alternate water quality renovation approaches should be explored for the purpose of protecting downstream recreational uses and ecological habitat. The long-term economy of stabilizing individual sites (often on the order of

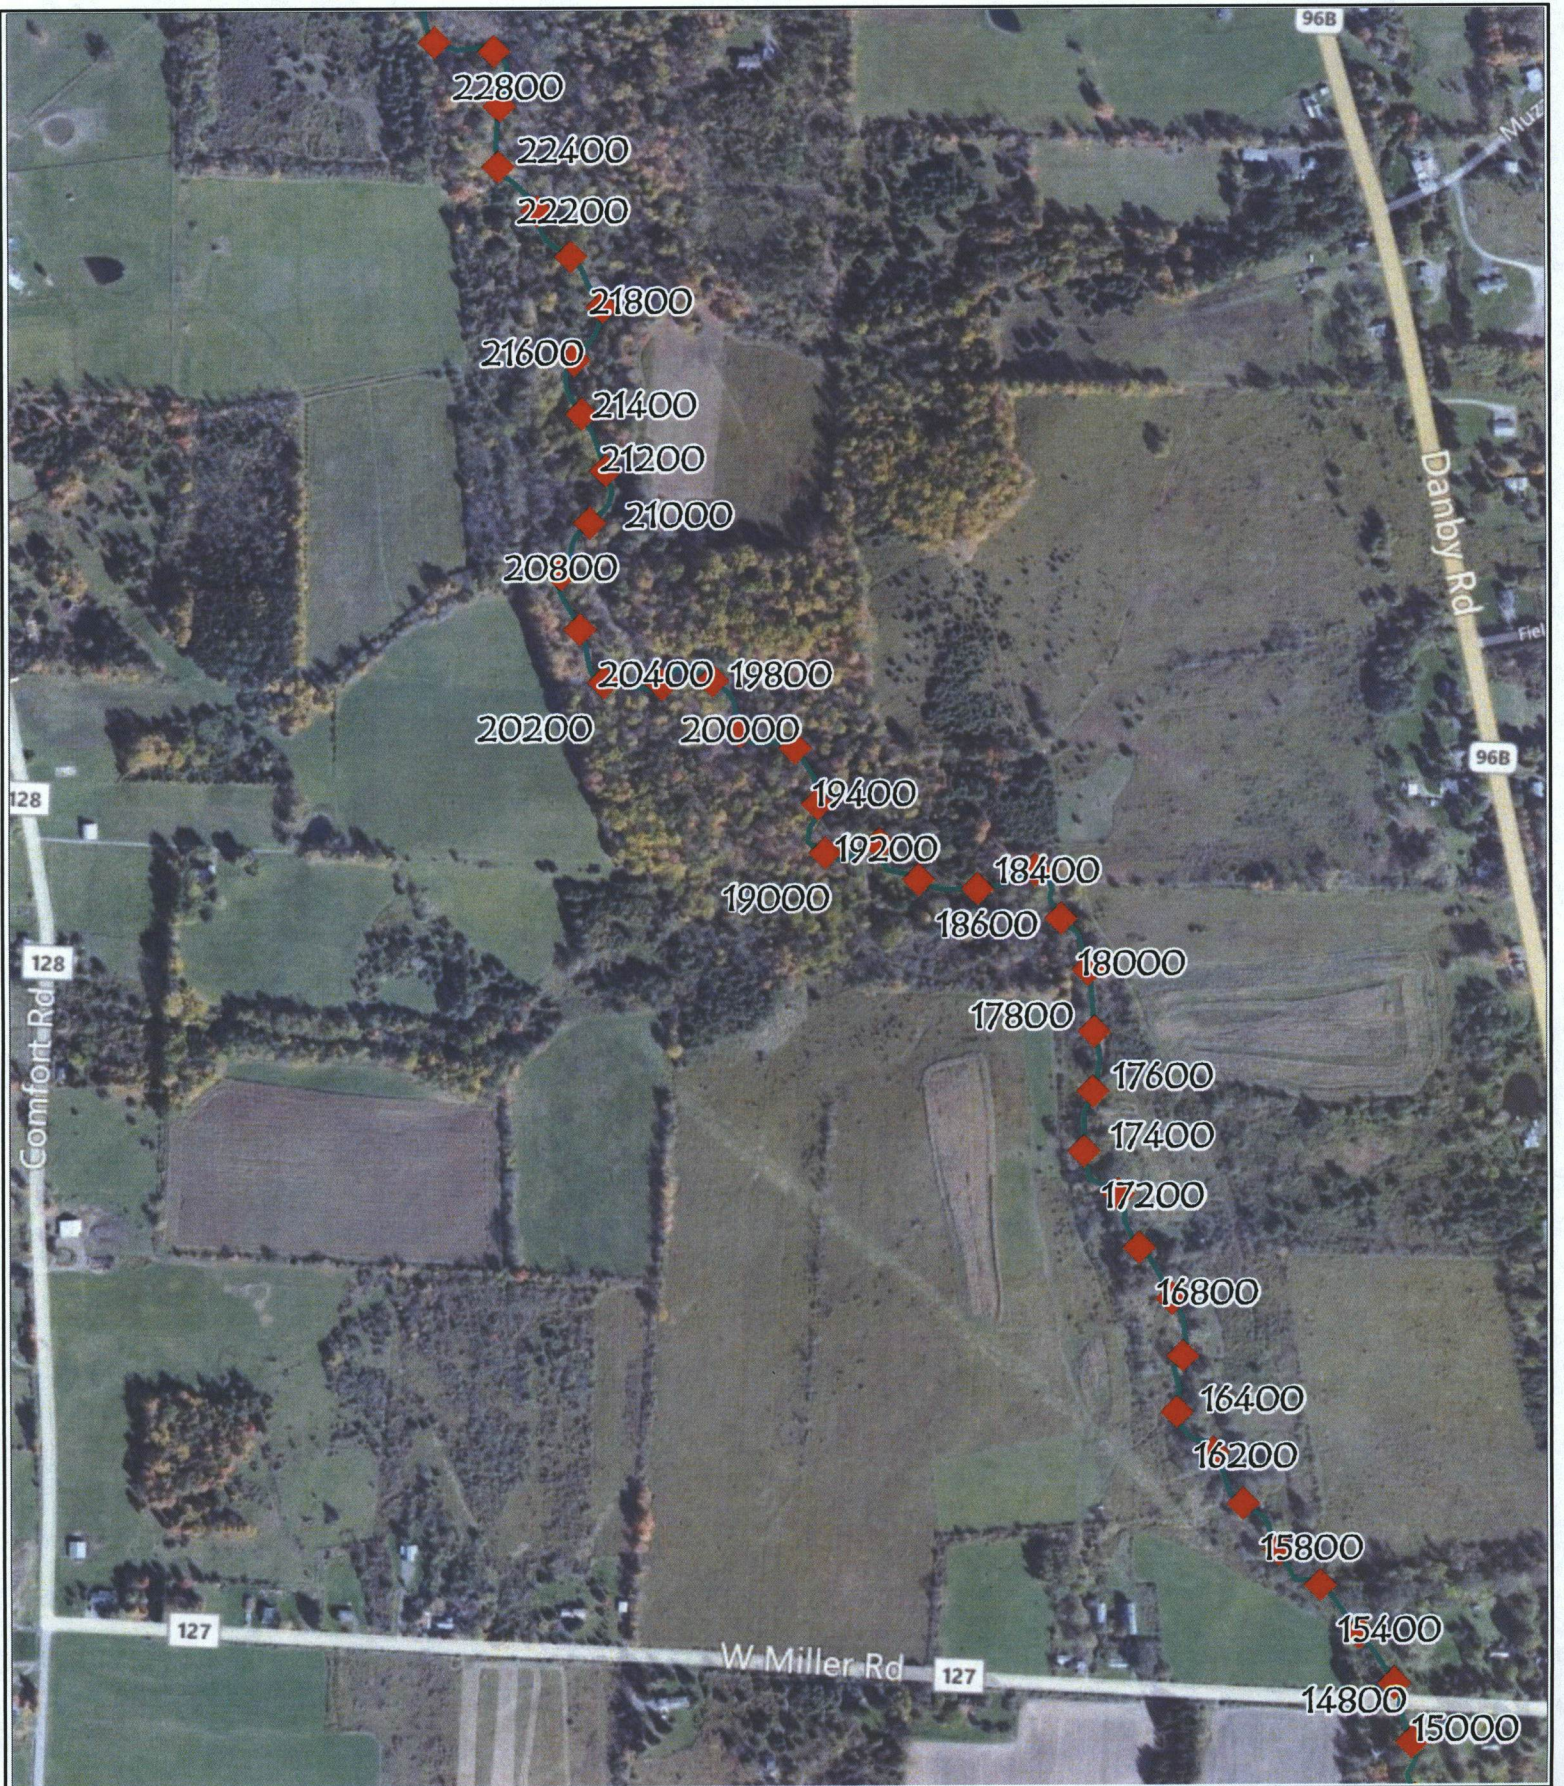
Figure 2-6 depicts Segment 7, which includes 7,650 feet of Buttermilk Creek extending from the West Miller Road Crossing (Station 149+50) to 600 feet upstream of a Dominion utility/gas line crossing at Station 226+00. Infrastructure within this reach requires periodic maintenance and mitigation. Interaction with utility companies should occur to advance any future mitigation measures.

Segment 7 is of lower priority and thus was reviewed to a lesser extent than the other segments. No infrastructure runs along the creek through this segment and little development surrounds the creek. The channel begins to meander more through this reach and bank erosion is evident at these meanders. There is an abundance of buffer with agricultural fields to the west of the creek beyond a forested buffer. Comfort Road and Route 96B run parallel to the creek towards the upper most limits of the watershed.

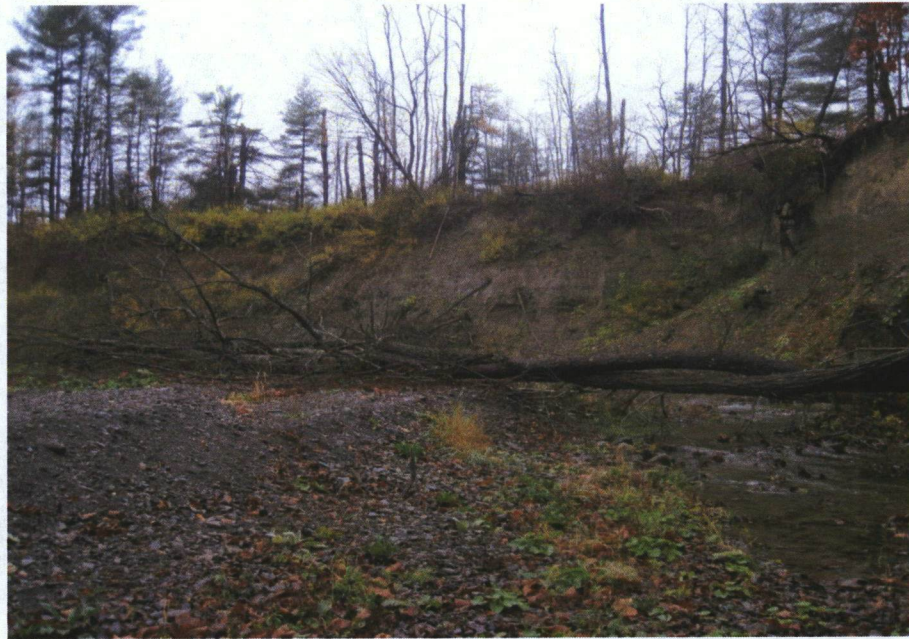
Bank Failure Site #1
See Table 2-2

Major slope erosion/failure along left bank, large woody debris in channel, site upstream of gas line crossing.
