Watershed Needs Assessment

Buttermilk Creek Tompkins County, New York

March 2013

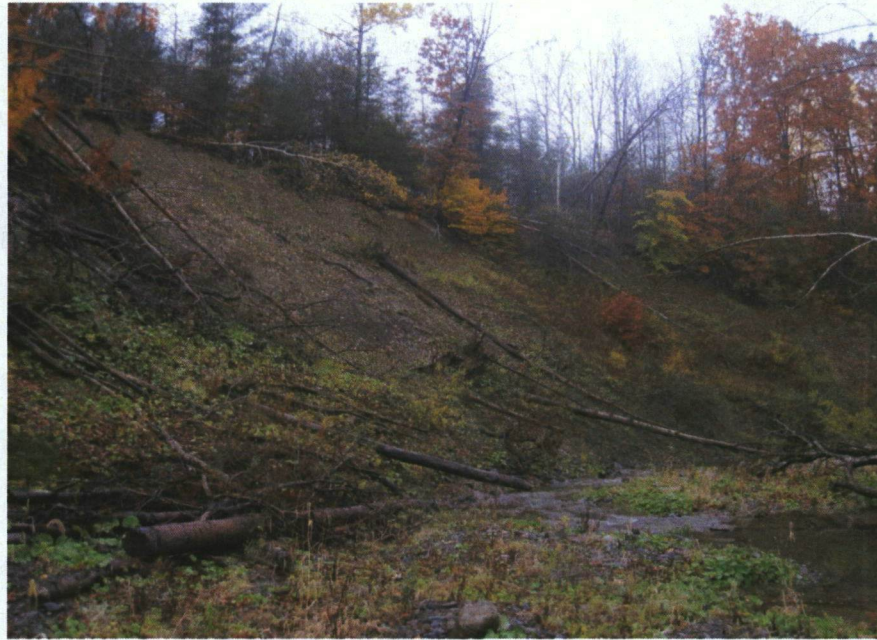
Bank Failure Site #2
See Table 2-2

Bank Failure Site #	Station #	Failure Height	Failure Location (Looking Downstream)
1	230+00	30 feet	Left Bank
2	245+00 to 249+00	45 feet	Left Bank
3	254+00	54 feet	Right Bank
4	260+00	20 feet	Left Bank
5	262+00	20 feet	Right Bank
6	266+00	20 feet	Left Bank
7	274+50	25 feet	Left Bank
8	277+00	40 feet	Right Bank

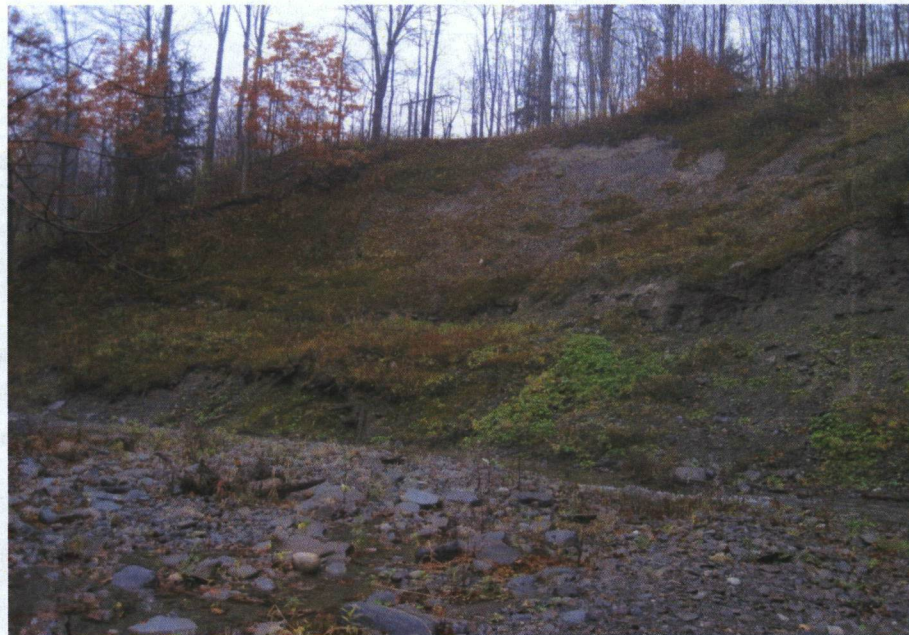
Bank Failure Site #8
See Table 2-2

In other instances, erosion sites and bank failures may self-stabilize in time. One site on Buttermilk Creek that can be used as a template for self-healing bank stabilization occurs near Station 277+00. The bank has hit an angle of repose (i.e. has become stable) and has begun to vegetate itself. A lower floodplain bench at the toe of the bank has naturally formed. Additional armoring of the toe of this bank would further stabilize the site against high flow events. The use of a combination of low stone and log revetments can serve as a more natural reinforcement to the bank.
