**BIN 3314460**  
**Podunk Road over Taughannock Creek**  
**Town of Ulysses, Tompkins County**

**Historic Bridge Disposition (Bridge for Sale)**

Materials Available for Review:

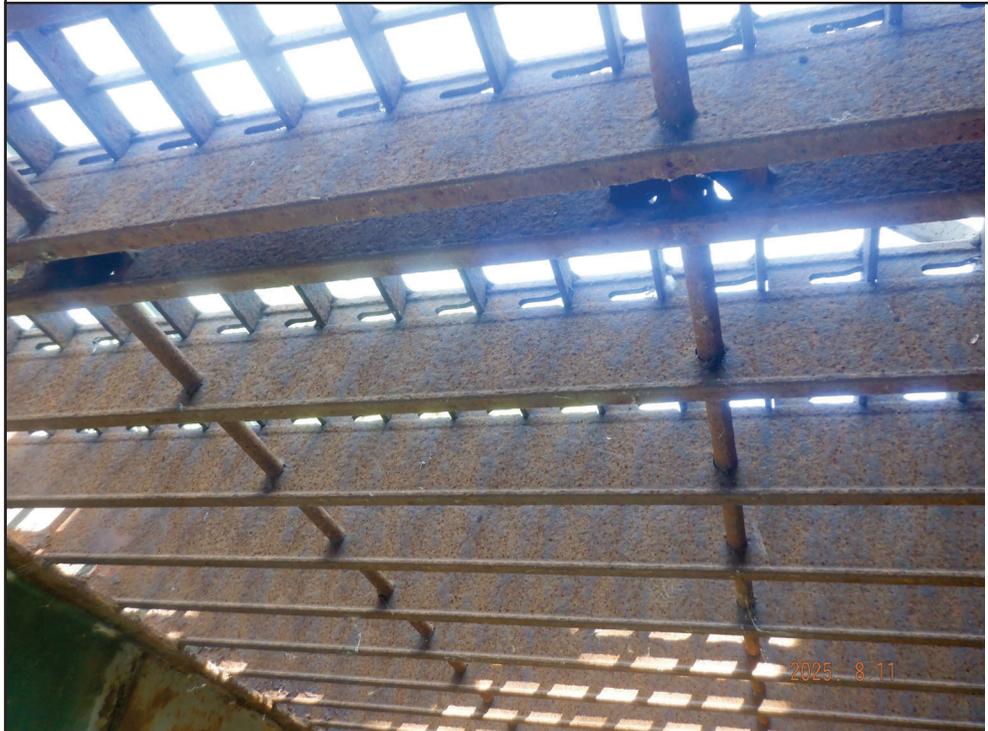
Photo Number: 2

**Attachment Description:**  
The deck sleeper under Panel 3 Stringer Bay 2 (corrosion with perforation), looking towards end.

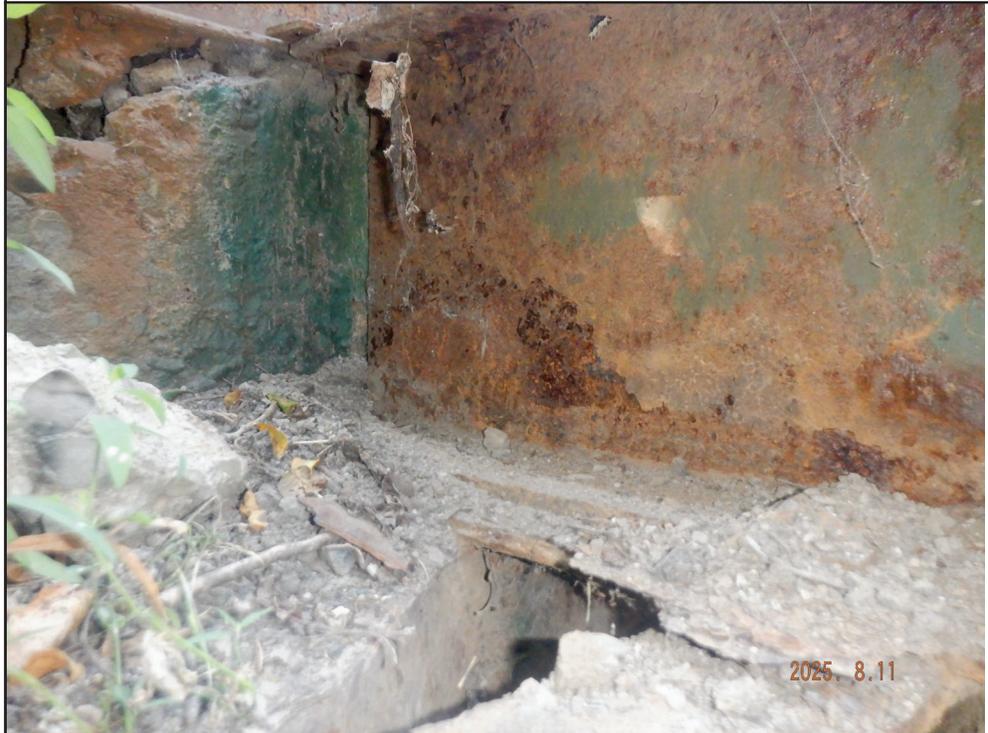
Photo Number: 4

Stringers S2-S5 also exhibit 10-15% full height web section loss at the begin abutment and over floorbeams (typically at locations without the web repair) (Photo 4).

**Attachment Description:**  
Stringer S4 at the begin abutment (web SL and bearing paint condition photo), looking towards begin left.

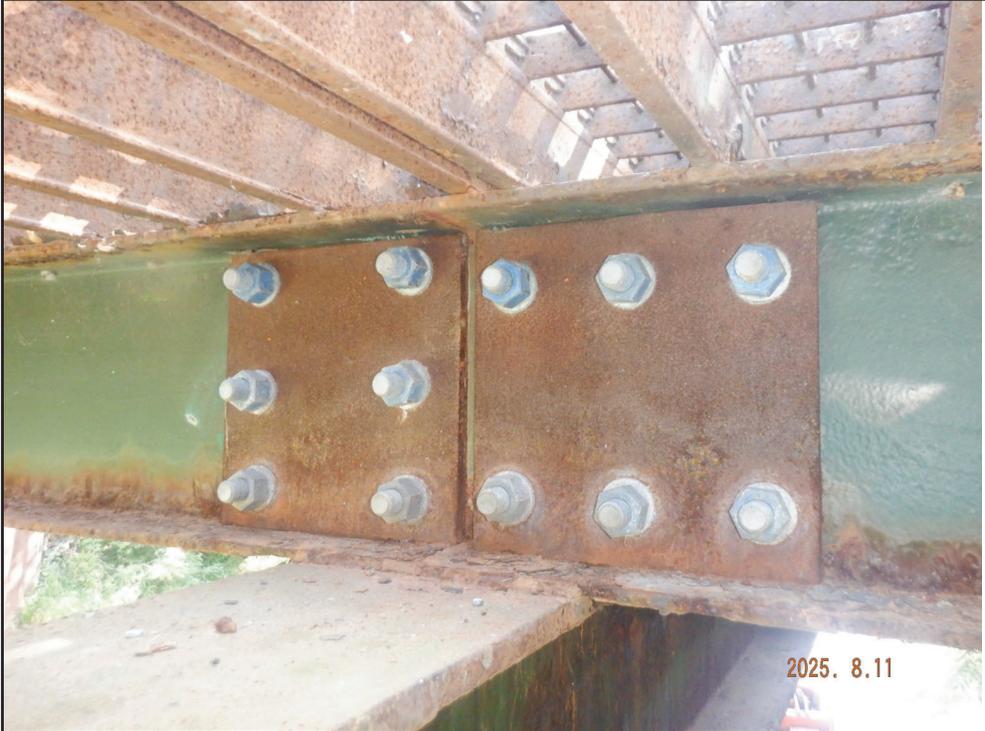
Photo Number: 5

Stringer S2 over Floorbeam FB2 and Stringer S4 over Floorbeam FB4 have been repaired with strengthen plates (Photo 5). Previously issued Red Flag 3B2468W020 has been removed prior to this inspection.

**Attachment Description:**  
Stringer S2 over Floorbeam  
FB2 (typ. stringer web  
repair), looking towards end  
right.

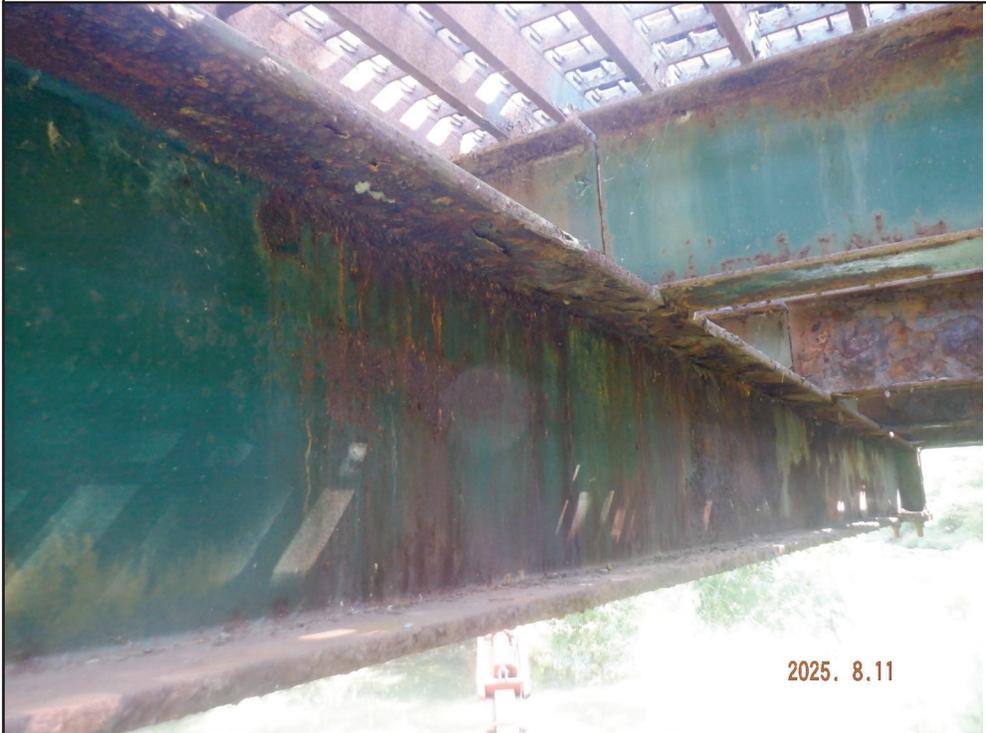
Photo Number: 8

The floorbeam paint has failed over an estimated 50% of the surface area, leading to corrosion and minor section losses along the top and bottom flanges, as well as the webs near the truss connections (Photo 8).

**Attachment Description:**  
General view of Floorbeam  
FB1, begin face (paint  
condition photo), looking  
towards right.

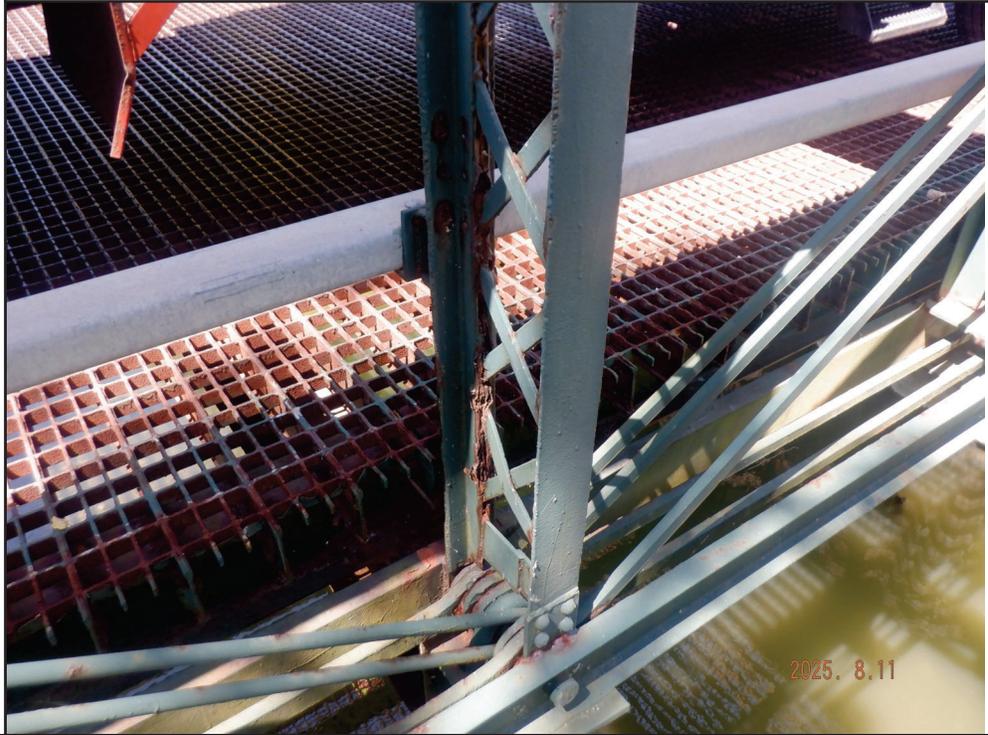
Photo Number: 9 Photo Filename: 25\_3314460\_DSCF2544.JPG

The vertical truss members exhibit scattered areas of pack rust between the transverse angle legs (Photo 9). Localized sections losses are estimated to be up to 25%, with overall section loss estimated at less than 10%.

**Attachment Description:**  
Truss T2, U3L3 near L3  
(pack rust), looking towards  
end left.

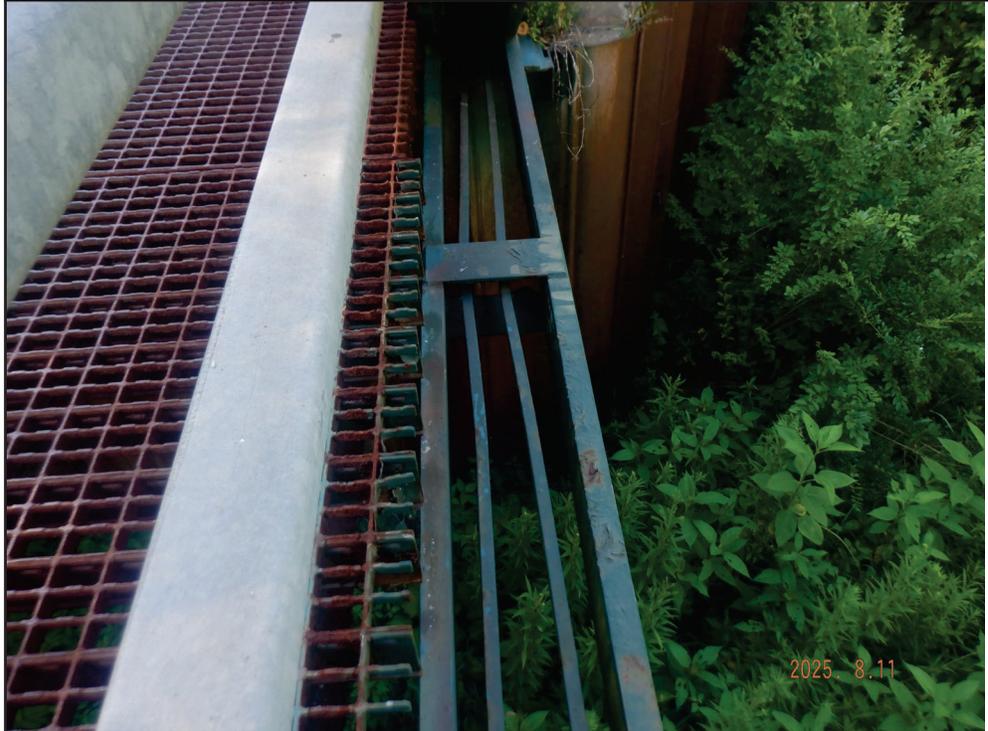
Photo Number: 10 Photo Filename: 25\_3314460\_DSCF2497.JPG

**Attachment Description:**  
Truss T1, L0L1 (bent  
eyebars), looking towards  
begin.

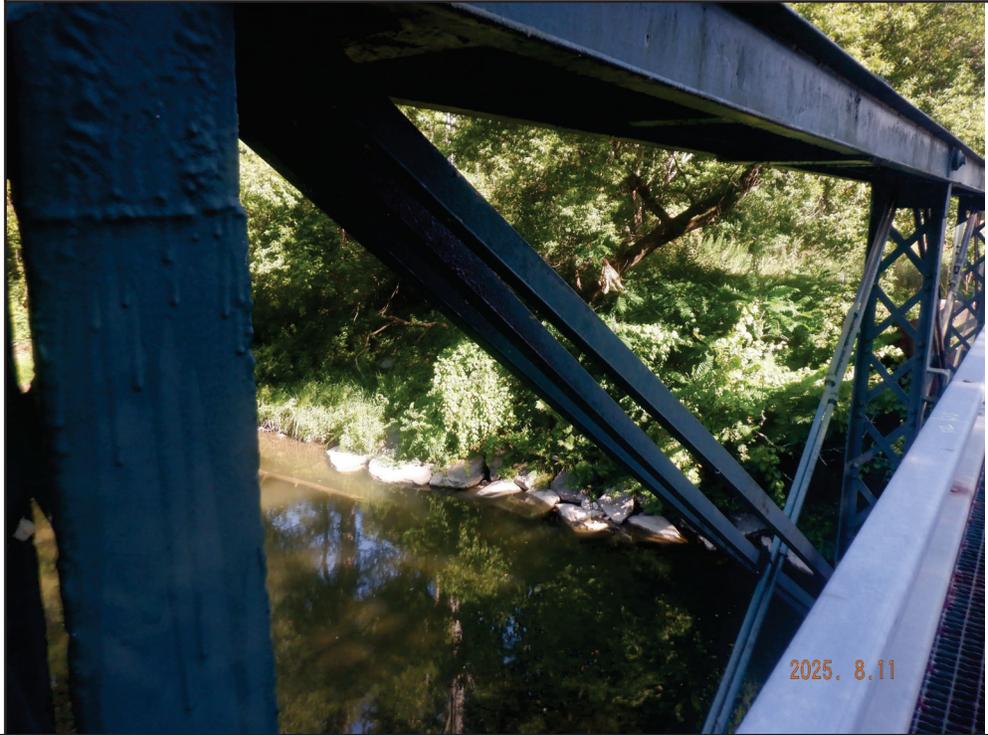
Photo Number: 11

The inboard eyebars of the Truss 1 diagonal members U1L2 (Photo 11) and L3U4 and the outboard eyebar of Truss 2 U1L2 are loose and can be easily deflected transversely up to 3" by hand.

**Attachment Description:**  
Truss T1, U1L2 (inboard  
eyebars loose), looking  
towards end left.

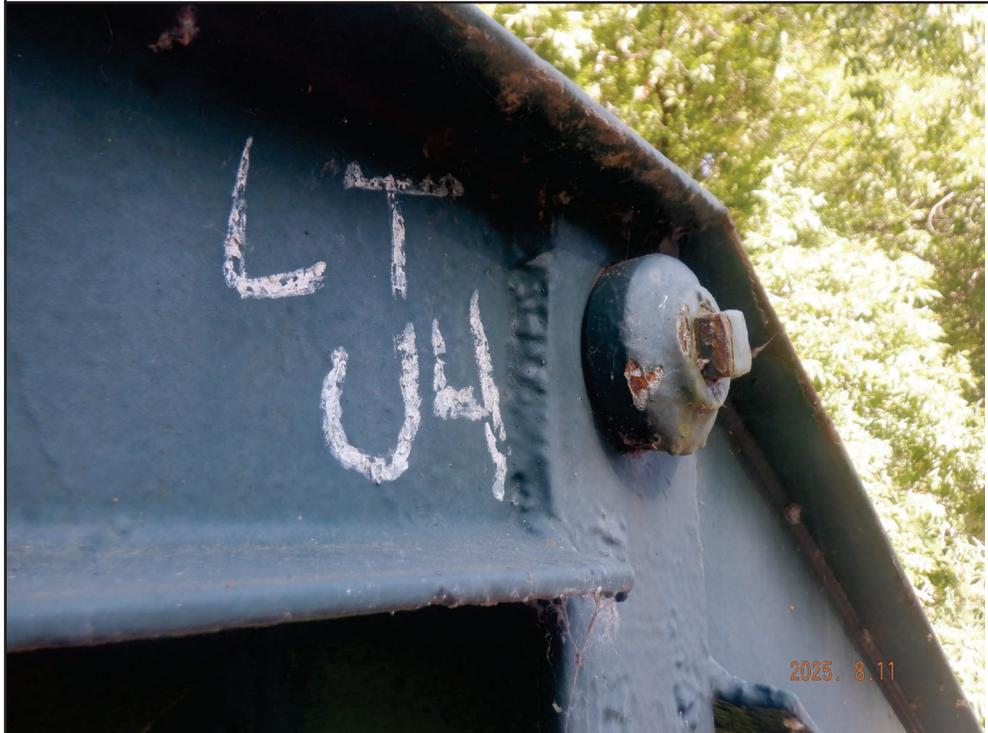
Photo Number: 12

**Attachment Description:**  
Truss T1, U4 pin cap (not  
fully seated), looking  
towards end left.

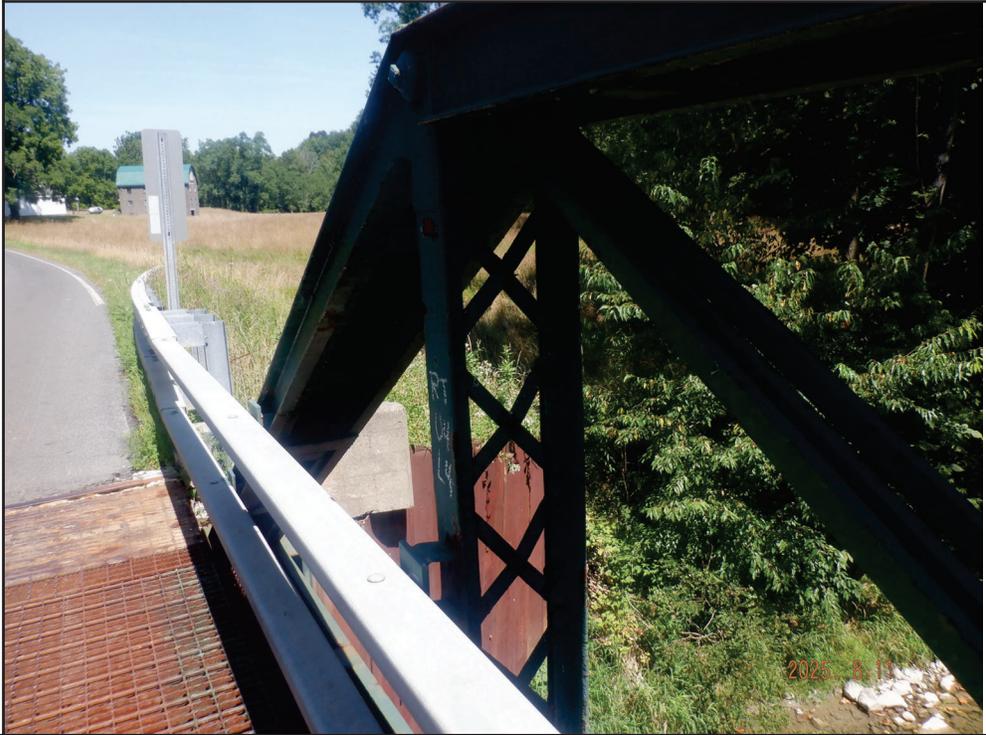
Photo Number: 13

The Truss 2 U4L4 member is bent outwards by up to 1/4" as a result of a previous impact damage (Photo 13).

**Attachment Description:**  
Truss T2, U4L4 (minor impact damage), looking towards end right.

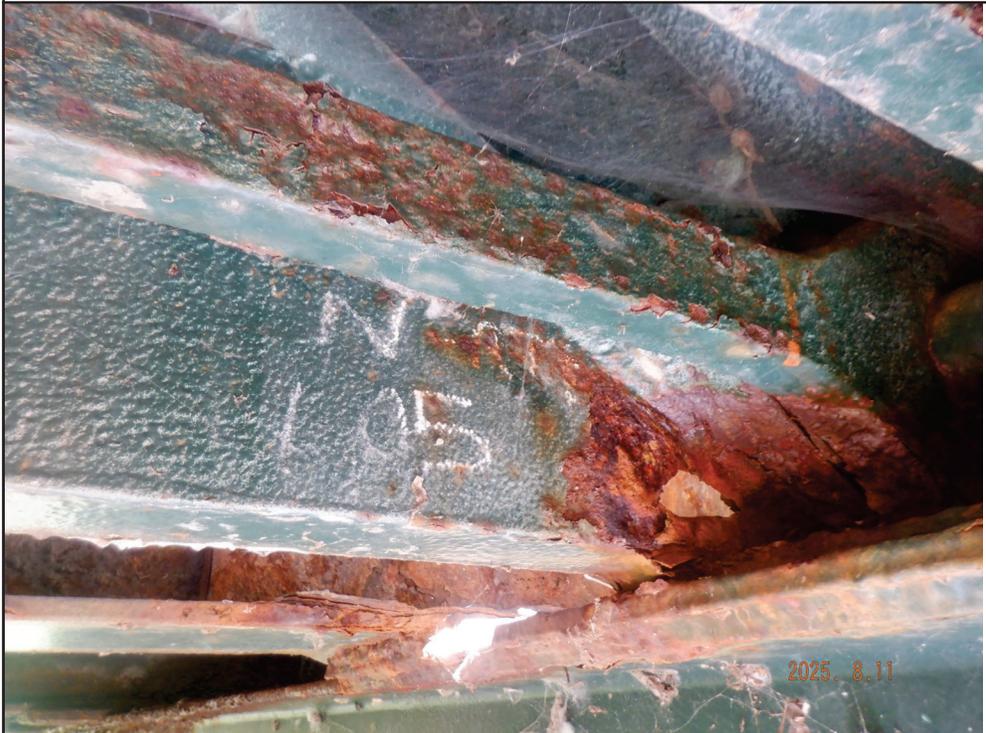
Photo Number: 14

The Truss 2 bottom chord member L4L5 exhibits localized web section loss to both the inner and outer channels at L5 below member U4L5. There is a 1" wide x 3/4" high corrosion hole in the web of the inner channel in this location (Photo 14).

**Attachment Description:**  
Truss T2, L4L5 at L5 (corrosion with perforation), looking towards end left.

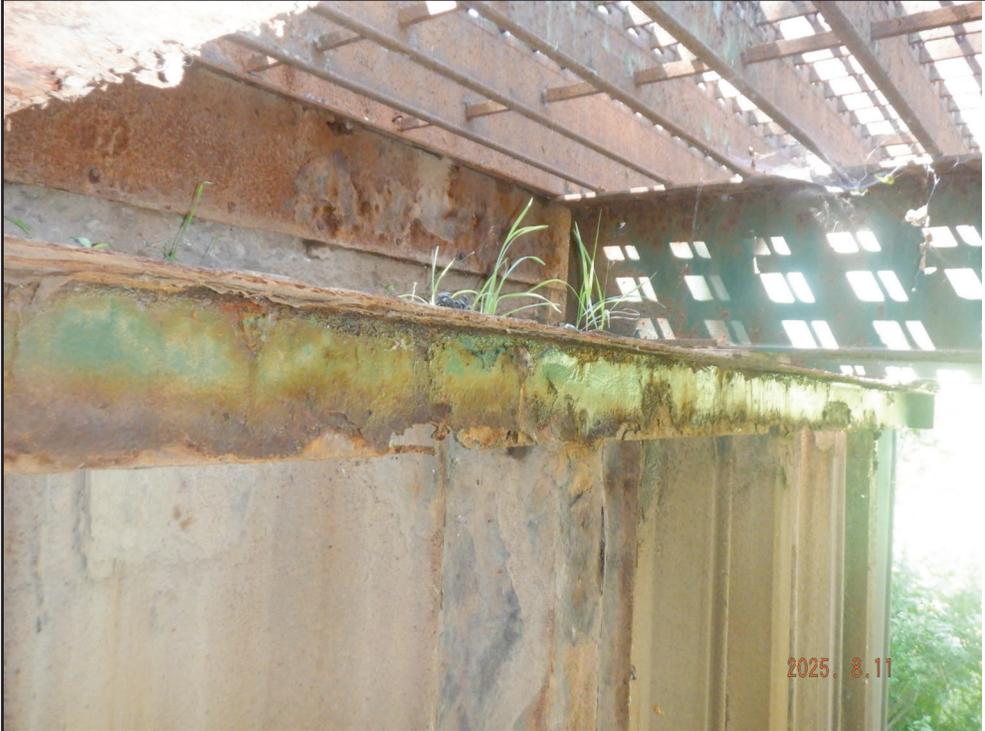
Photo Number: 17

The begin and end abutment steel cap beams exhibit corrosion and section loss along their horizontal and vertical legs over the full width of the substructures. Section losses typically up to 15% but at some locations corrosion holes present intermittently along the element width on the vertical legs (Photos 17 & 18).

**Attachment Description:**  
The left half of the begin abutment steel cap (corrosion with perforations), looking towards left.

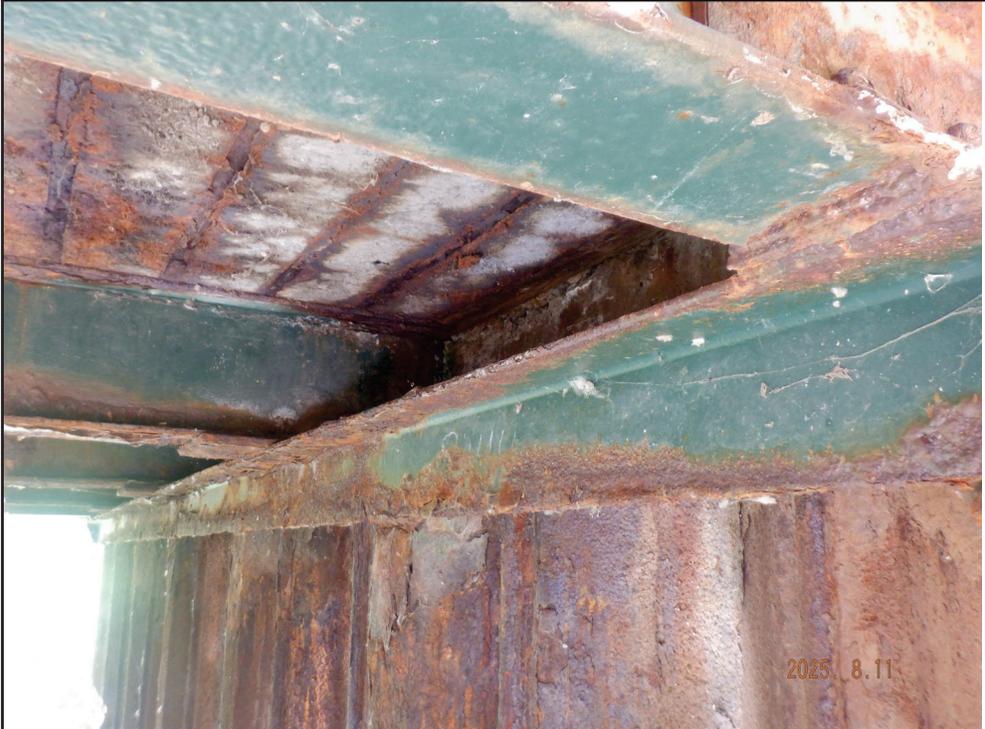
Photo Number: 18

**Attachment Description:**  
The end abutment steel cap (corrosion), looking towards end left.

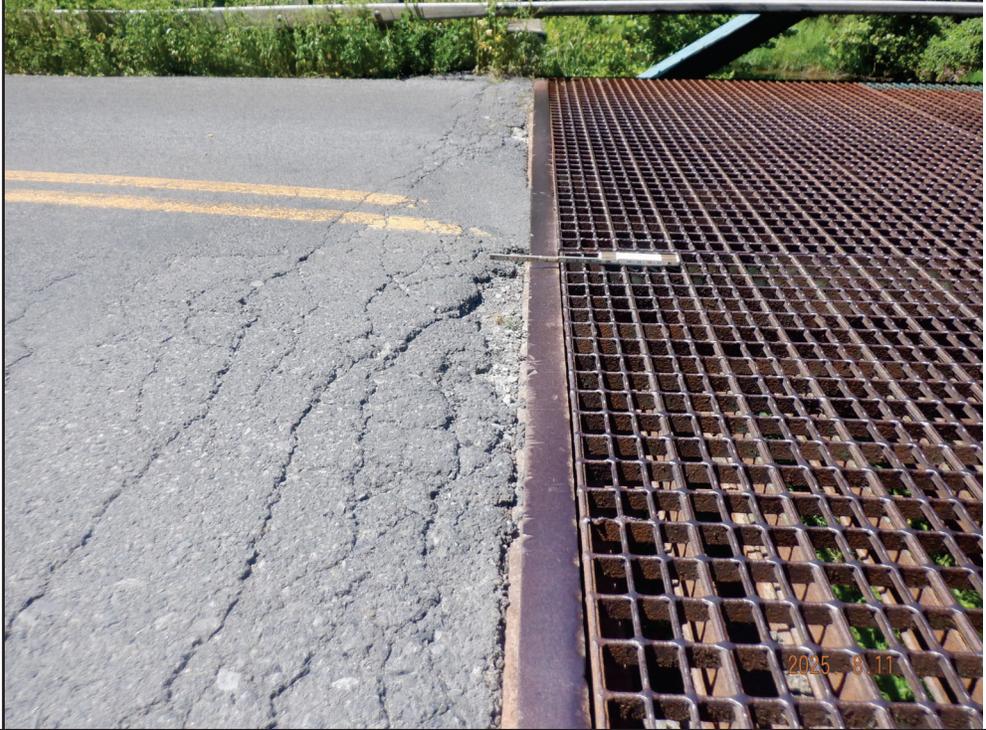
Photo Number: 19

**Attachment Description:**  
The top of the begin joint  
(height difference), looking  
towards left.

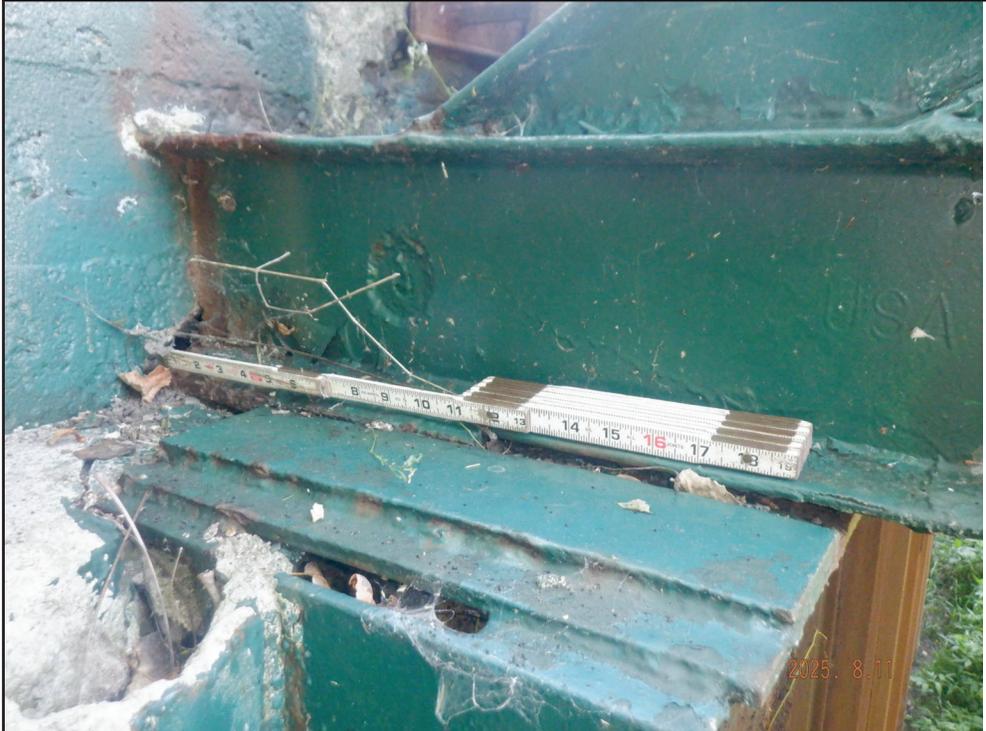
Photo Number: 20

Both bottom chords are in contact with the backwalls, preventing further expansion. This is a long standing condition, first documented in 2005.

**Attachment Description:**  
Truss T2 bearing at the  
begin abutment (over-  
expansion), looking towards  
begin left.

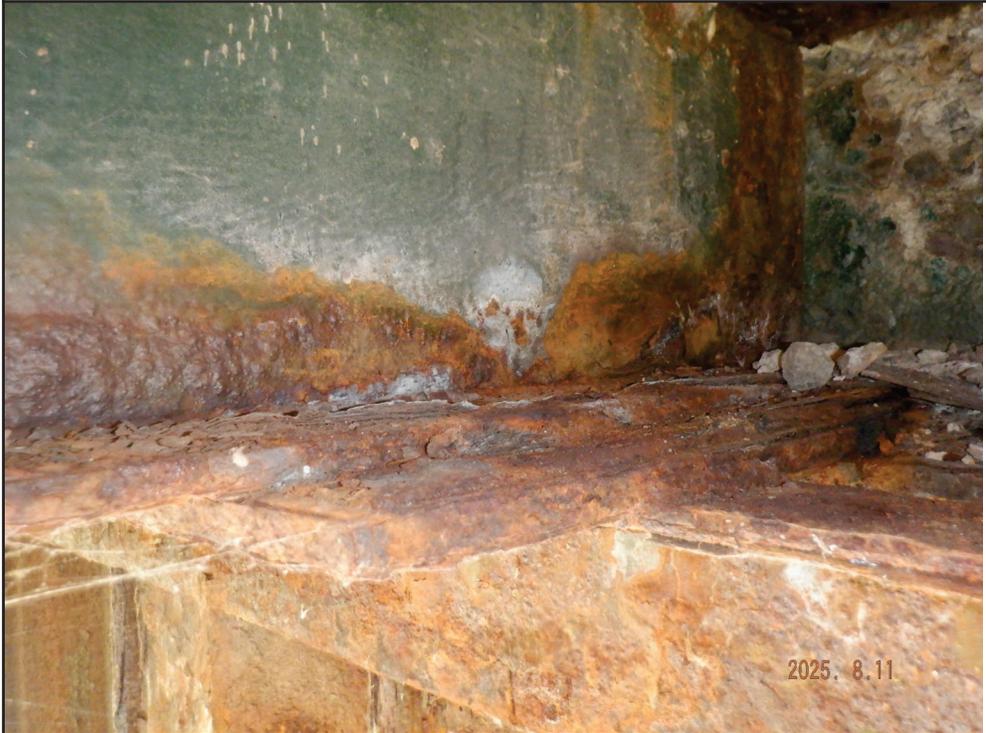
Photo Number: 21

The paint on the stringer bearings at each abutment has failed, leading to corrosion and minor section losses.

**Attachment Description:**  
Stringer S4 bearing at the end abutment (paint condition photo), looking towards end left.

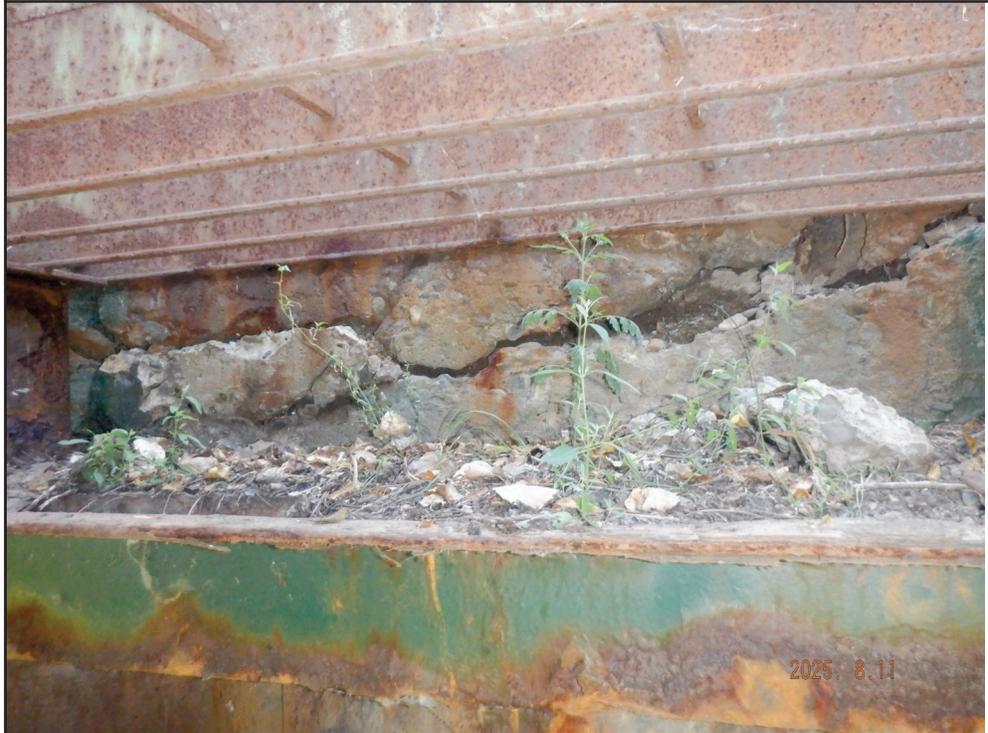
Photo Number: 25

The begin abutment backwall is cracked and spalled between Stringers 1 and 5. The spalling measures up to 2.5" deep, and the cracks typically measure up to 1/4" wide. In Bay 4, the concrete is cracked x up to 1/2" wide and has become fully separated and is slightly loose.

**Attachment Description:**  
The begin backwall under  
Stringer Bay 4 (cracking),  
looking towards begin.

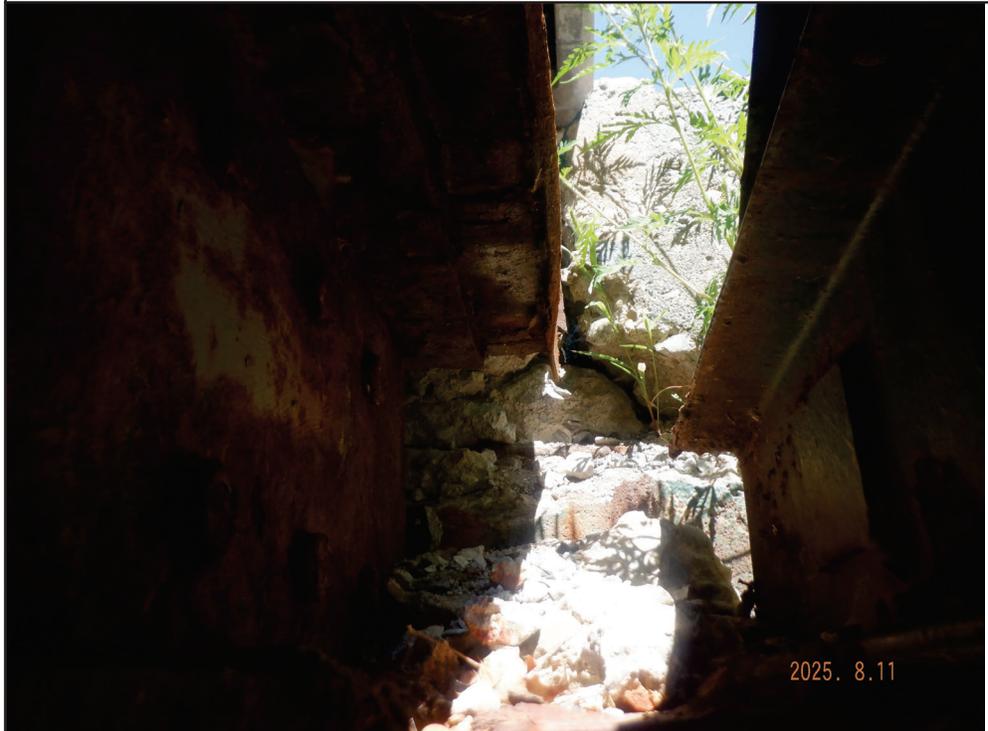
Photo Number: 26

CS4:  
 The end abutment backwall is cracked through its full thickness at the right deck fascia. The portion of the backwall to the right of the crack is separated and rotated (the backwall is moves towards end for 2" at the crack while the tip of the backwall moves towards the stream for 3"-4") (Photos 26 & 27).  
 Affected Quantity: 4 LF

**Attachment Description:**  
The end backwall at the  
right side (cracking and  
separation), looking towards  
end.

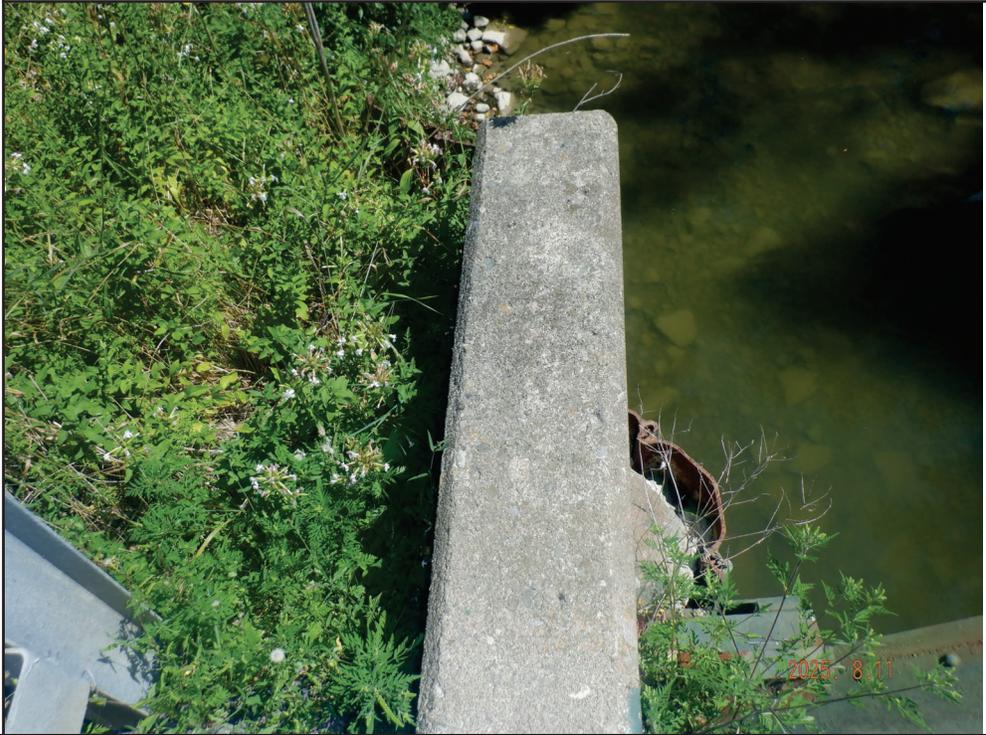
Photo Number: 27

**Attachment Description:**  
The right portion of the end backwall (rotation), looking towards right.

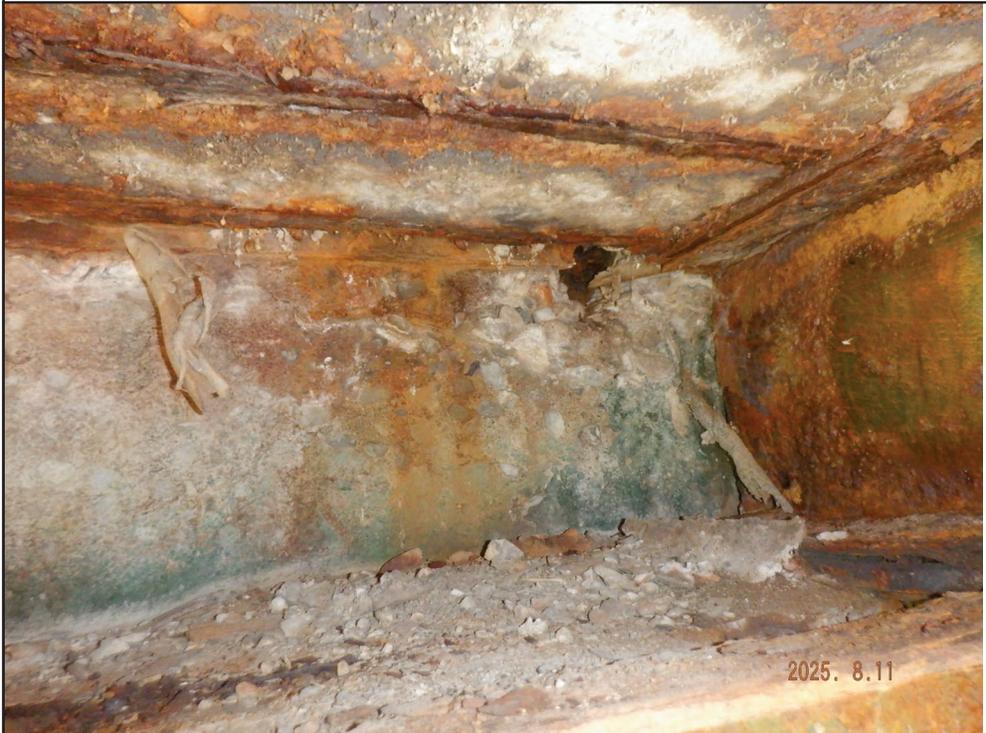
Photo Number: 28

CS3:  
 The top of the backwall under Stringer Bay 3 is spalled 1 SF x up to 4" deep adjacent to Stringer S4 (Photo 28).

**Attachment Description:**  
The end backwall under Stringer Bay 3 (spalling), looking towards end.

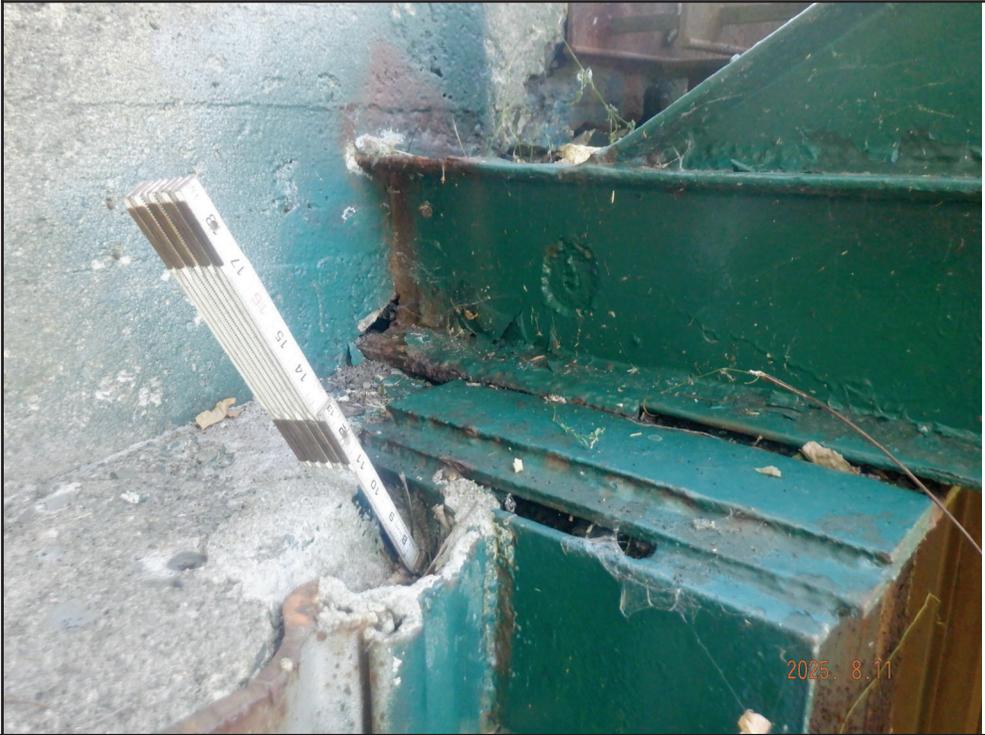
Photo Number: 29

**Attachment Description:**  
Truss T2 bearing at the begin (spalling), looking towards begin left.

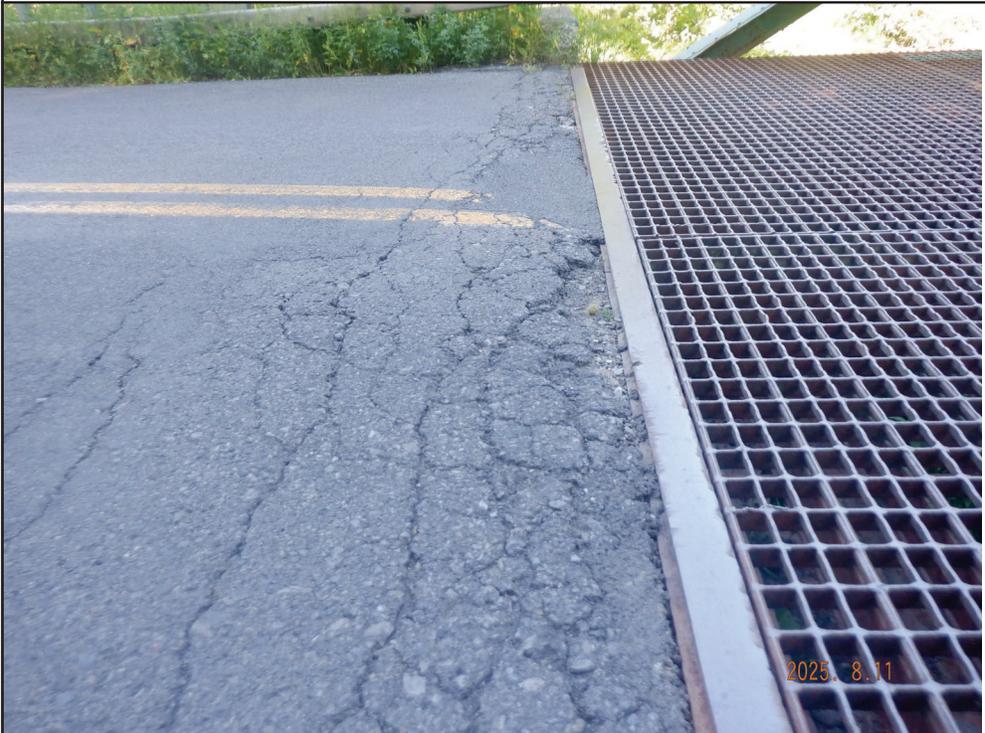
Photo Number: 30

**Attachment Description:**  
General view of the begin approach pavement (spalling and settlement), looking towards left.

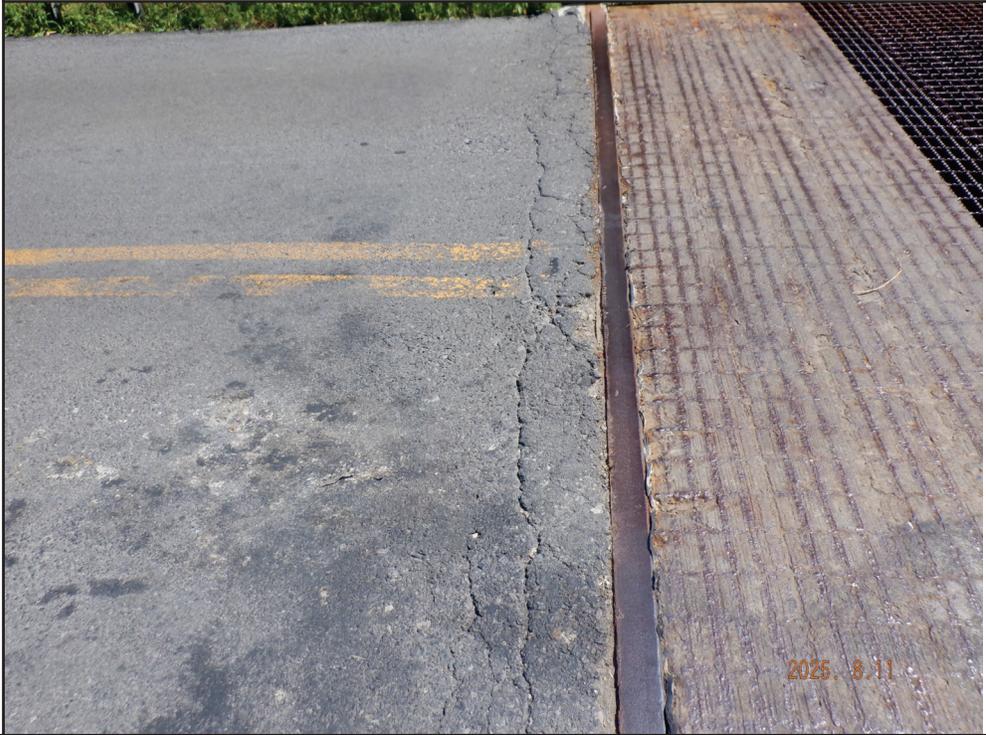
Photo Number: 31

**Attachment Description:**  
The end approach  
pavement (spalling), looking  
towards right.

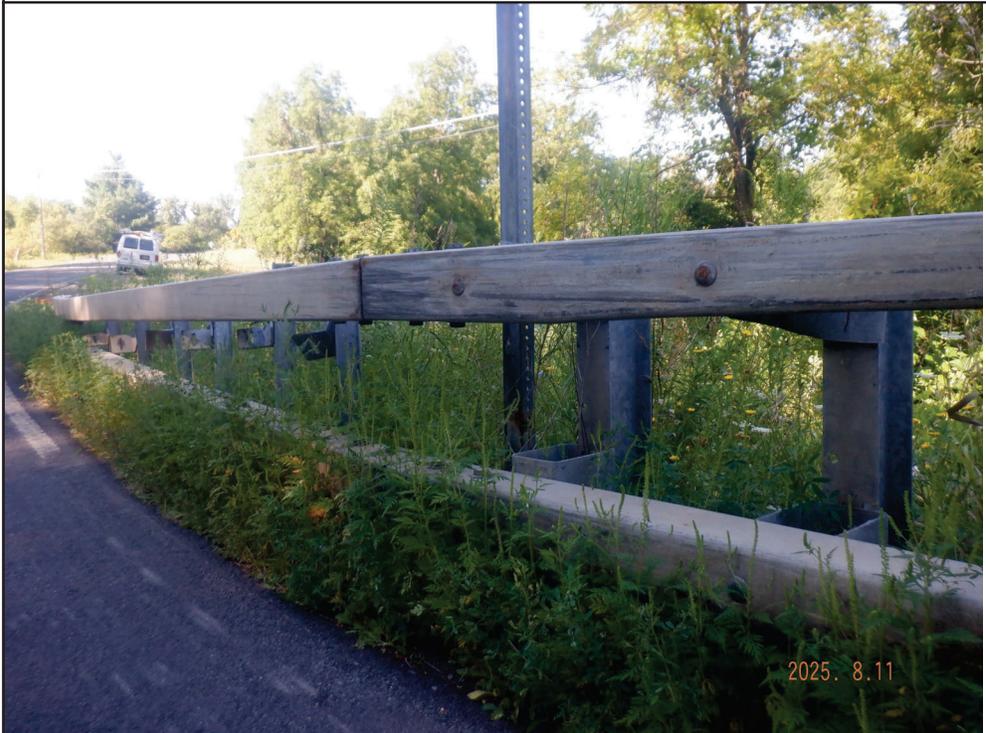
Photo Number: 32

**Attachment Description:**  
The begin left approach  
guide railing (disconnected  
railing posts), looking  
towards begin left.

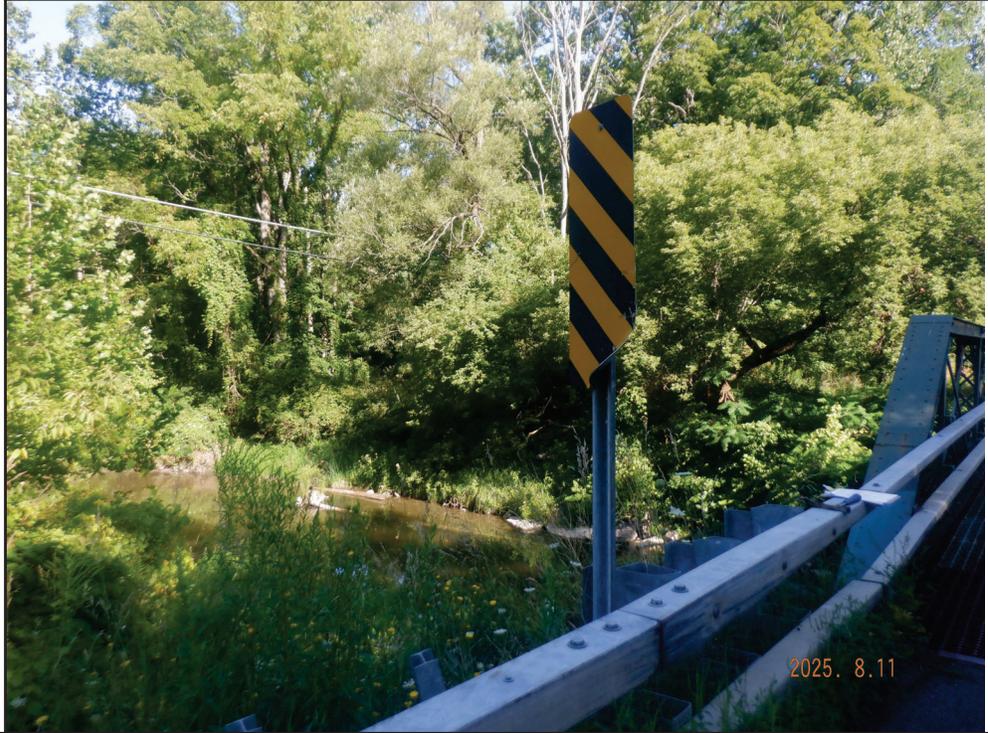
Photo Number: 33

**Attachment Description:**  
The begin left horizontal  
clearance marker (impact  
damage), looking towards  
end left.

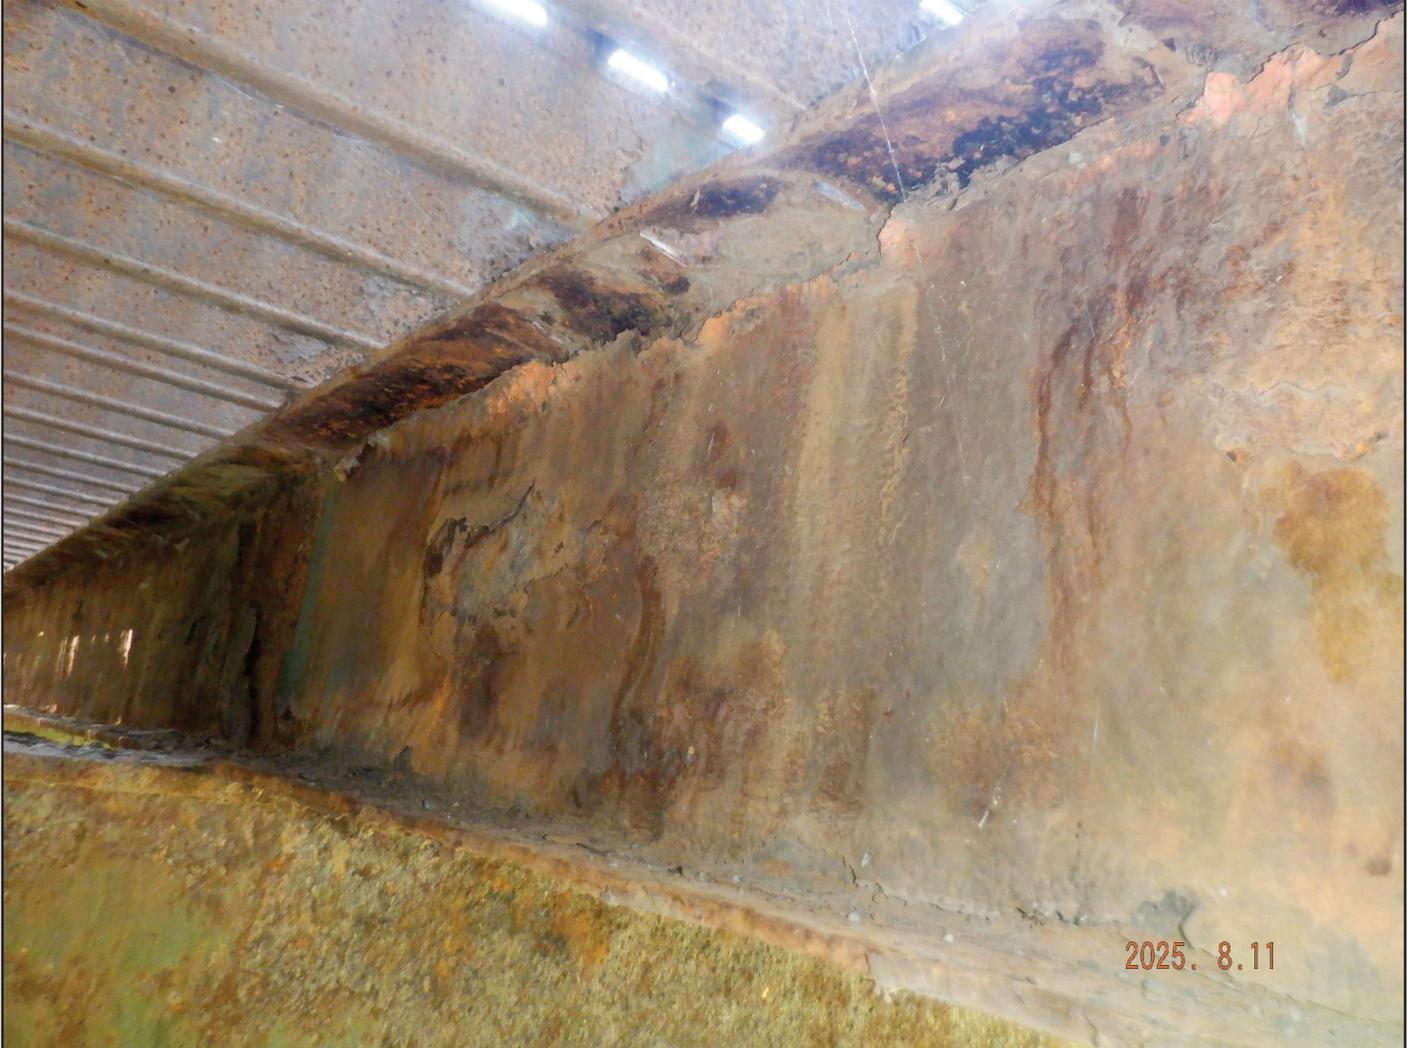
**Attachment Description:** Panel 2, Stringer S3 at 2' from Floorbeam FB1 (Flange SL with perforation), looking towards begin left.

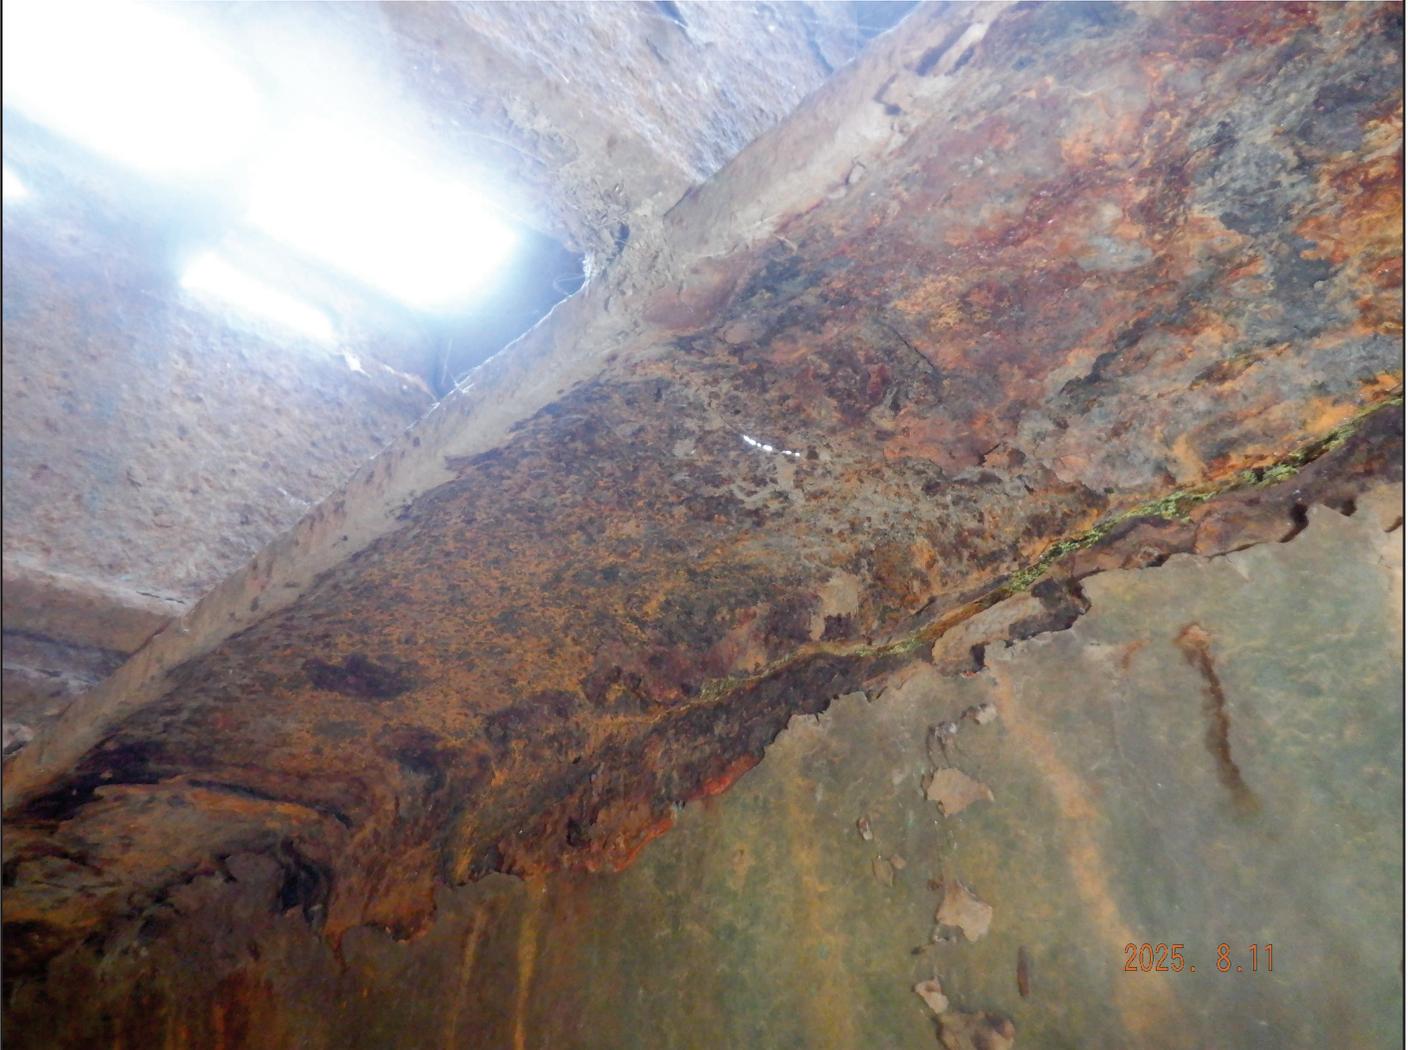
**Attachment Description: Panel 2, Stringer S3 at ½ L (Top right flange SL with perforation), looking towards begin left.**
