**BIN 3314460**  
**Podunk Road over Taughannock Creek**  
**Town of Ulysses, Tompkins County**

**Historic Bridge Disposition (Bridge for Sale)**

Materials Available for Review:

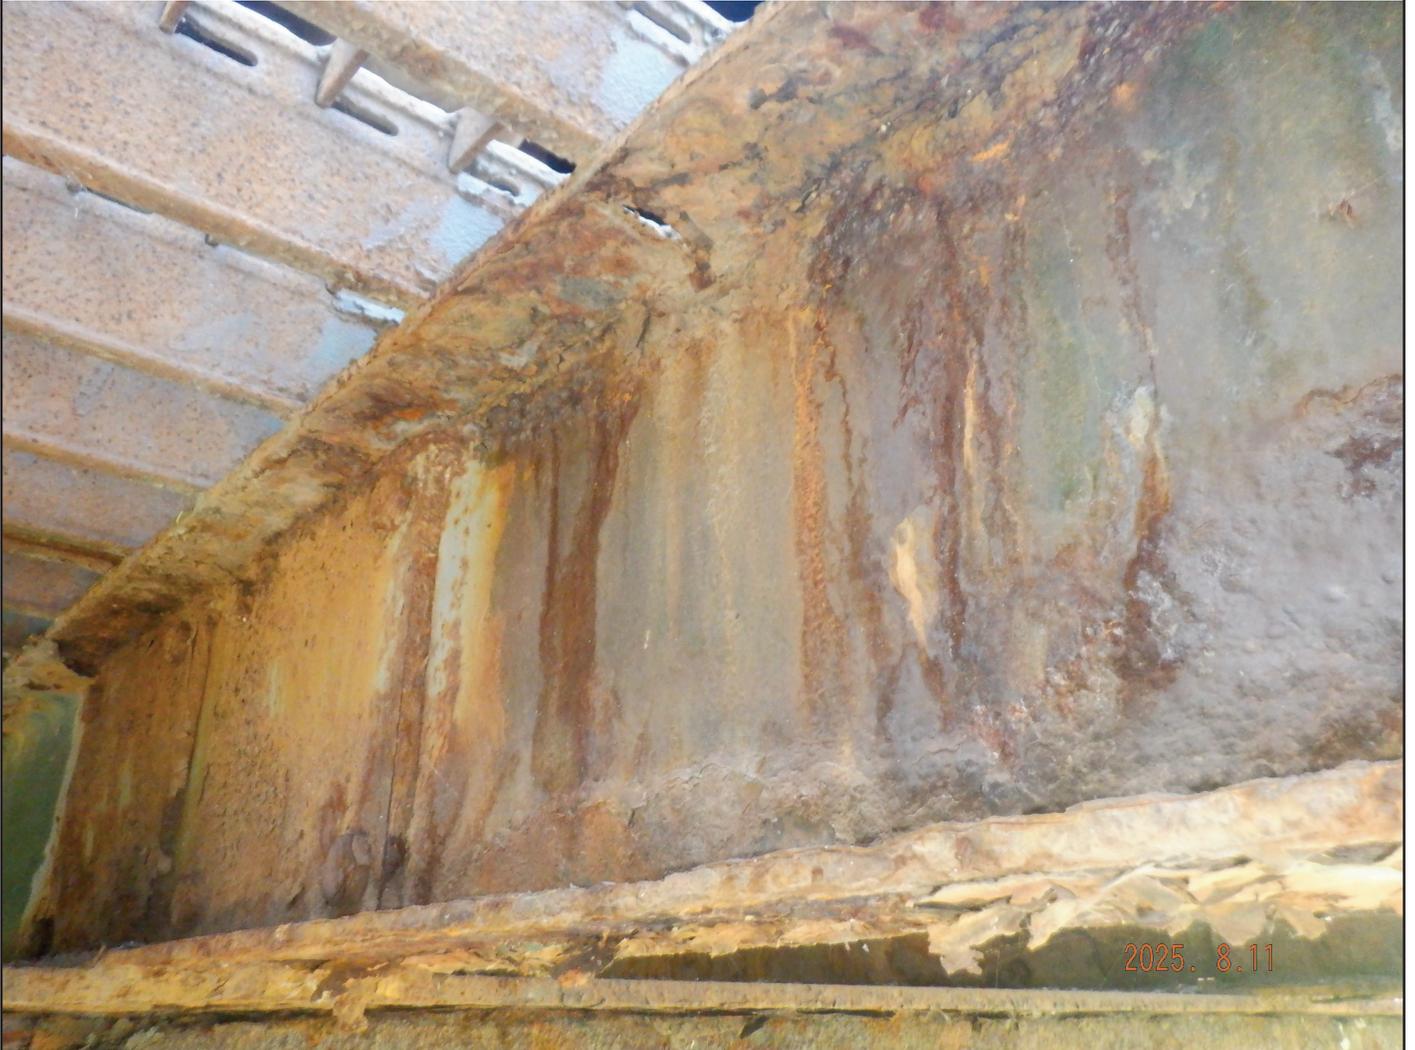
**Attachment Description:** Panel 3, Stringer S4 at 2' from Floorbeam FB3 (Flange SL with perforation), looking towards begin left.

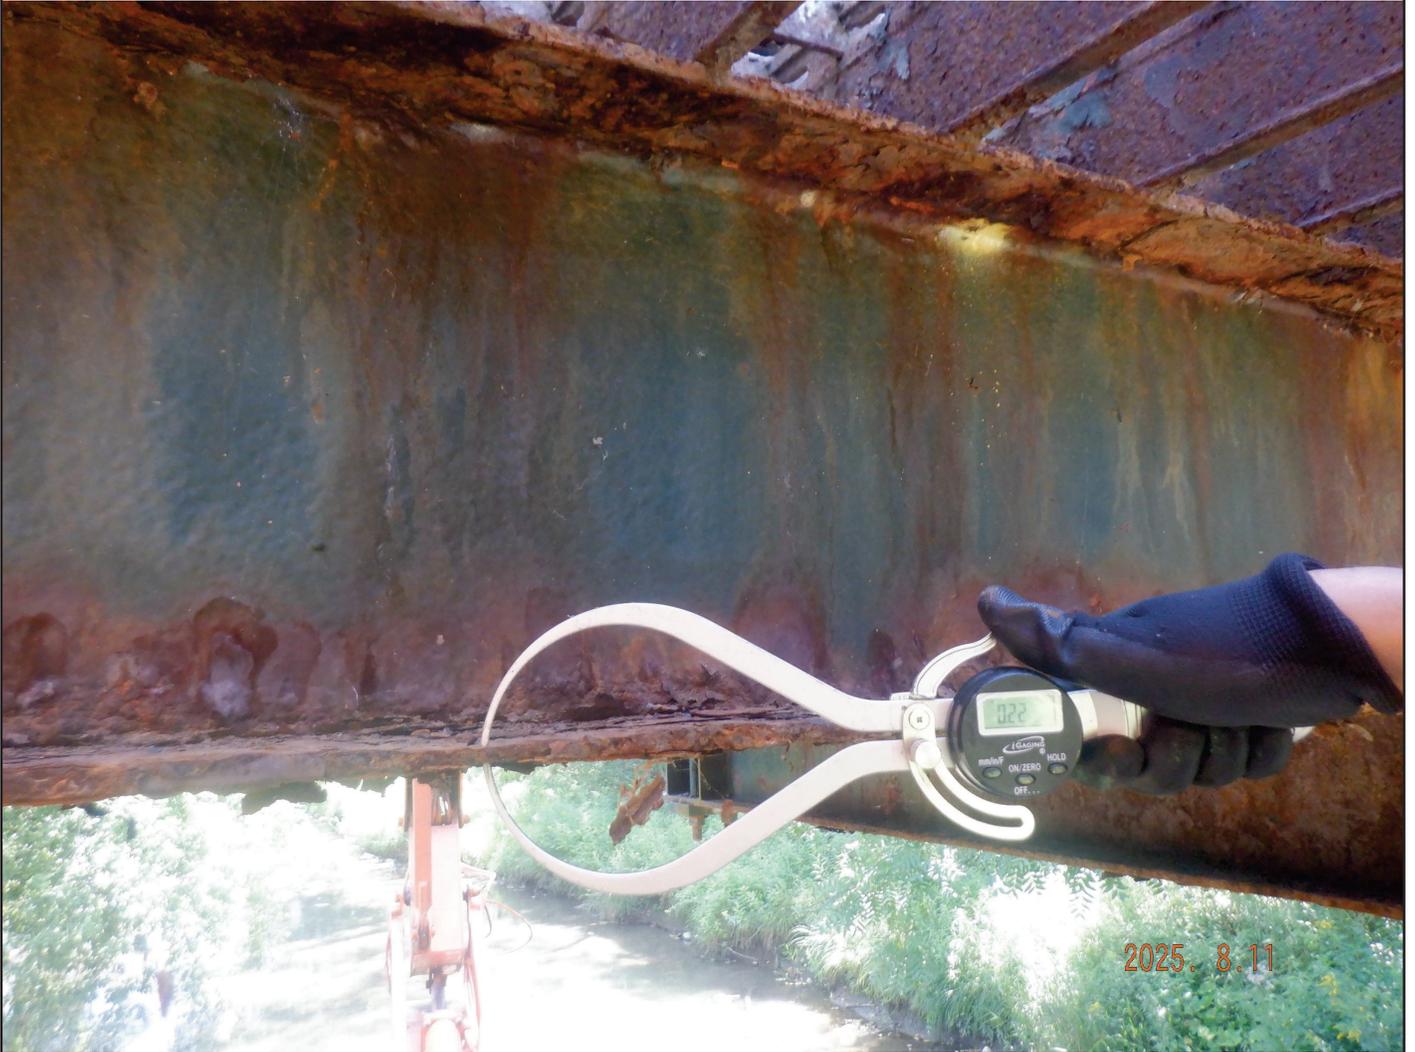
***Attachment Description: Panel 4, Stringer S3 at ½ L (Flange SL), looking towards right.***

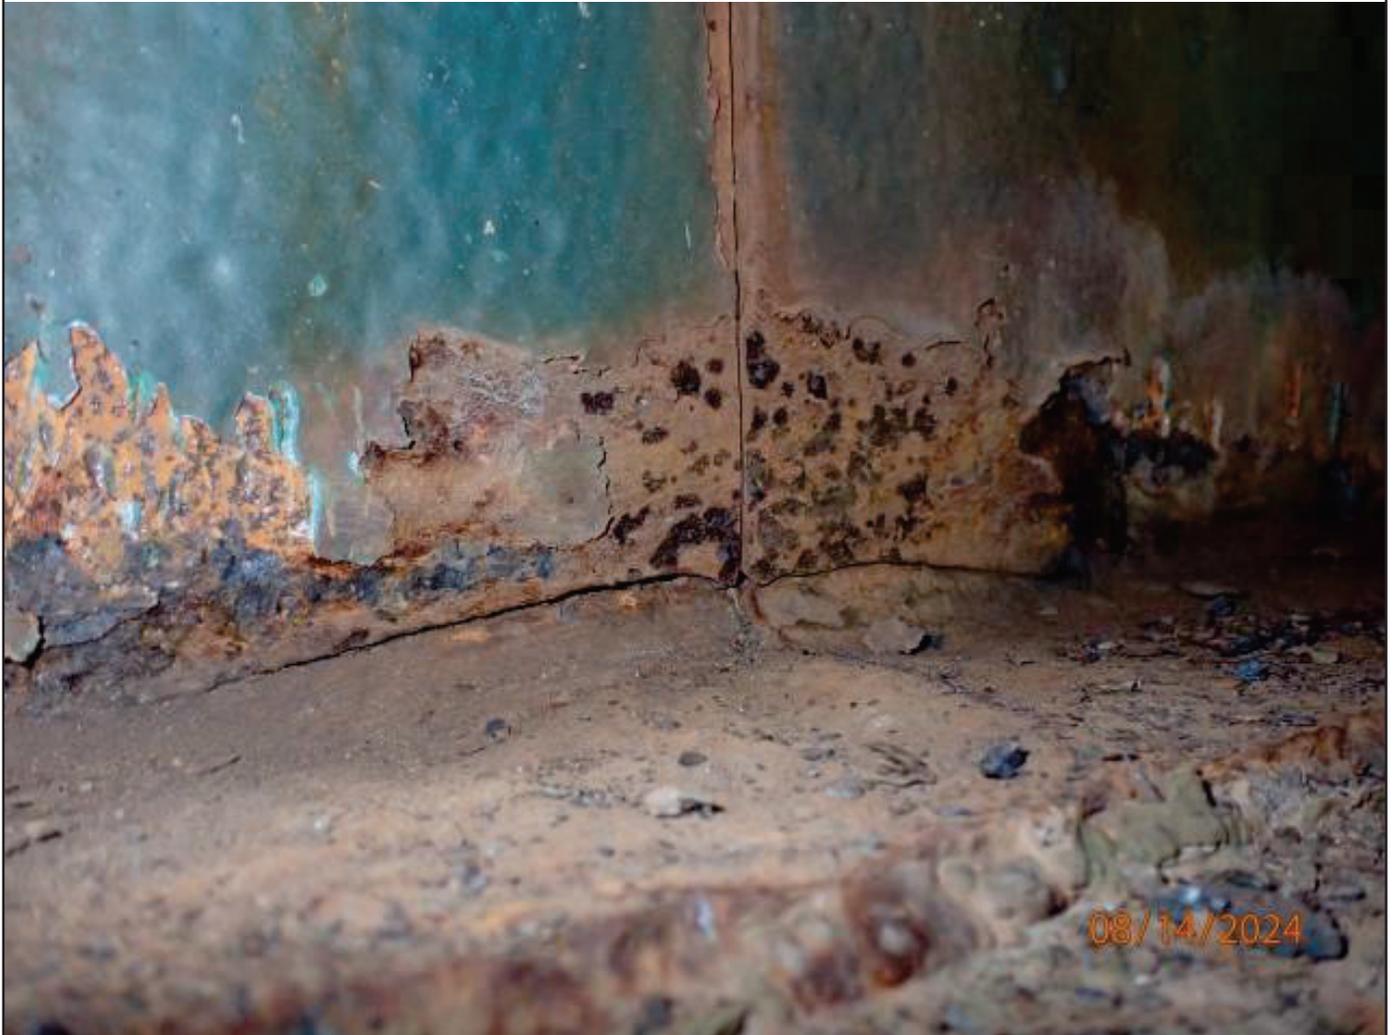
**Attachment Description: Stringer 2 over Floorbeam 2, lower web cracked on both Begin and End portions – looking End Left**

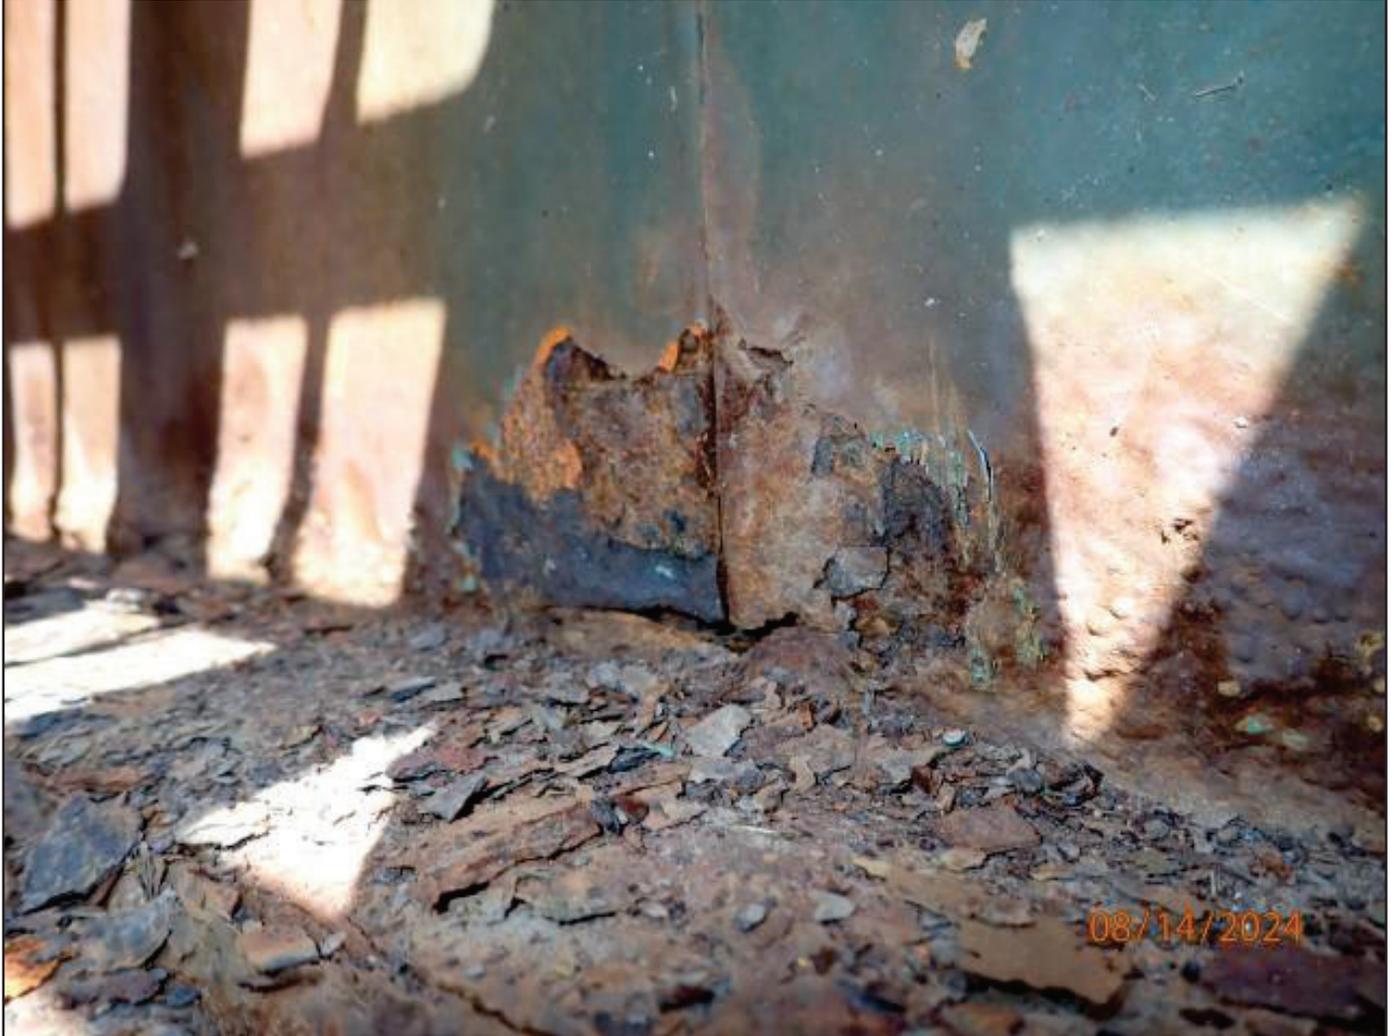
**Attachment Description: Stringer 4 over Floorbeam 4, lower web cracked on both Begin and End portions – looking End Right**
