# Tompkins County ADA Transition Plan - 2017

**Project:** Tompkins County Transition Plan 2017

**Building:** Tompkins County Office of Human Rights

**Date:** June 21, 2017

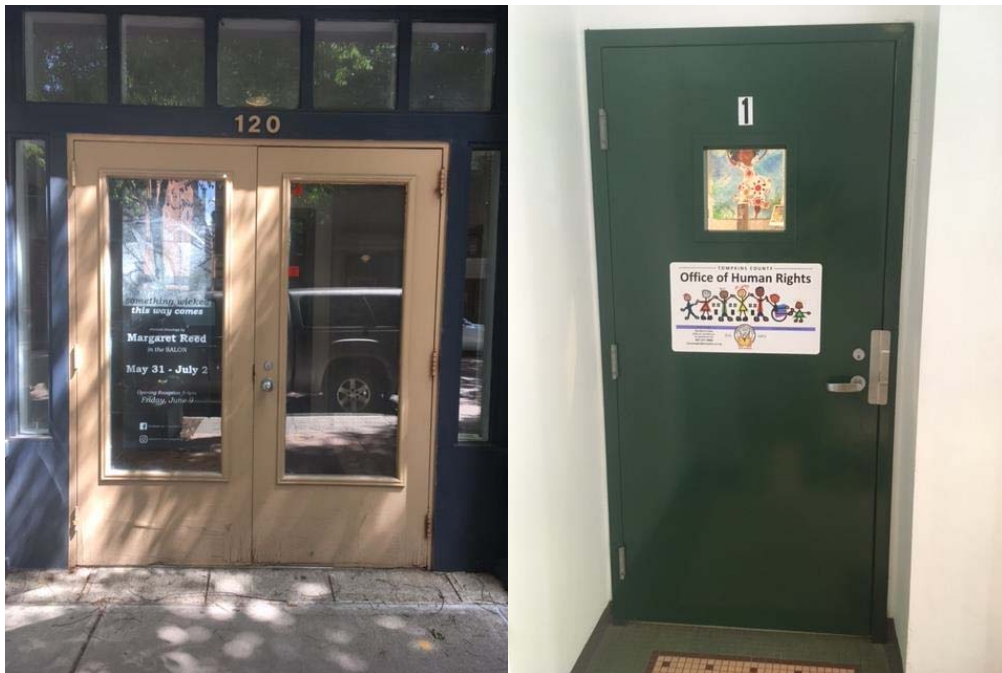
The above photo on the left is the street entrance that opens to a vestibule which also serves as the main entrance to other business as one can detect by the print on the door glass. The photo on the right is the entrance to the office. The vestibule does have a slope of approximately 1/12 which is acceptable.

As far as improvements, the main entrance door knob should be replaced with a lever handle. The closer allowed the door to close in only 3 seconds. 5 seconds is the minimum time to allow a wheelchair to negotiate the opening. The closer should be either adjusted or replace.

It may also be beneficial to provide a notification device in the form of a door bell or buzzer that visitors could use to alert HR staff that they need assistance entering the building.

Item	Correction	Target Date	Date Completed
Entrance Door	Replace knob handle with lever.	Sept 2017	
Closer	Adjust or replace closer.	Sept 2017	
Buzzer	Install buzzer at front door.	Sept 2017

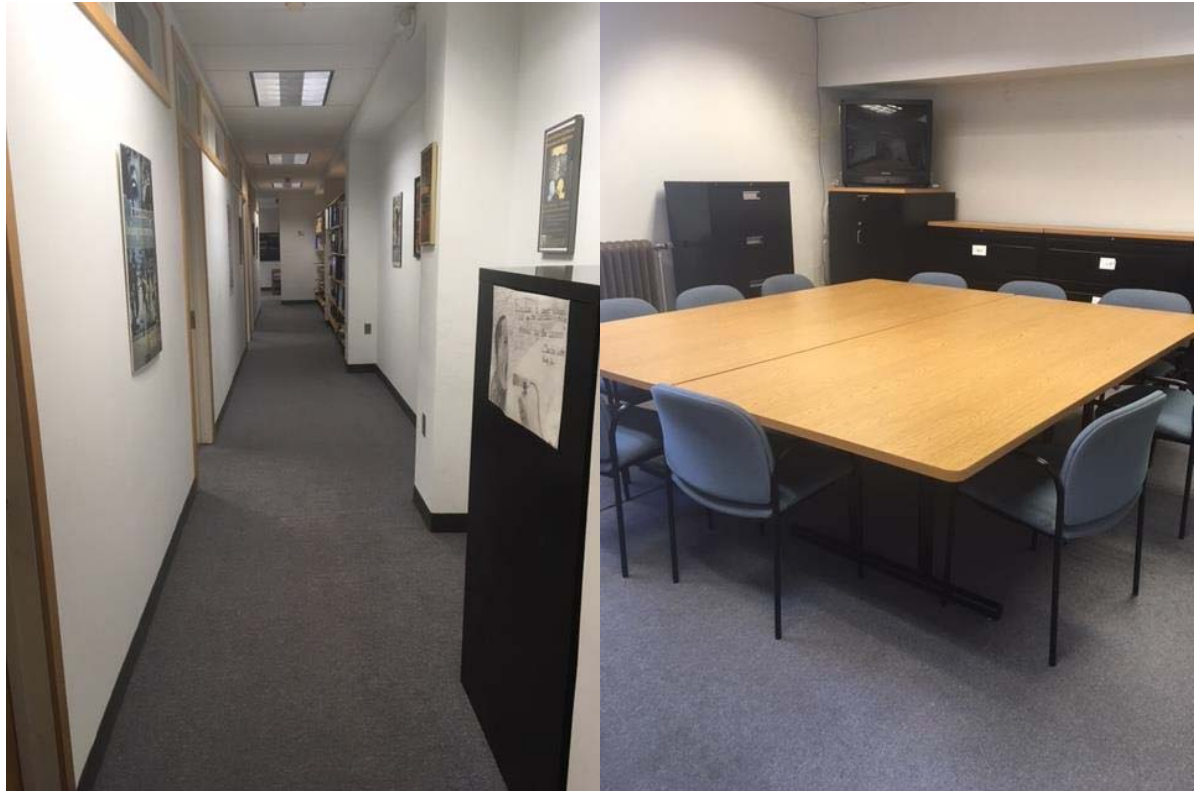
The photo on the left is the corridor taken from the back of the office and looking toward the reception/lobby area. The photo on the right is the conference/break room. This space is open with no fixed seating easily accommodating a wheelchair if necessary.
