# Cayuga Coal Ash Disposal Facility

Mitigation & Remediation Options

John Dennis and Brian Eden

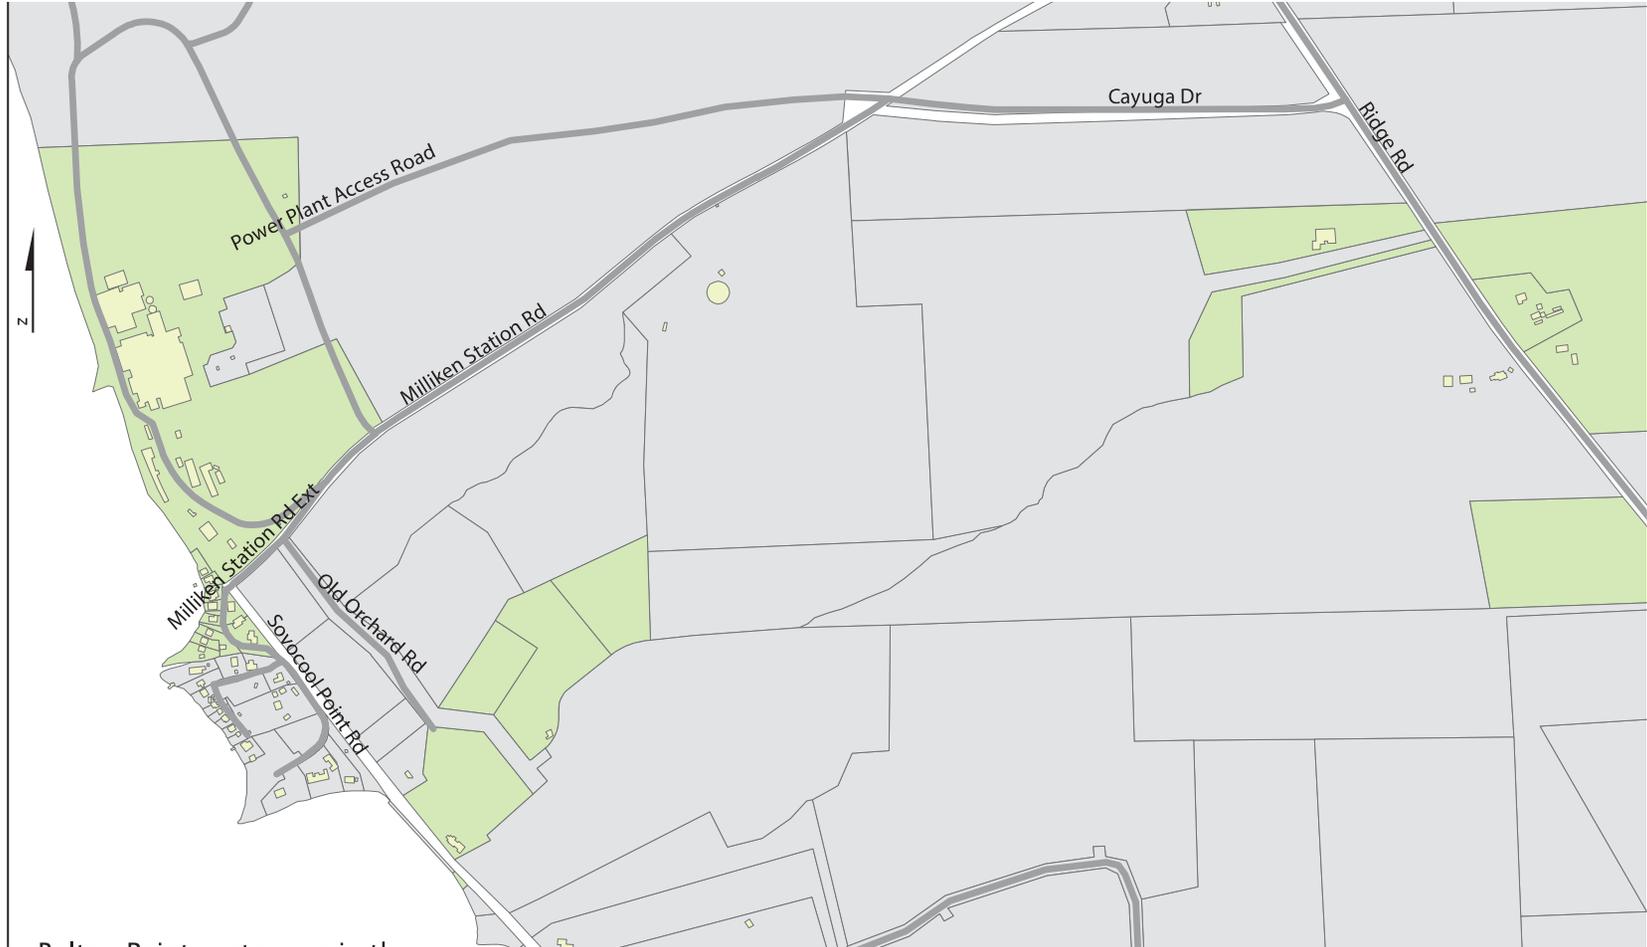
# Bolton Point Water >2000

Brian noted that the EPA Facility Report on Cayuga can be accessed on the EPA web site. It indicates that “no wastewater treatment technology is currently in place at the facility”. A potable drinking water source was added to the plant in the 1990s and some residents on the north side of Milliken Creek at Lake Ridge Point were added to the Bolton Point system in 2001.
