# Watershed Needs Assessment

## Buttermilk Creek Tompkins County, New York

March 2013

MMI #4395-03

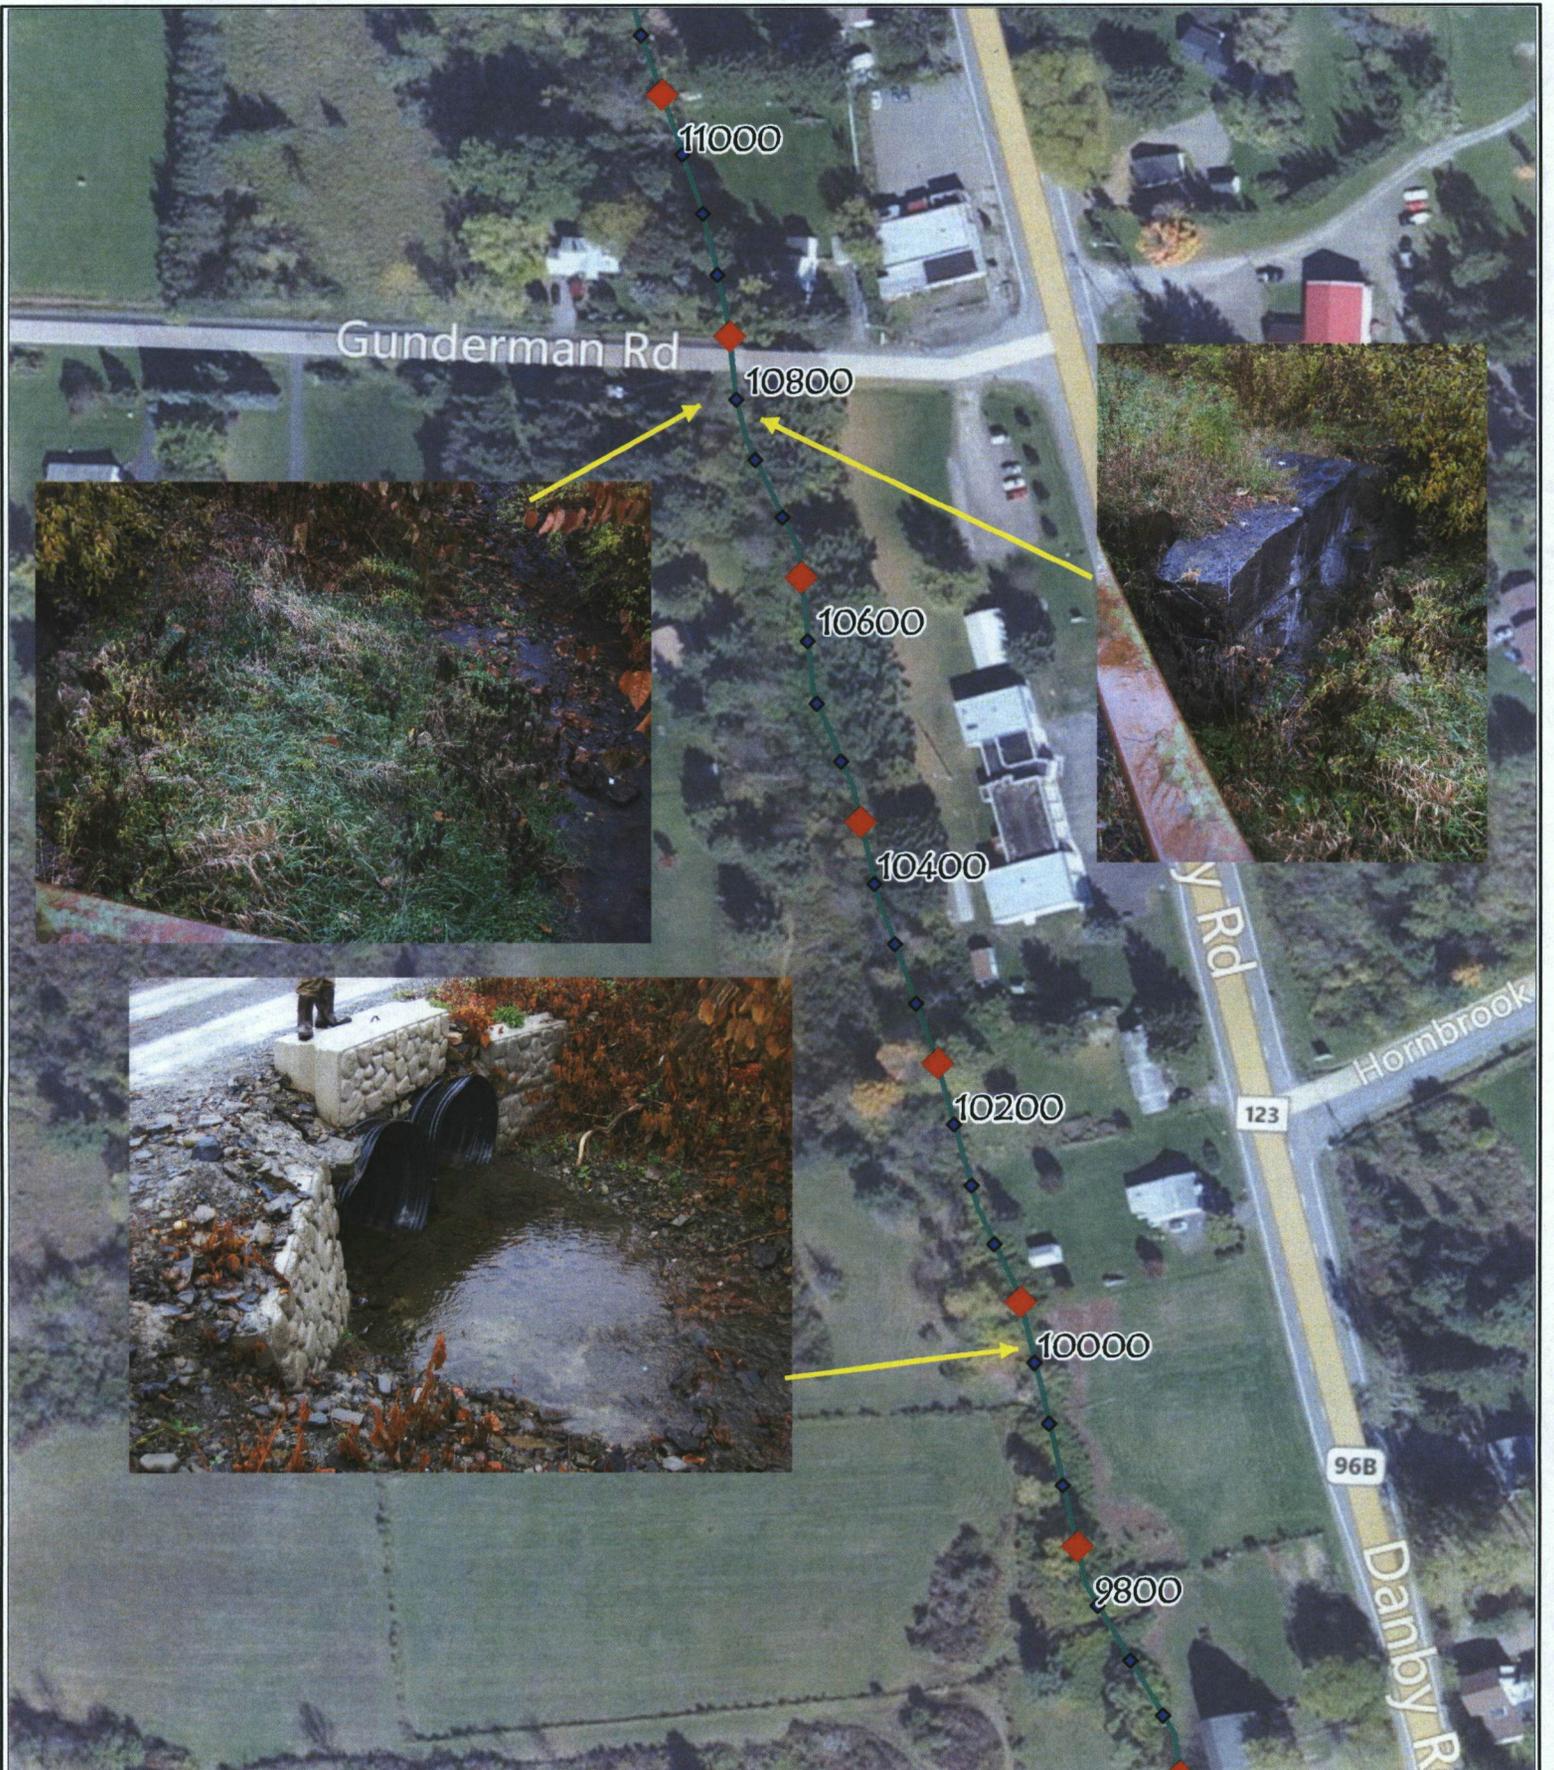
**Figure 2-3: Segment #4**

Figure 2-3 depicts Segment 4, which includes 900 feet of Buttermilk Creek, extending from the double culvert near Hornbrook Road (Station 99+00) to Gunderman Road Bridge (Station 108+00). The average slope of the channel in this segment is 1.1%. This segment is a relatively straight channel with some areas that consist of multiple flow paths and minor meanderings. Cobble and some boulders make up the bed material. A decrease in slope provides better floodplain access and increases the width to depth ratio of the stream. In 2010, two residential property owners worked with Tompkins County Stream Corridor and Flood Hazard Mitigation Program to plant and formally protect a 100-foot riparian buffer to the creek. While the buffer continues to be healthy, it is bordered by Japanese Knotweed. The width of the stream increases throughout the segment, with a resulting width to depth ratio of 4:1.

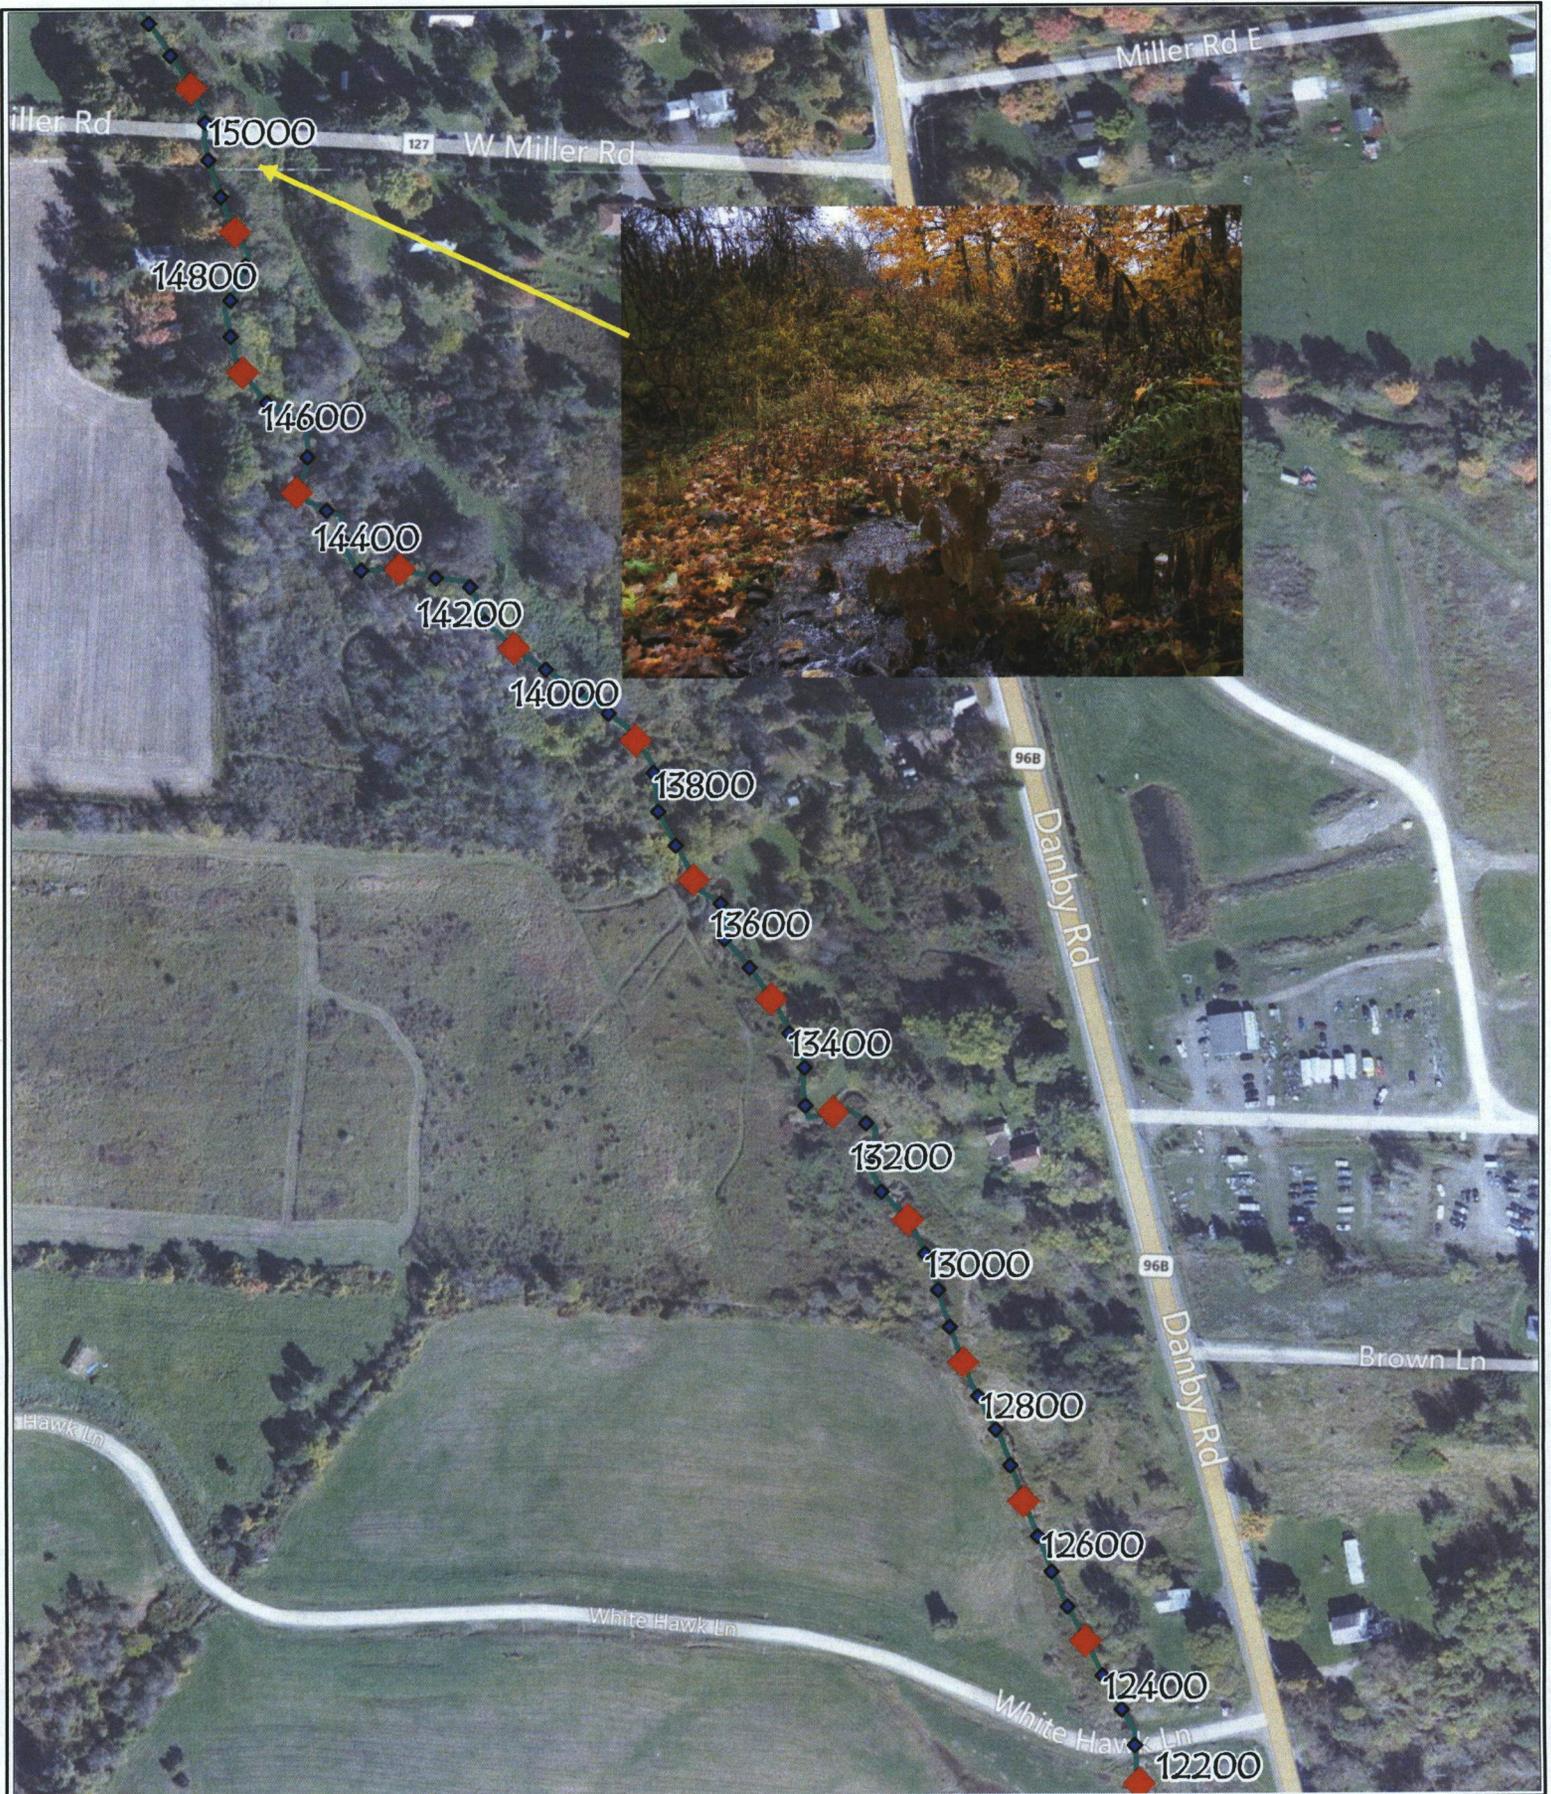
Figure 2-5: Segment #6

Figure 2-5 depicts Segment 6, which includes 2,700 feet of Buttermilk Creek extending from White Hawk Lane (Station 122+50) to West Miller Road bridge (Station 149+50). The slope of the channel in this segment is relatively flat at 0.8%. This segment is a straight channel with multiple flow paths from Station 136+50 to 145+50. It is largely cobble dominated bed material.

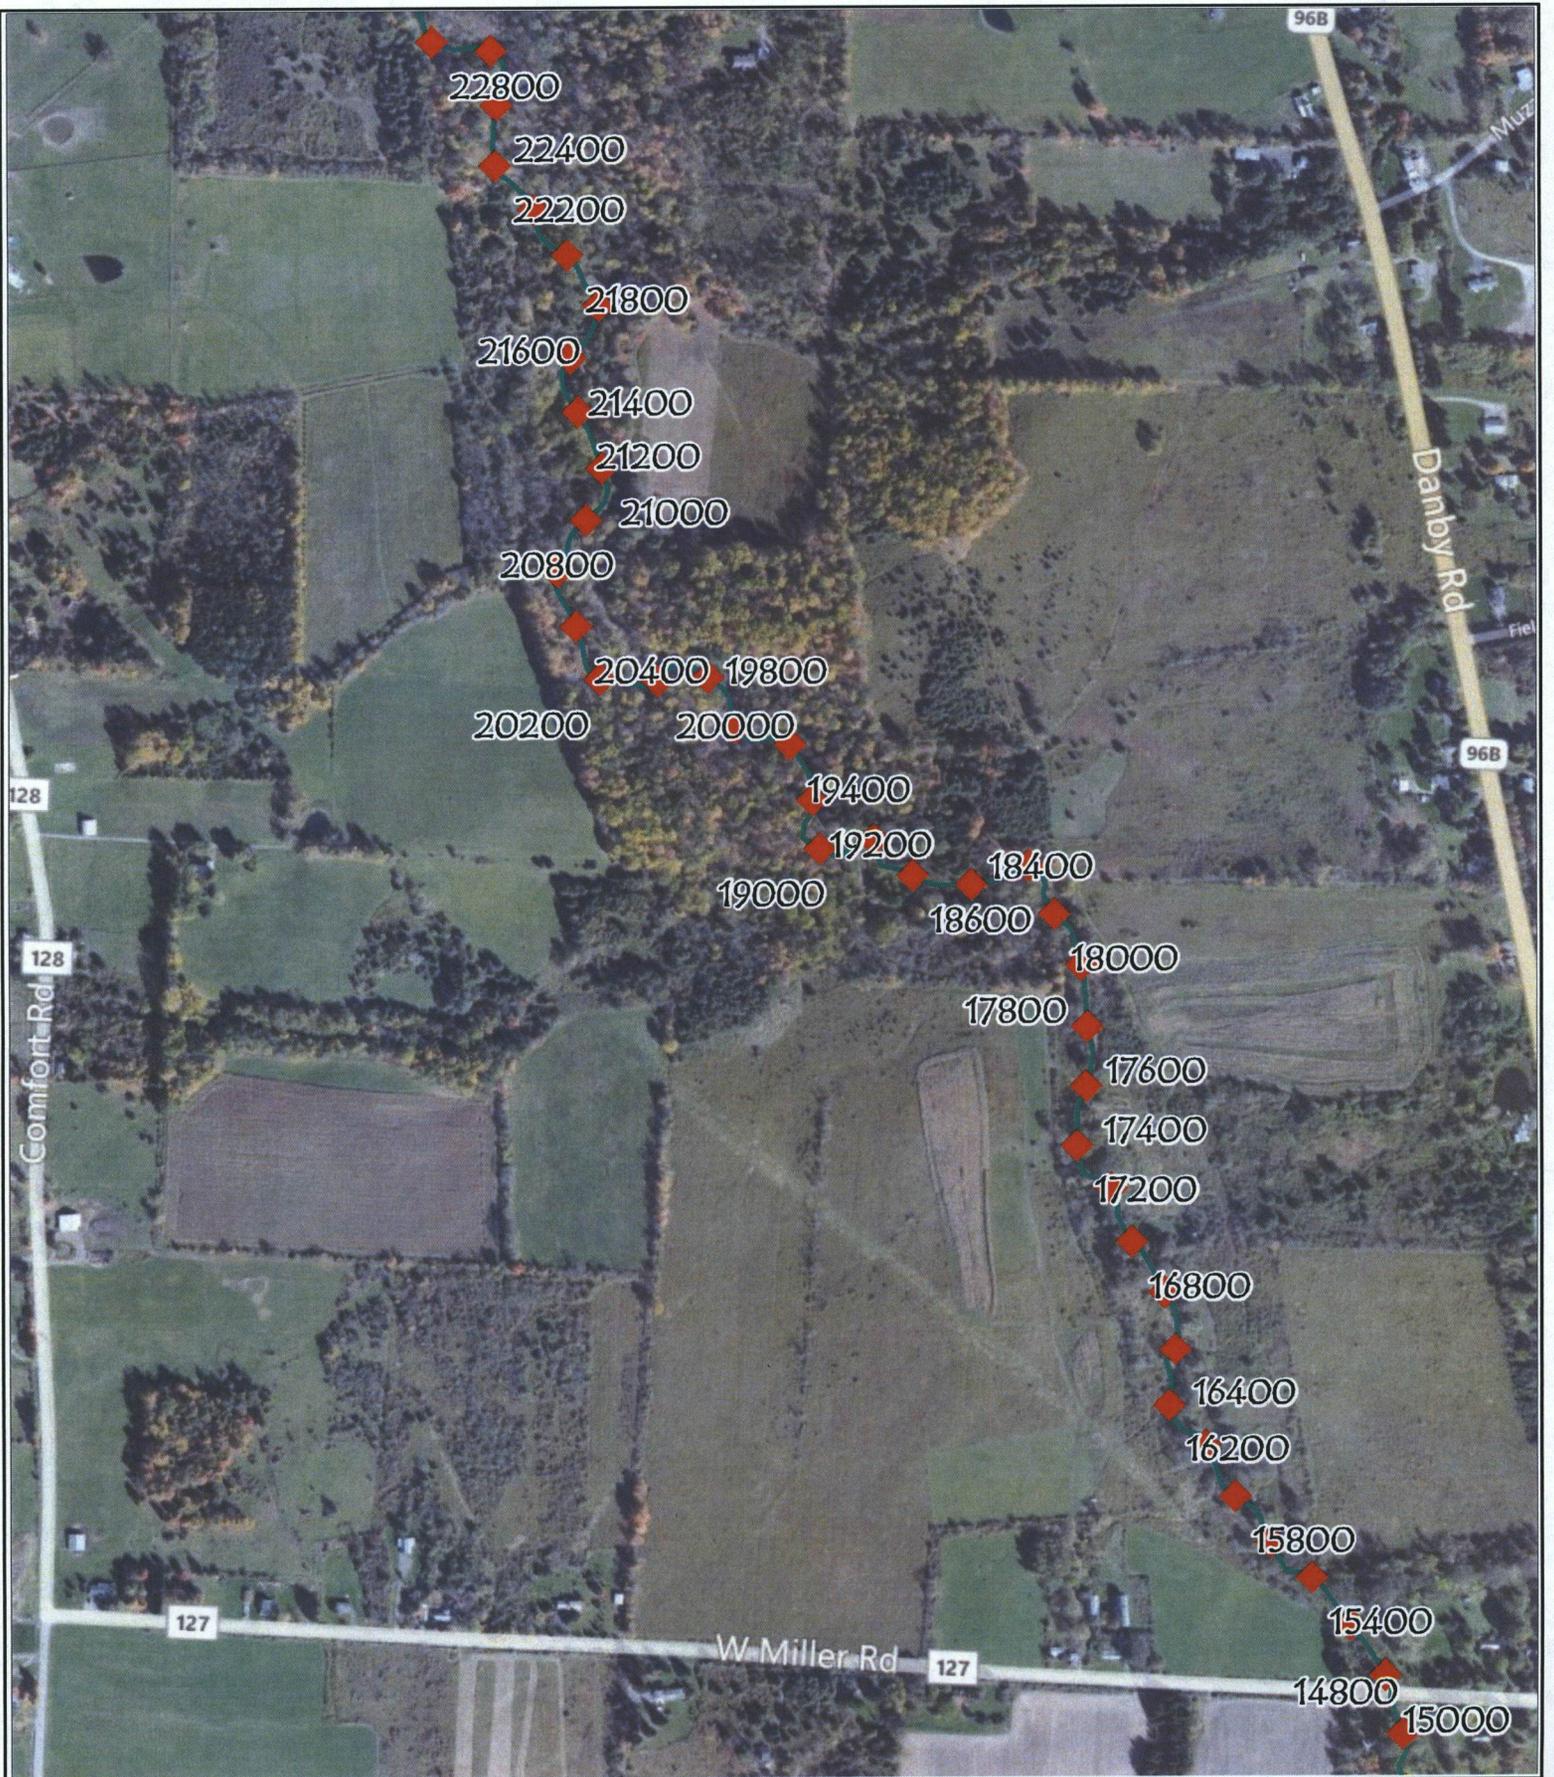
| <p>SOURCE(S):<br/>Bing Maps Hybrid</p> | <p><b>Figure 2-6: Segment #7</b></p> | <p>LOCATION:<br/><b>Danby, NY</b></p> |

Figure 2-6 depicts Segment 7, which includes 7,650 feet of Buttermilk Creek extending from the West Miller Road Crossing (Station 149+50) to 600 feet upstream of a Dominion utility/gas line crossing at Station 226+00. Infrastructure within this reach requires periodic maintenance and mitigation. Interaction with utility companies should occur to advance any future mitigation measures.
