Watershed Needs Assessment

Buttermilk Creek Tompkins County, New York

March 2013

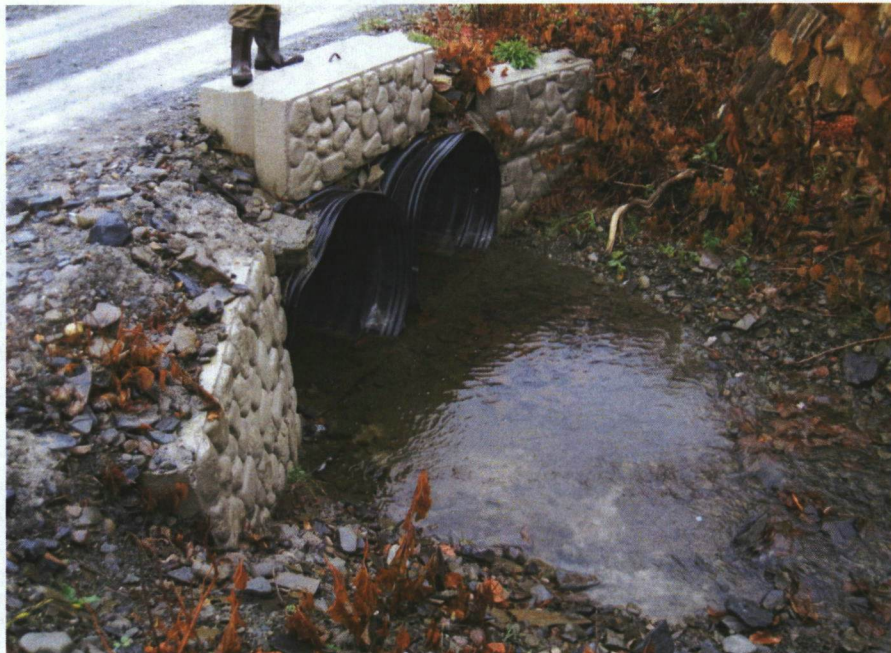
10

The newly constructed crossing west of Hornbrook Road is comprised of twin 50-inch corrugated plastic pipe culverts that appear to be undersized to handle significant storm events. No hydraulic computations were available to indicate that the crossing had been designed to any particular storm event. The upstream and downstream approaches are overgrown with invasives and other vegetation. No evidence of erosion was observed in this reach and no reports of flooding.
