**BIN 3314460**  
**Podunk Road over Taughannock Creek**  
**Town of Ulysses, Tompkins County**

**Historic Bridge Disposition (Bridge for Sale)**

Materials Available for Review:

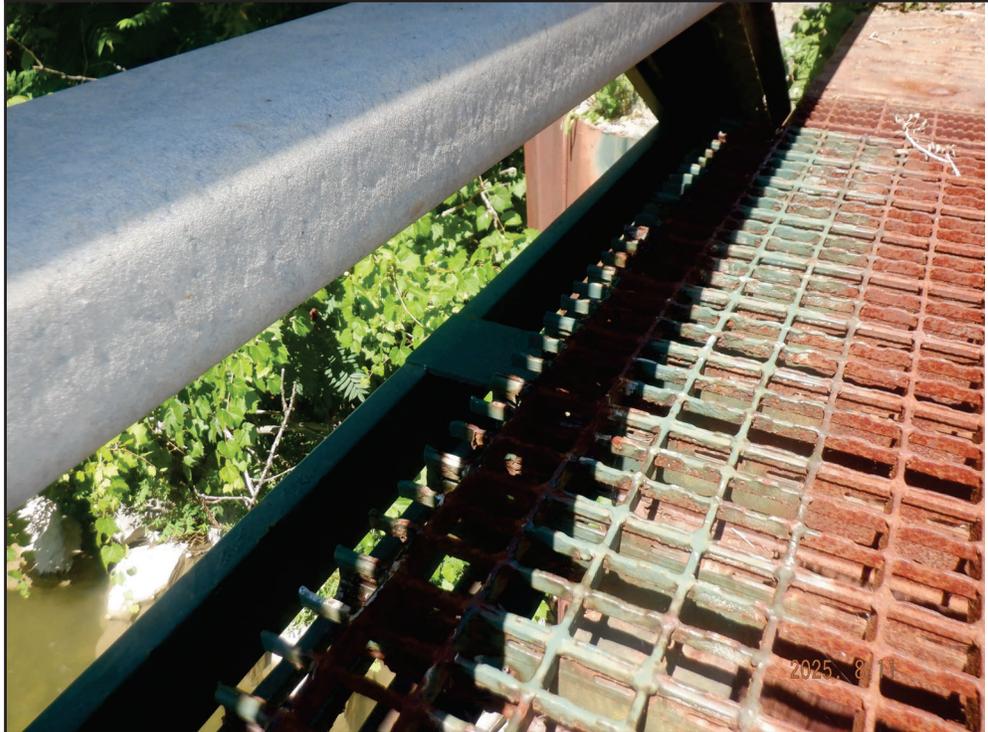
TQ	CS-1	CS-2	CS-3	CS-4	CS-5
<p><b>Span 1: 28 - Steel Deck with Open Grid</b></p> <p><b>Condition State 3 Note</b>  <i>Referenced Photo(s):</i> 1, 2  <i>Referenced Sketch(es):</i> None</p> <p>A narrow band of the steel grid deck under the bridge rails exhibits corrosion along the full length of the span. Section losses vary with some areas exhibiting corrosion holes (Photo 1). Rate 1' width along either side of the bridge deck CS3 for this condition.</p> <p>In addition, the sleeper beams below the steel grid exhibit scattered corrosion holes (Photo 2). Rate 1% of the bridge deck CS3 for this condition.</p> <p>Affected Quantity: 59' bridge rail length x 2 sides + 1165 SF x 0.01 = 130 SF</p>	1165	0	1035	130	0	0
<p><b>Span 1: 28 - Steel Deck with Open Grid-510 - Wearing Surfaces</b></p> <p><b>Condition State 3 Note</b>  <i>Referenced Photo(s):</i> 1  <i>Referenced Sketch(es):</i> None</p> <p>Several isolated and scattered transverse bars within the steel grid deck are bent or broken. The bars do not protrude above the deck wearing surface in any location. Rate 1% of the deck area CS3 for this condition.</p> <p>Affected Quantity: 1120 SF x 0.01 = 11 SF</p>	1120	0	1109	11	0	0

**Attachment Description:**  
The deck grating at the end left (corrosion with perforations), looking towards end left.

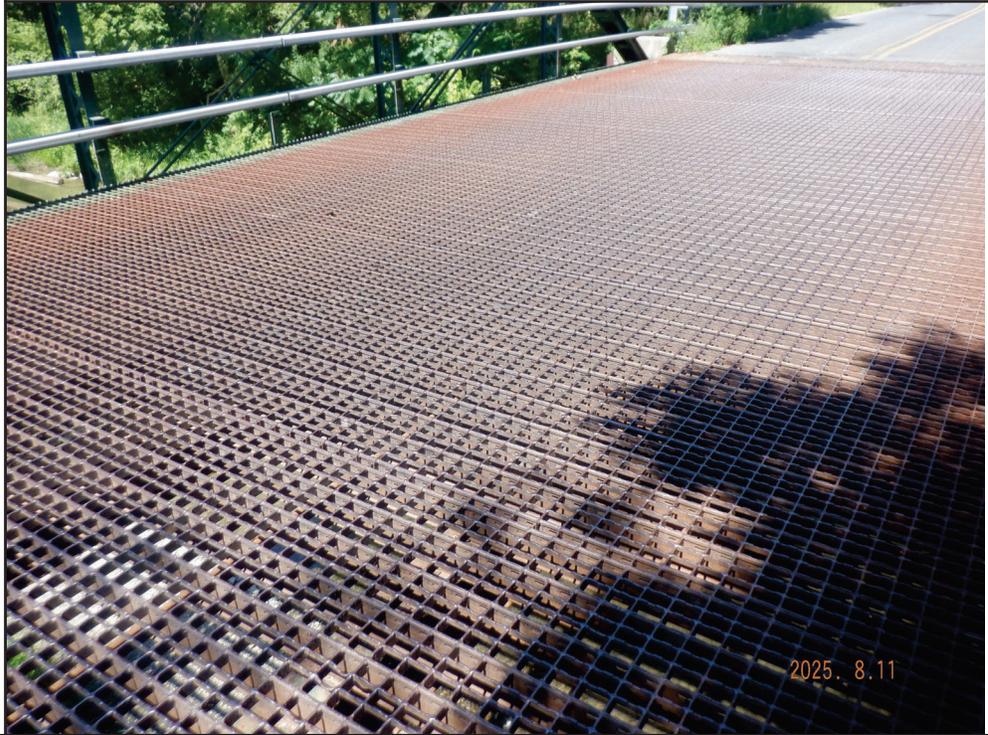
**Attachment Description:**  
General view of the top of the deck, looking towards end left.

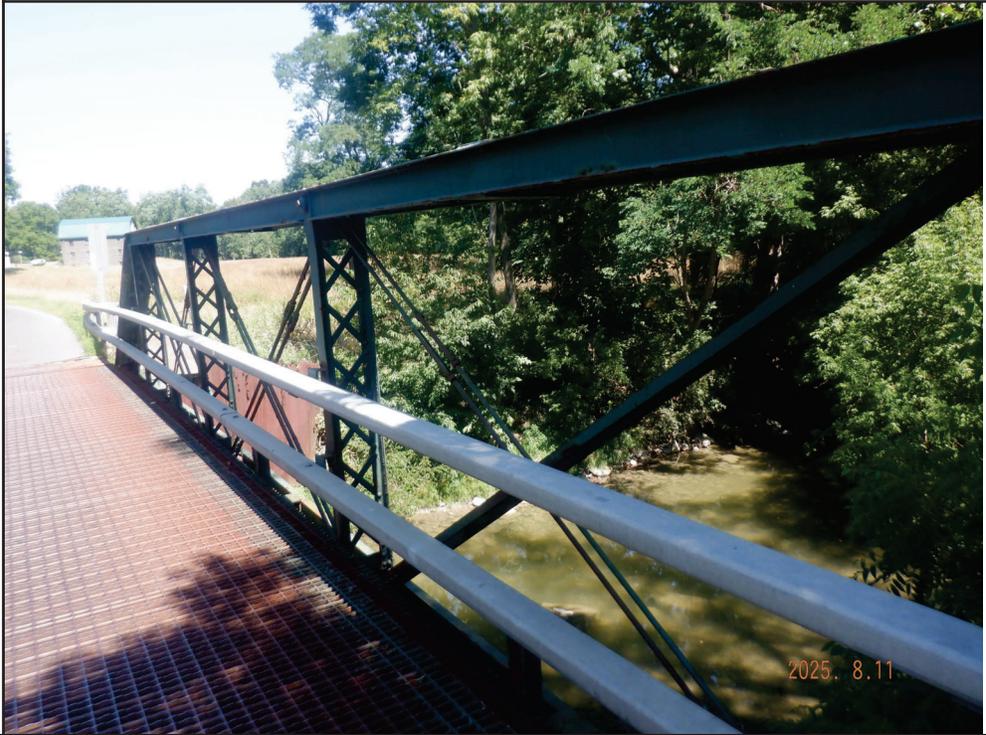
Photo Number: 7

The stringer paint has failed over an estimated 50% of Stringers 2-4, or 30% of the overall element quantity (Photo 6). The truss paint has failed over an estimated 10% of the surface area, generally along the bottom chords and at the deck level of the vertical and diagonal members (Photo 7).

**Attachment Description:**  
General view of Truss T2  
above the deck (paint  
condition photo), looking  
towards end right.

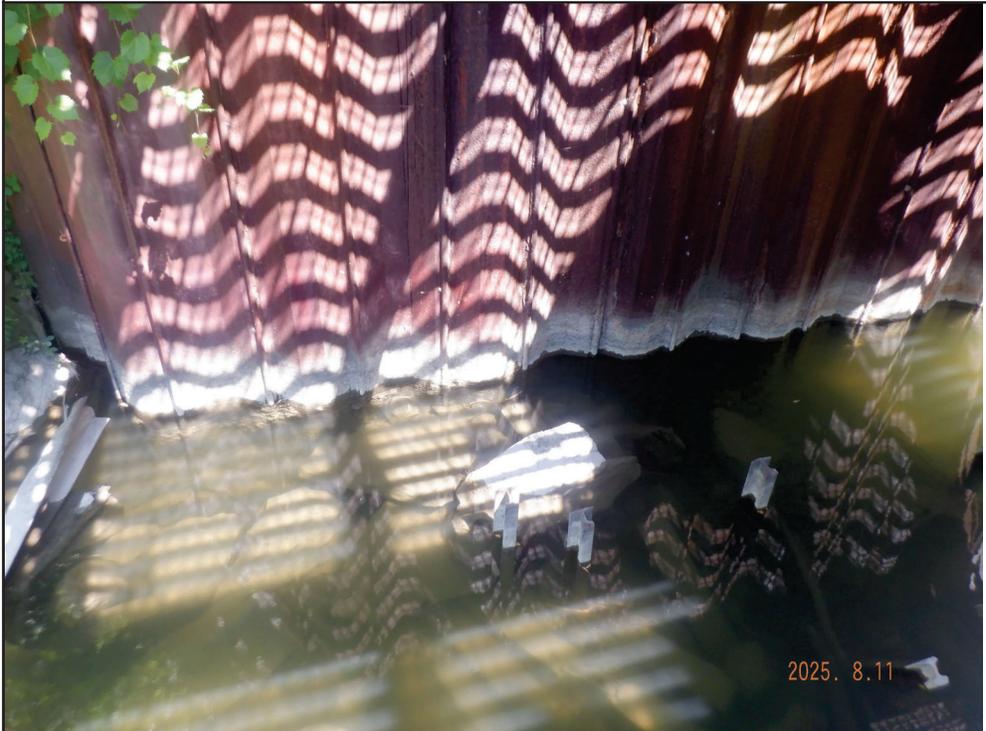
**Attachment Description:**  
The scour protection along the end abutment, looking towards end.

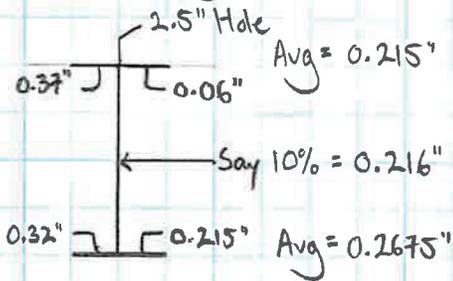
- Panel 2, Stringer 3 FB1:

$A = 5.147 \text{ in}^2$   
 $I = 112.648 \text{ in}^4$   
 $S_x = 16.164 \text{ in}^3$   
 $S_b = 22.616 \text{ in}^3$

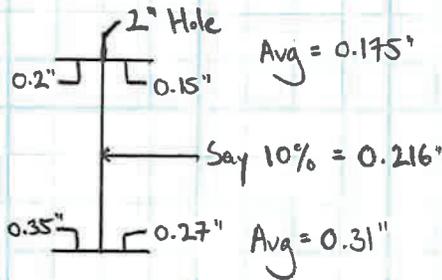
- Panel 2, Stringer 3 Mid:

$A = 5.354 \text{ in}^2$   
 $I = 115.23 \text{ in}^4$   
 $S_x = 15.814 \text{ in}^3$   
 $S_b = 24.709 \text{ in}^3$

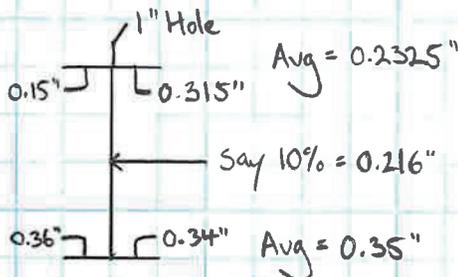
- Panel 3, Stringer 2 Mid:

$A = 6.094 \text{ in}^2$   
 $I = 143.762 \text{ in}^4$   
 $S_x = 20.835 \text{ in}^3$   
 $S_b = 28.468 \text{ in}^3$

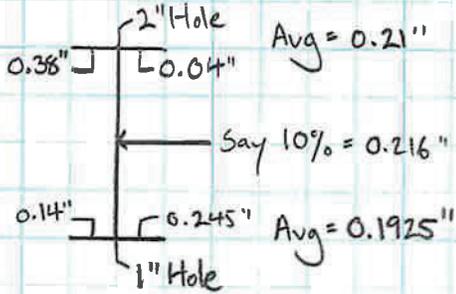
- Panel 3, Stringer 4 FB3:

$A = 4.562 \text{ in}^2$   
 $I = 98.134 \text{ in}^4$   
 $S_x = 16.008 \text{ in}^3$   
 $S_b = 16.862 \text{ in}^3$

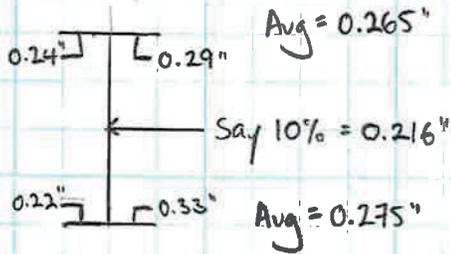
- Panel 4, Stringer 3 Mid:

$A = 6.059 \text{ in}^2$   
 $I = 148.516 \text{ in}^4$   
 $S_x = 24.609 \text{ in}^3$   
 $S_b = 25.108 \text{ in}^3$

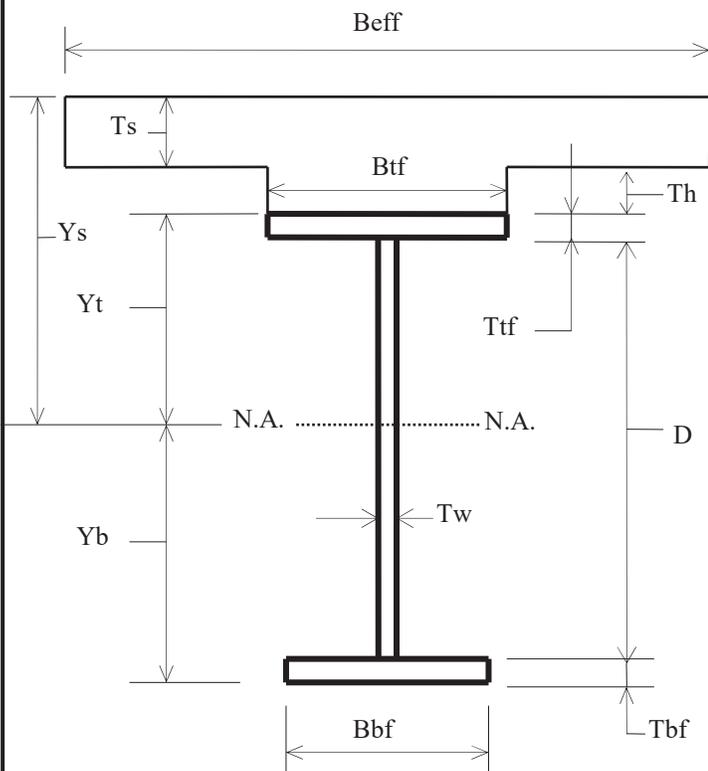
### PANEL 2 - STRINGER 3 FB 1

- Panel 2, Stringer S3, 2' from Floorbeam FB1: Top flange: 52 % SL with a 2.5" long corrosion hole on the top right flange (2024: 67%) (Photo 2); Bottom flange: 33% SL (2024: 31%)

Top Flange Width :	Btf =	4.0000 in
Top Flange Thickness :	Ttf =	0.2150 in
Web Depth :	D =	11.4675 in
Web Thickness :	Tw =	0.2160 in
Bottom Flange Width :	Bbf =	6.5000 in
Bottom Flange Thickness :	Tbf =	0.2675 in
Girder Depth :	=	11.9500 in

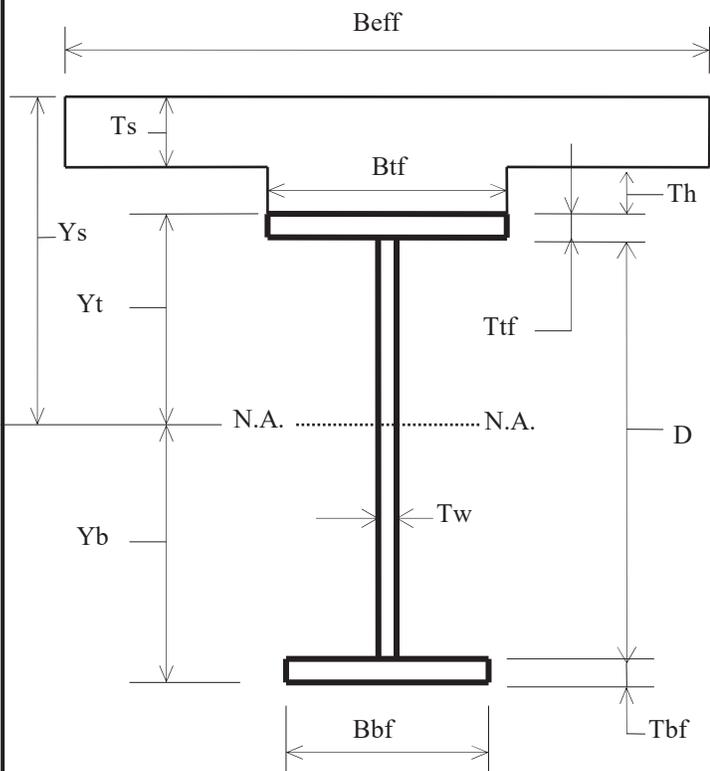
### PANEL 2 - STRINGER 3 MID

- Panel 2, Stringer S3 at ½ L: Top flange: 68 % SL with a 2" long corrosion hole on the top right flange (2024: 15%) (Photo 3); Bottom flange: 23% SL (2024: 22%). The top of the web at this location also exhibits a 12" long x ¼" high perforation.

Top Flange Width :	Btf =	4.5000 in
Top Flange Thickness :	Ttf =	0.1750 in
Web Depth :	D =	11.4650 in
Web Thickness :	Tw =	0.2160 in
Bottom Flange Width :	Bbf =	6.5000 in
Bottom Flange Thickness :	Tbf =	0.3100 in
Girder Depth :	=	11.9500 in

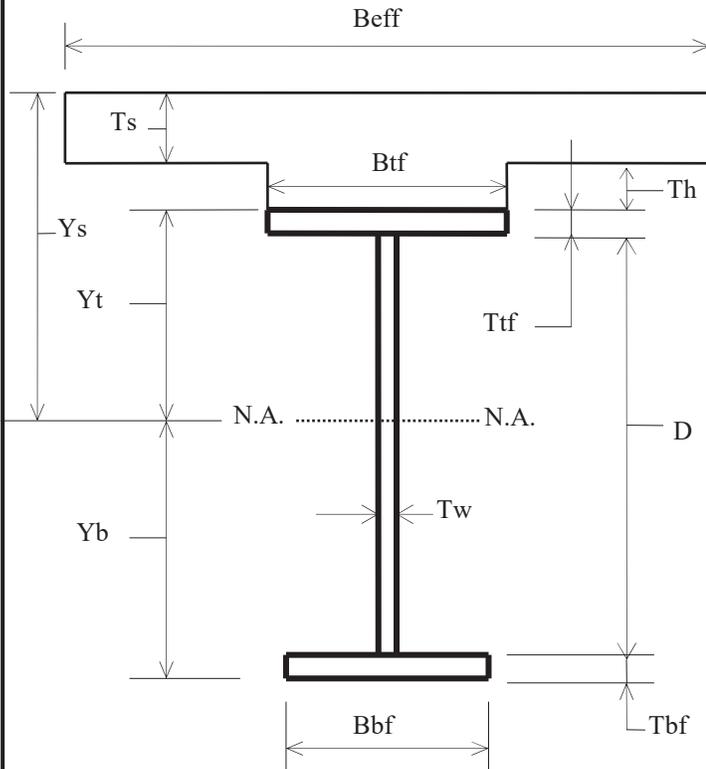
### PANEL 3 - STRINGER 2 MID

Top Flange Width :	Btf = 5.5000 in
Top Flange Thickness :	Ttf = 0.2325 in
Web Depth :	D = 11.3675 in
Web Thickness :	Tw = 0.2160 in
Bottom Flange Width :	Bbf = 6.5000 in
Bottom Flange Thickness :	Tbf = 0.3500 in
Girder Depth :	= 11.9500 in

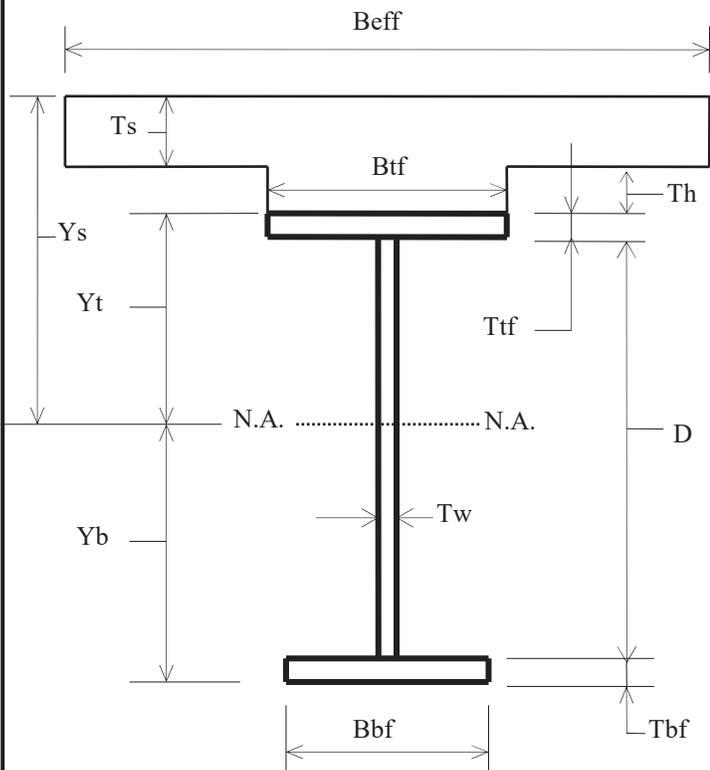
**PANEL 3 - STRINGER 4 FB3**

Top Flange Width :	Btf = 4.5000 in
Top Flange Thickness :	Ttf = 0.2100 in
Web Depth :	D = 11.5475 in
Web Thickness :	Tw = 0.2160 in
Bottom Flange Width :	Bbf = 5.5000 in
Bottom Flange Thickness :	Tbf = 0.1925 in
Girder Depth :	= 11.9500 in

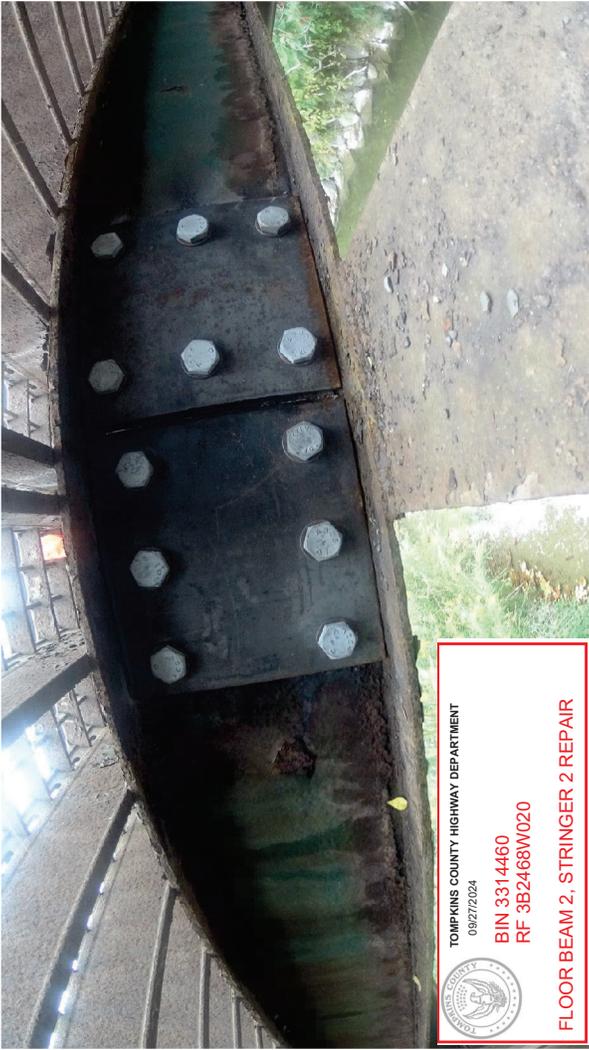
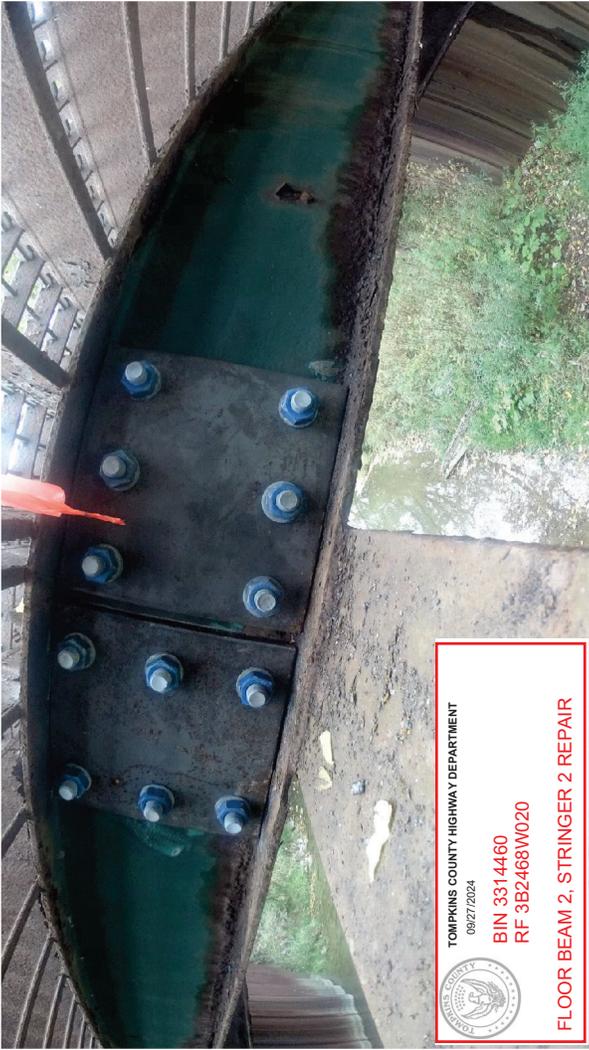
FLOOR BEAM 2, STRINGER 2 REPAIR

Above Floorbeam 2, Stringer 2 is cracked at the bottom of the web on both the Panel 2 and Panel 3 portions of the stringer, which is discontinuous over the floorbeam [Photo 3]. The Panel 2 (begin) side of the stringer is cracked 3.75" long, measured from the seam between the two stringer portions. The Panel 3 (end) side of the stringer is cracked 3" long, measured in the same fashion. There is minimal section loss in the area.

It has been brought to our attention that the repairs made in the field to address Red Structural Flag 3B2468W020 were slightly different than what was detailed in the drawings provided by LaBella Associates. Instead of using one 18" long plate on each side of the web, two 9" plates were used on each side of the web, on each stringer.

We have no objection to this repair alteration. The intent of the repair was to increase the bearing area and prevent the buckling of the webs due to the horizontal cracks at the base of the webs. Whether the 18" plate or the 9" plates are used, the goal is still achieved and the repairs made in the field are acceptable.

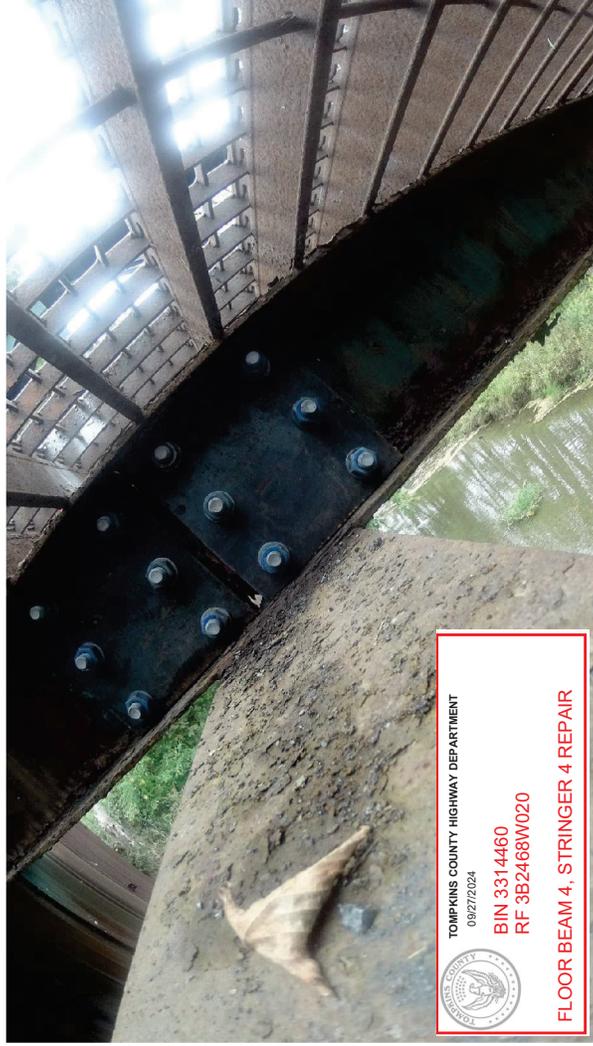
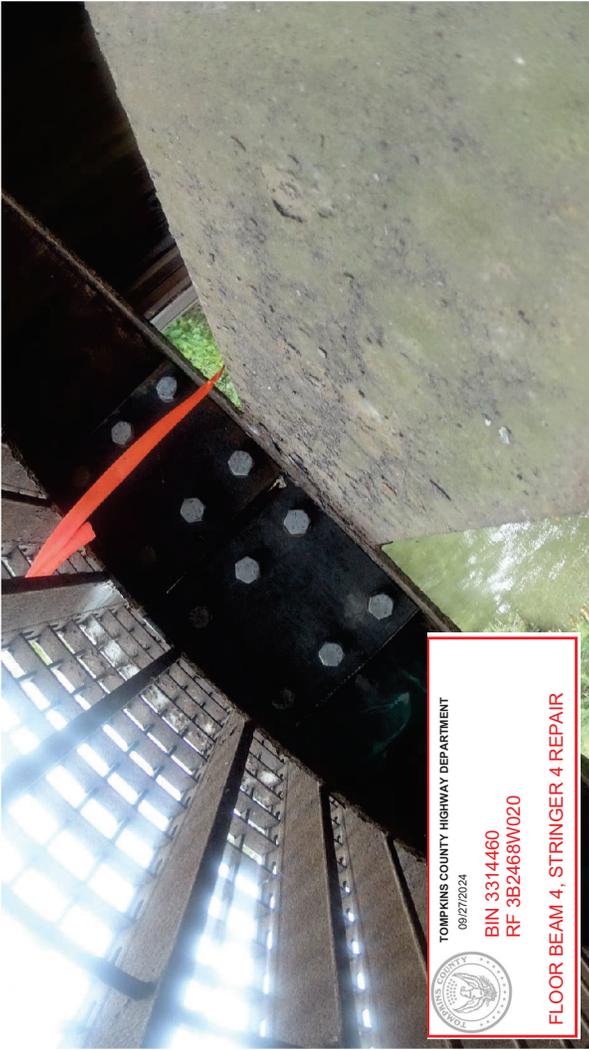
TOMPKINS COUNTY HIGHWAY DEPARTMENT  
09/27/2024  
BIN 3314460  
RF 3B2468W020  
FLOOR BEAM 4, STRINGER 4 REPAIR

Above Floorbeam 4, Stringer 4 is cracked at the bottom of the web on both the Panel 4 and Panel 5 portions of the stringer, which is similarly discontinuous over the floorbeam [Photo 4]. The Panel 4 (begin) side of the stringer is cracked 1.25" long, and the Panel 5 (end) side of the stringer is cracked 2" long, measured in the same fashion as above. There is moderate section loss in the area.

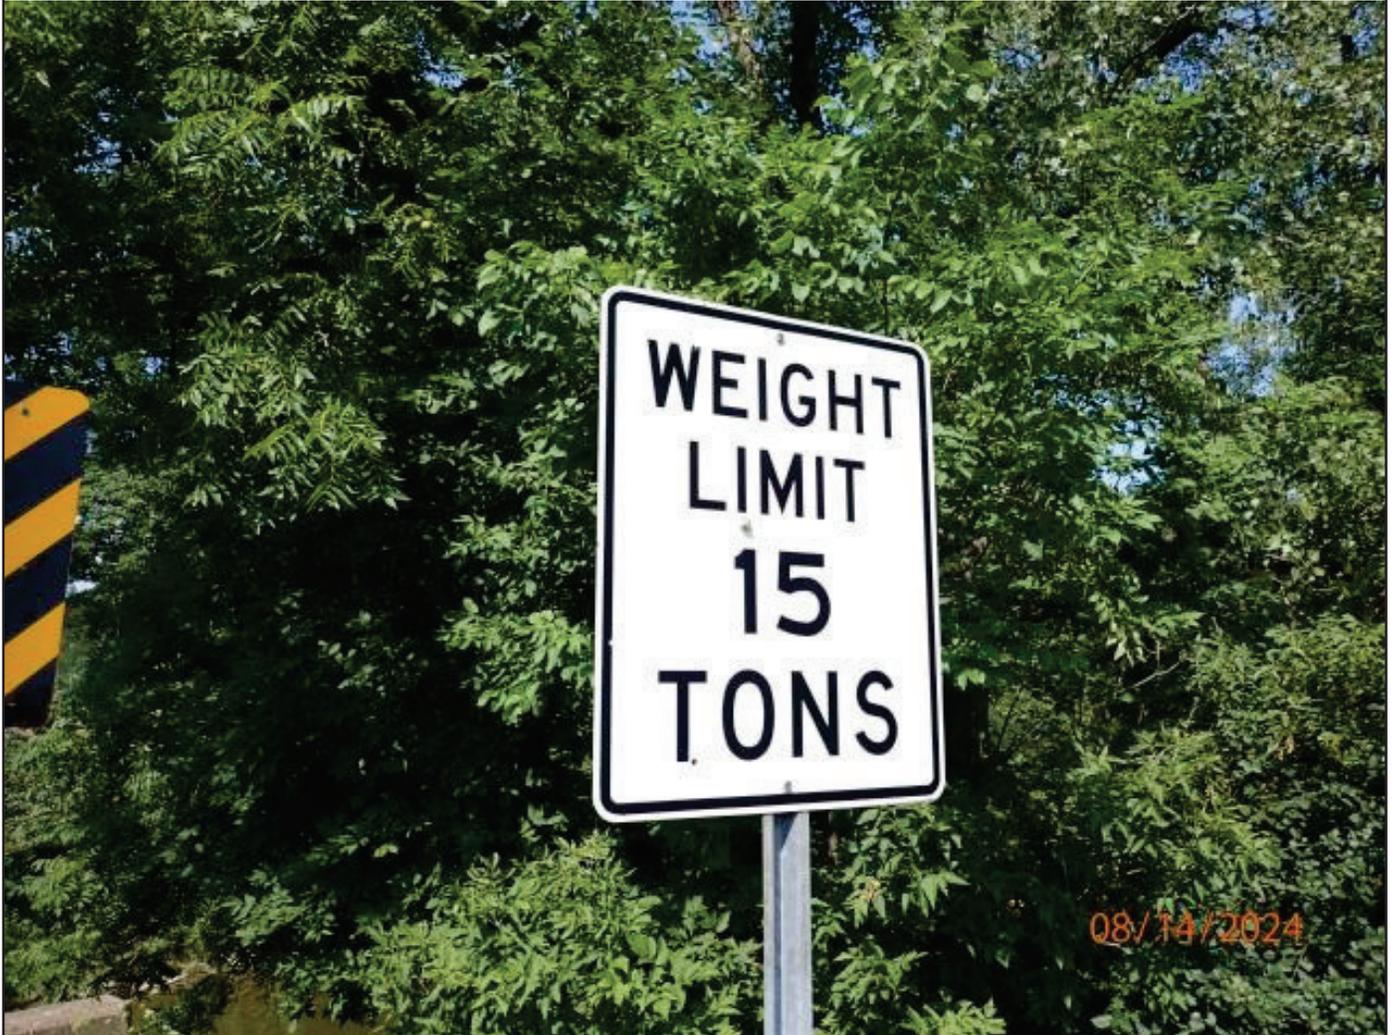
Photo Number: 1

This structure is a steel truss with a stringer-floorbeam system below an open steel grate deck. The structure is load posted for 15 tons; there are load posting signs on both approaches that are in good condition [Photos 1-2].

*Attachment Description: Begin load posting sign – looking End Right*

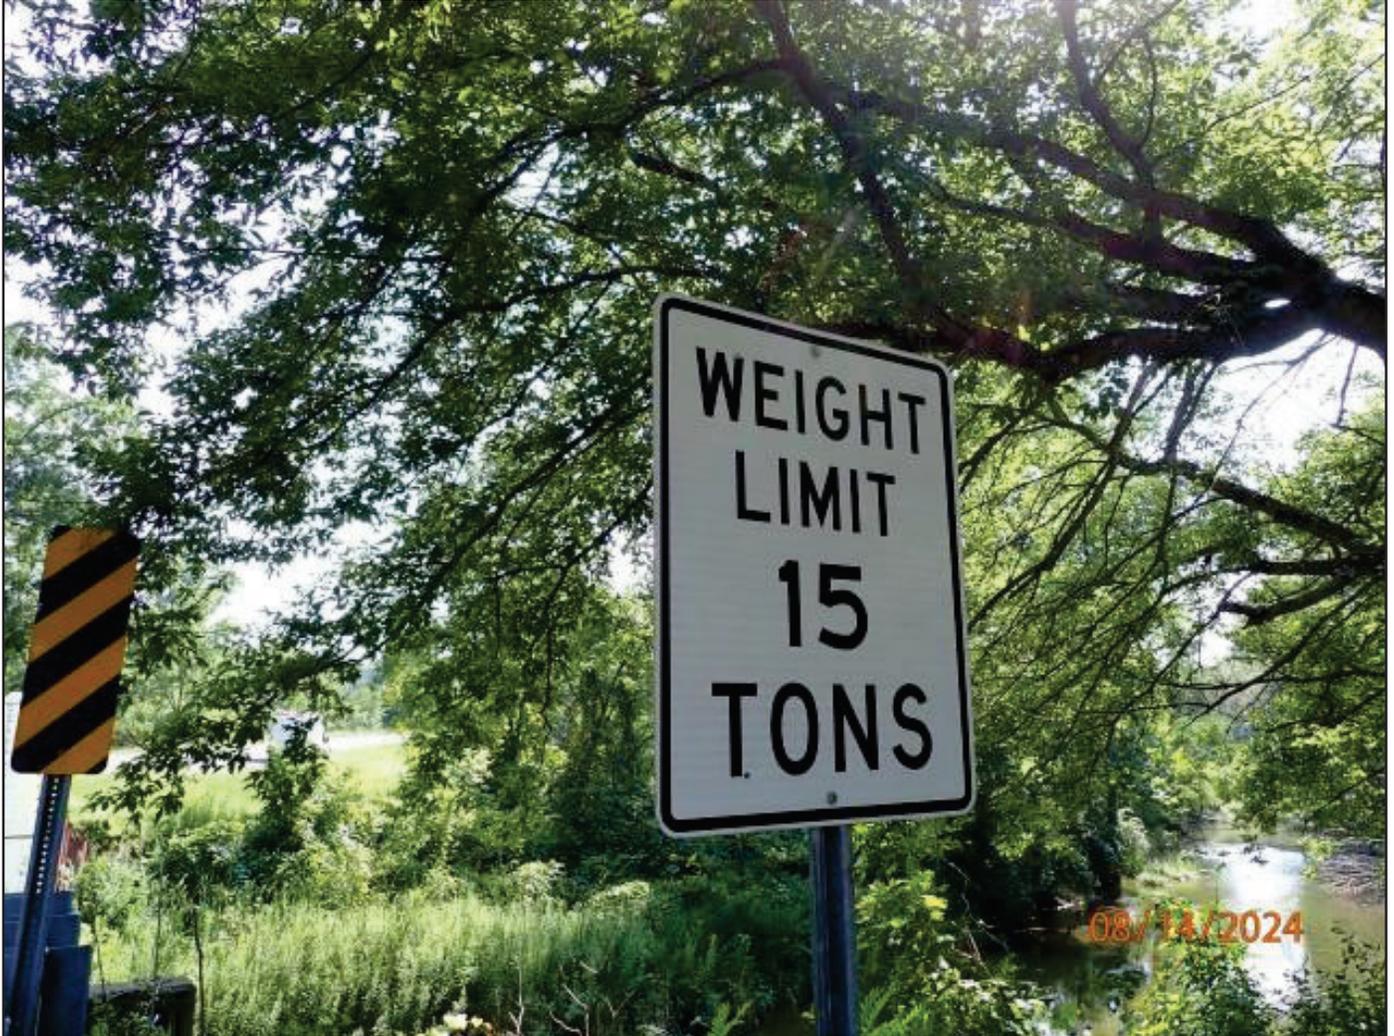
Photo Number: 2

*Attachment Description: End load posting sign – looking Begin Left*
